CMS MOTORHOME INSPECTION FORM

Make & Model	Autotrail Arapaho SE
Reg Number - NO GAP	DF08JLF
HPI Clear	Yes
VAT	No
Engine Size	3.0
BHP	180
Transmission	Manual
Vehicle Weight (kg)	N/A
Miles or KM	Miles
Mileage	44936
Confirm miles (within 5,000)	Yes
Is Mileage Warranted	Yes
Engine Keys Count	2
V5 present	Yes
V5 VIN Match	Yes

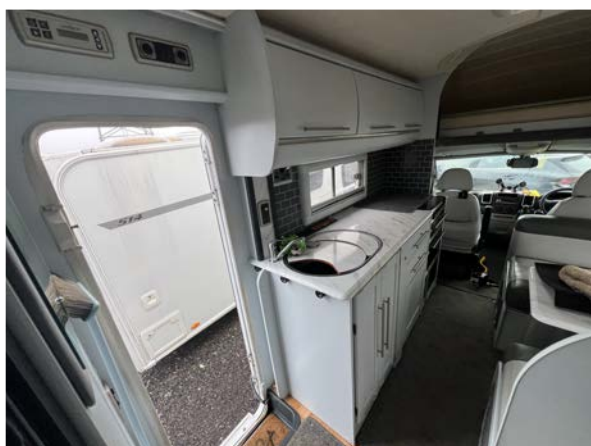
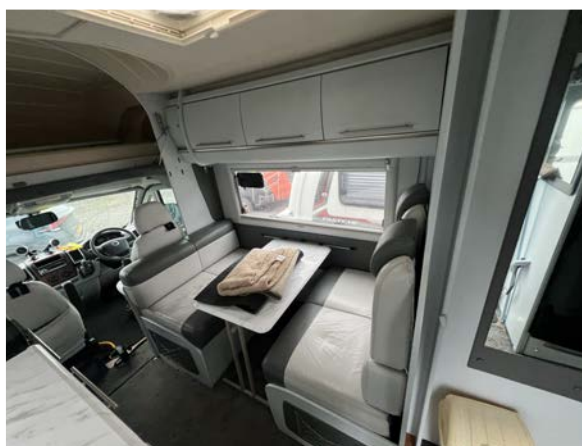
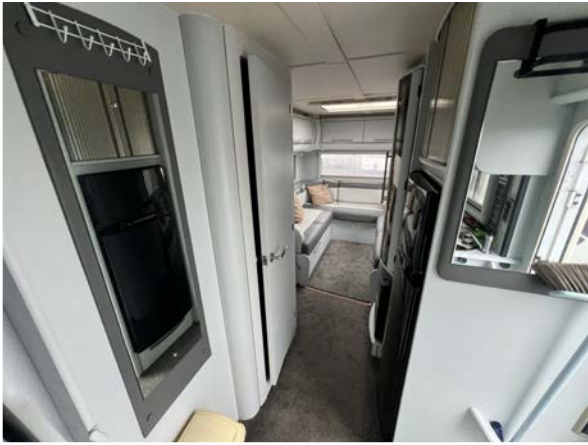
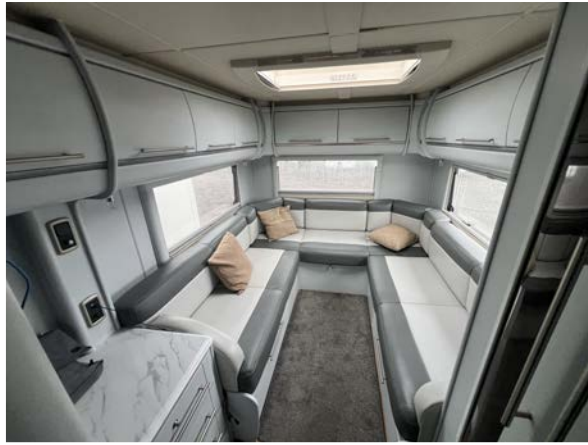
Does internal look original?	Yes
Berths	6
Belts	4
Bed Options	Overcab Bed, U Shape Rear
Lounge Layout	Full Dinette
Layout Correct	Yes
Further Comments	Yes
Further Info	Whole inside re-painted

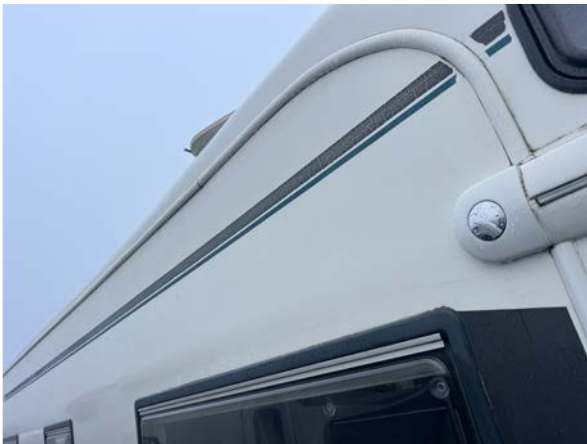
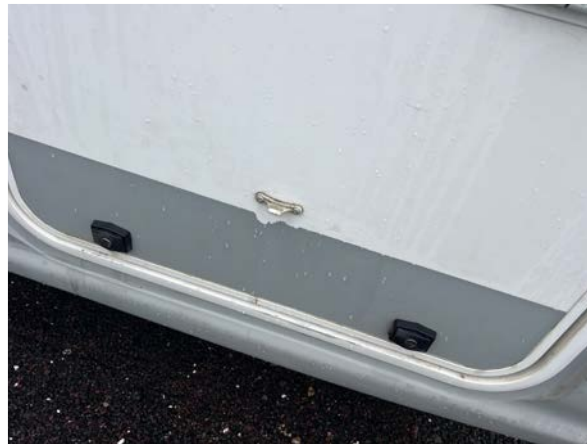
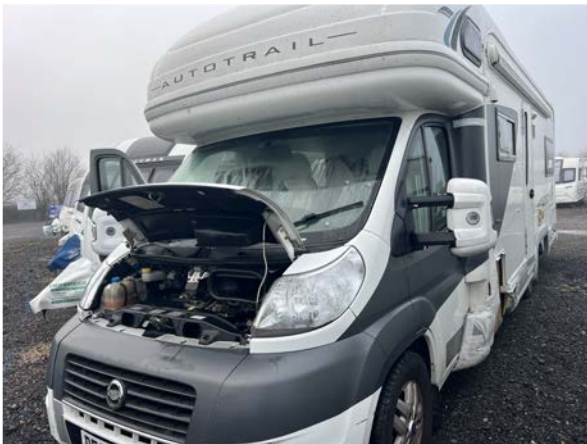
External Extras	Awning, BBQ point, Front fog lights, Tow bar, Ladder, Bike Rack, Reversing camera, Tv Aerial
Other External Extras	N/A
Decals	Need attention
Decals Further Info	Showing signs of age // front end wrapped

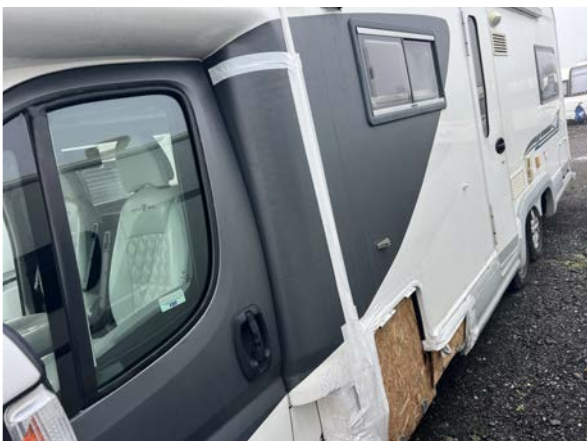
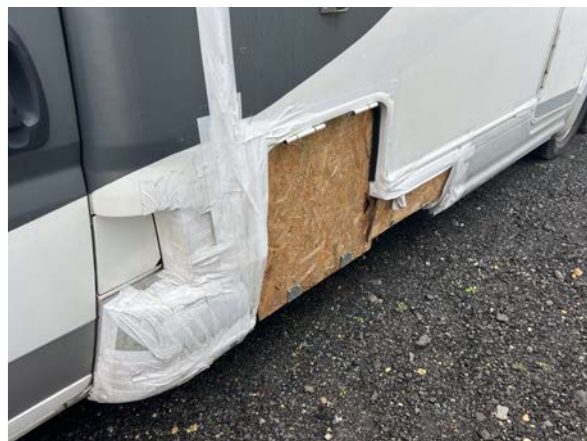
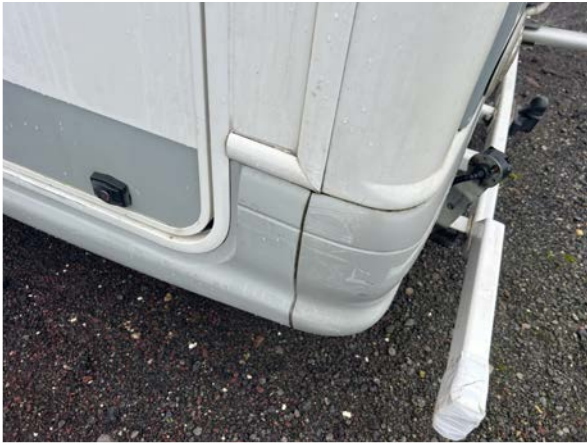
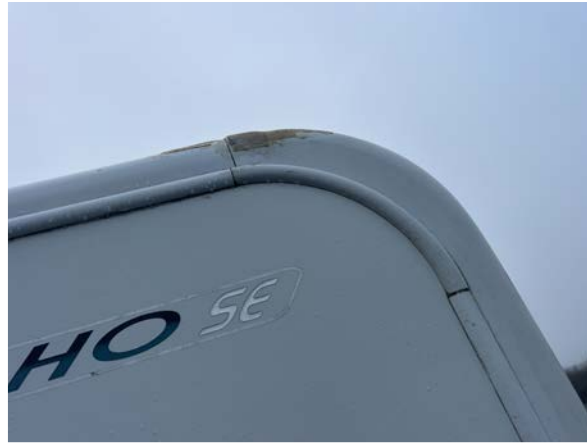
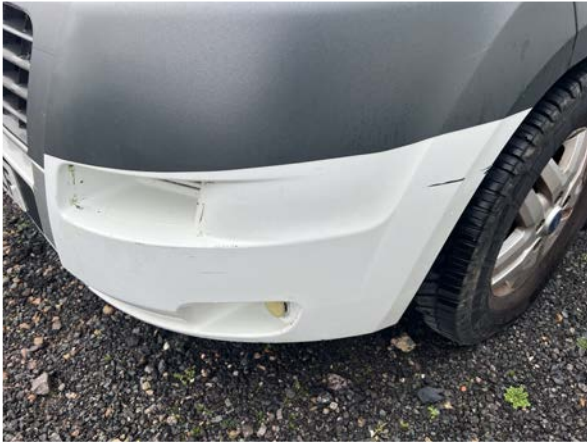
Any Damage Found	Yes
Damage Further Info	Heavy damage to NS // previous repair to NSR roof

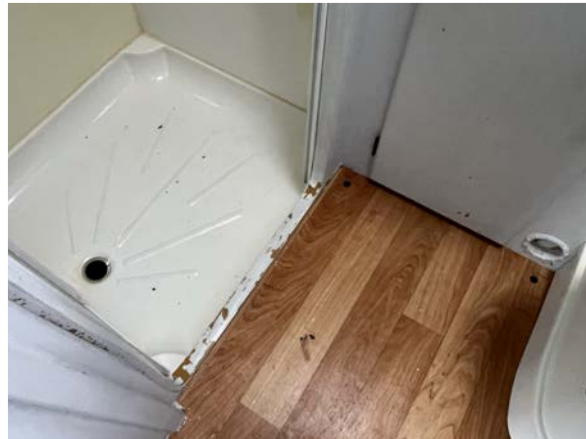
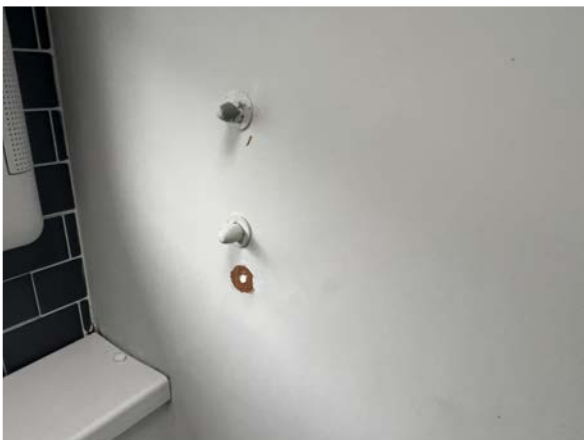
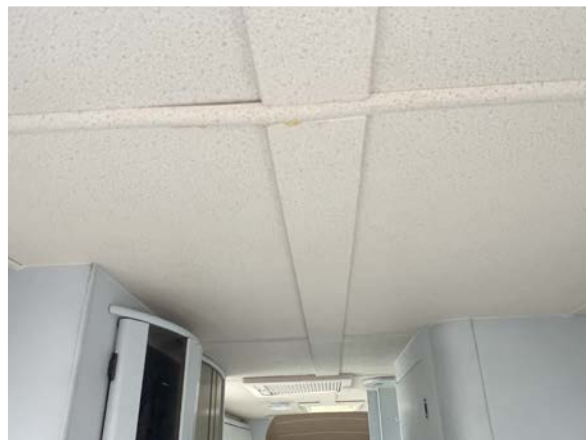
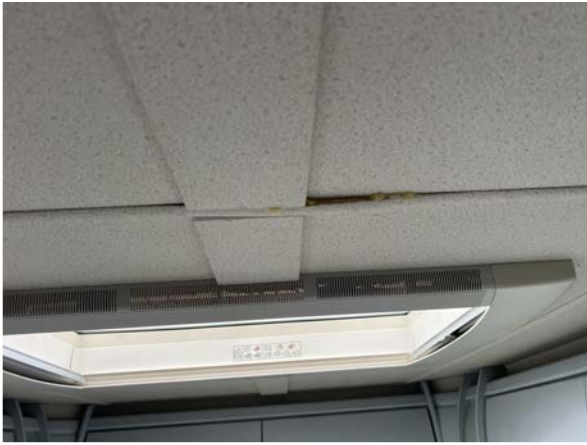
Internal Extras	Alarm, cab A/C, Cab blinds, Carpets, Cruise control, Tv(s), Leather, Oven
Other Extras	N/A
Electrics turn on	Yes
Control panel damaged	No
Stereo turn on	Yes
Smell or signs of smoking	No
Cushions correct	Yes
Boiler present	Yes
Overhead lockers ready	Yes
Internal Damage	Yes
Damage Info	Paint finish damage in areas // roof centre board fitted // roof rear trim glued

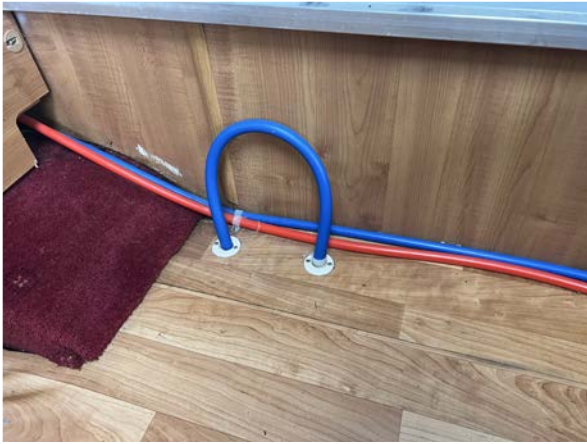
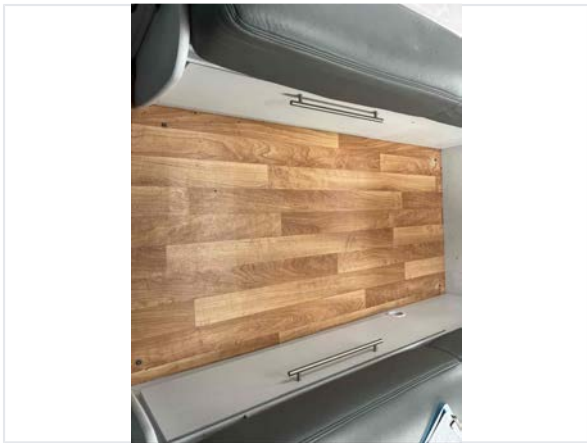
Damp (visible/soft)	Yes
Damp Info	Slight soft around OSR arch
Floor damp/spongy/damaged	Yes
Floor Info	2 areas of delamination - rear U shape and next to forward facing belted seats in kitchen
