CMS MOTORHOME INSPECTION FORM

| Make & Model | Elddis Prestige 120 |
| Reg Number - NO GAP | DG16HLV |

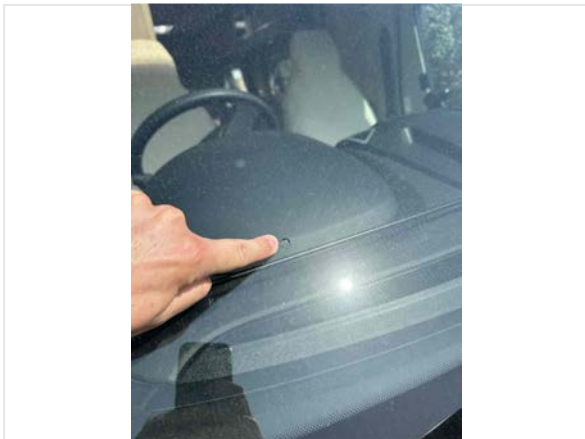
| Windscreen | Chip(s) smaller than 10p |

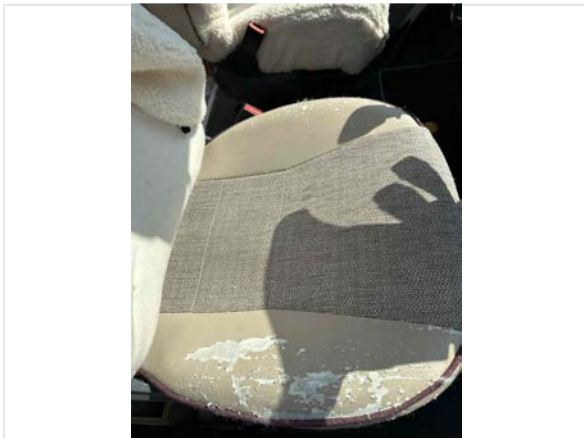
| Internal Damage | Yes |
| Damage Info | Driver seat leather is cracked |

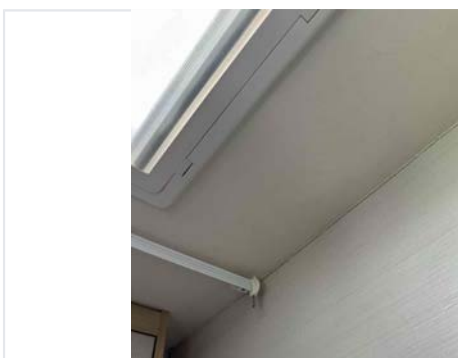
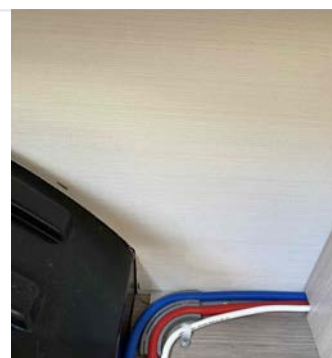
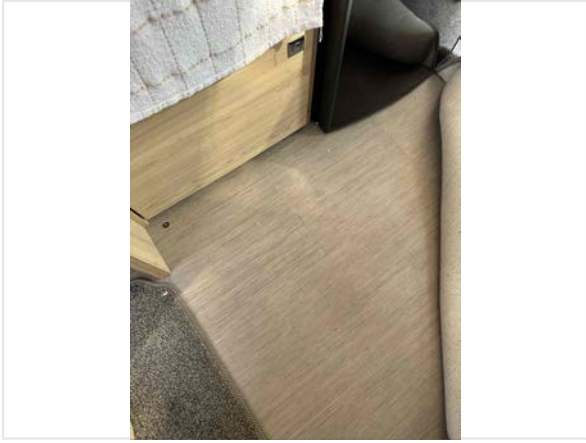
| Damp (visible/soft) | Yes |
| Damp Info | Bathroom roof stained blue // Blue staining on wall under N/S and O/S bench seats in front of wheel arches // Soft dry rot N/S wall behind wheel arch // Pimping on rear wall N/S |
| Floor damp/spongy/damaged | Yes |
| Floor Info | Soft floor next to fridge |
