## CMS MOTORHOME INSPECTION FORM

Make & Model	Elddis Prestige 130
Reg Number - NO GAP	DK12CWC
HPI Clear	Yes
VAT	No
Engine Size	2.2
BHP	110
Transmission	Manual
Vehicle Weight (kg)	3300
Miles or KM	Miles
Mileage	32966
Confirm miles (within 5,000)	Yes
Is Mileage Warranted	Yes
Engine Keys Count	1
V5 present	Yes
V5 VIN Match	Yes

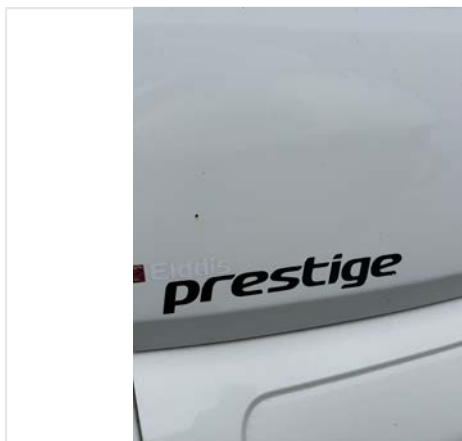
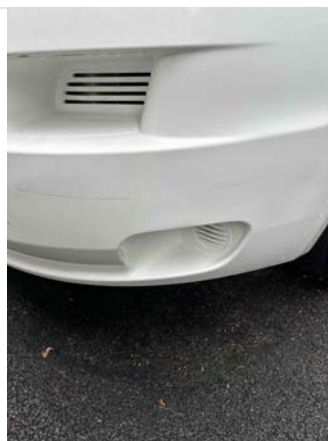
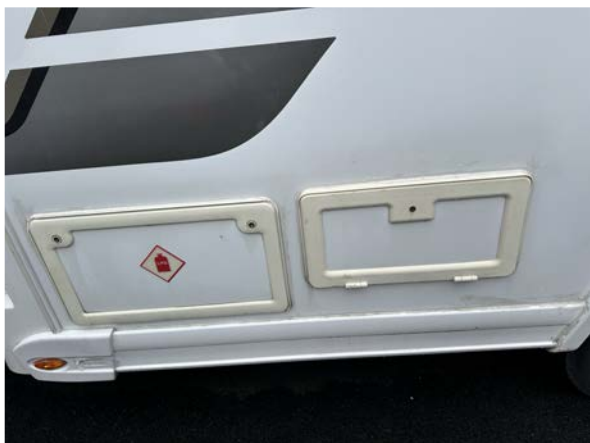
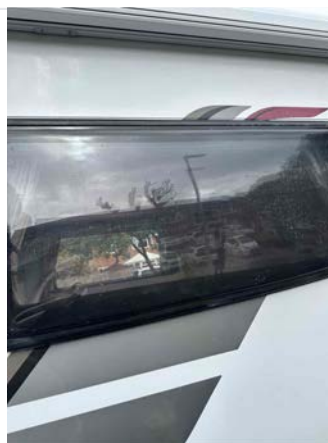
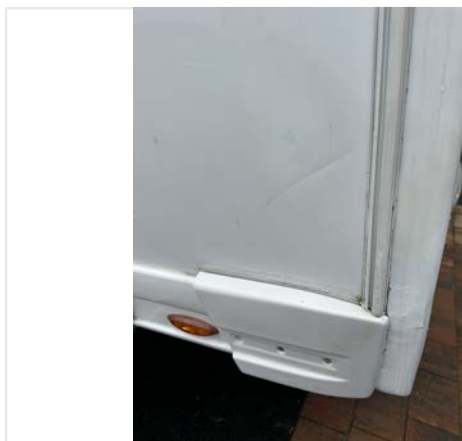
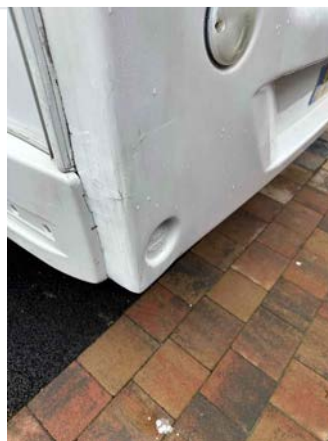
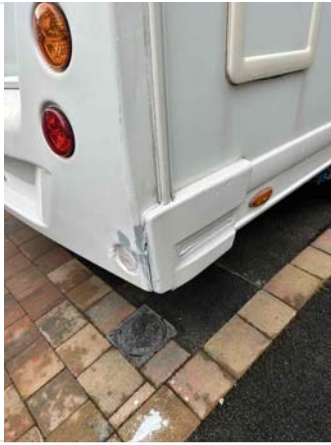
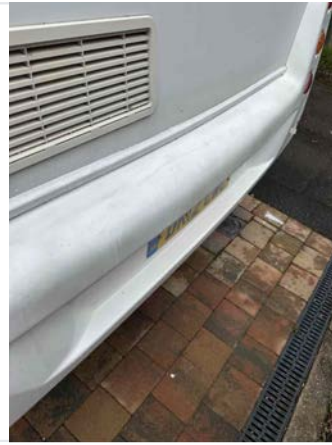
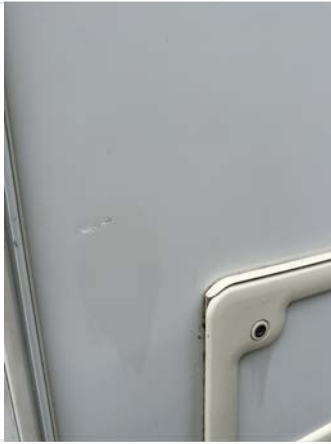
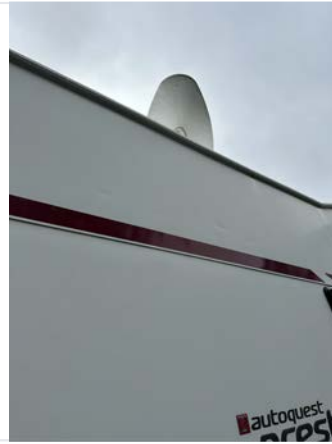
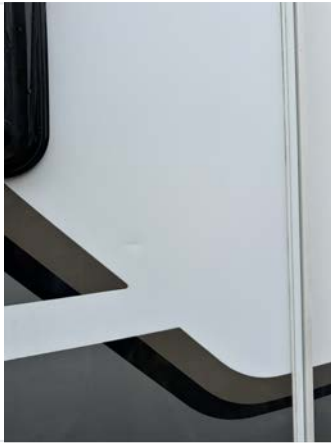
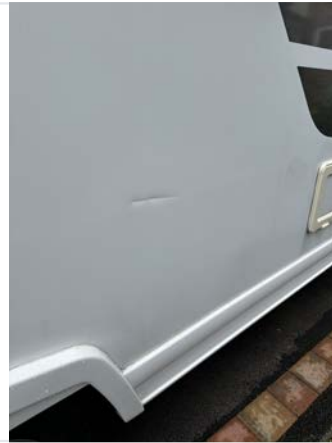
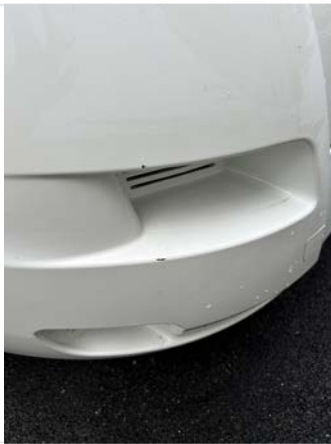
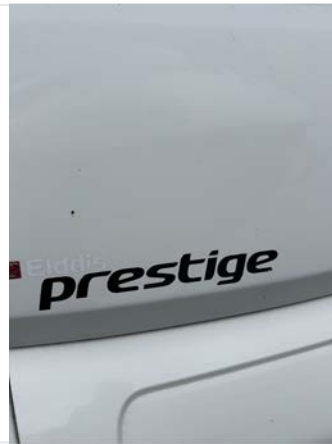
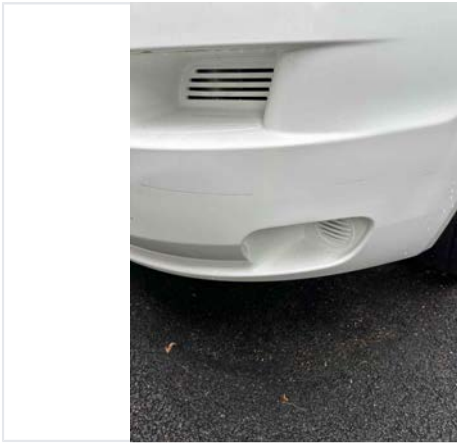
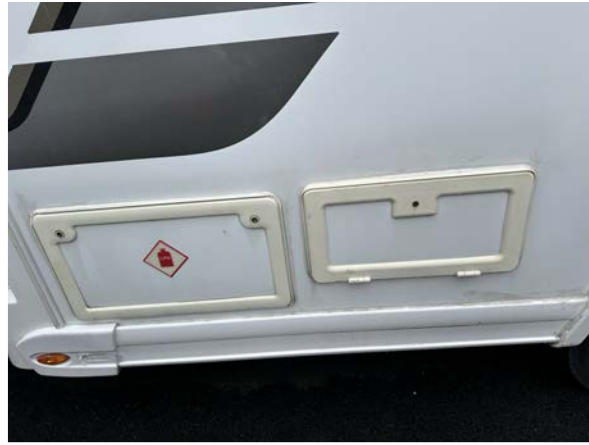
External Extras	Awning, Electric step, Tv Aerial
Other External Extras	N/A
Decals	Good
Any Damage Found	Yes
Damage Further Info	Stone chips on OSF corner and bonnet // Scuff NSF corner // Poor re-seal around N/S lockers // Bush scratches on NS window // Crease on NSR corner // Poor repair on NSR and OSR corners // Damage to rear bumper with bad paint work over the top // Small crack OSR corner // Several dinks on OS upper and below window // Crease on OS panel

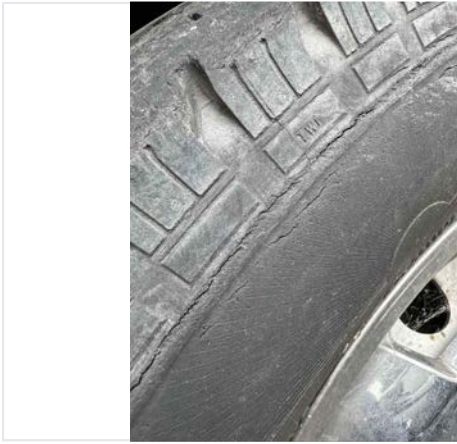
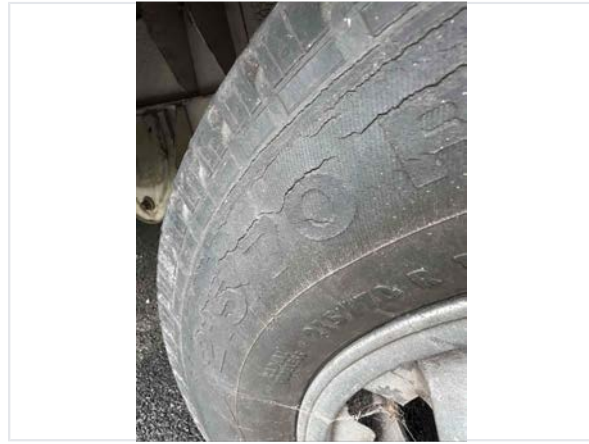
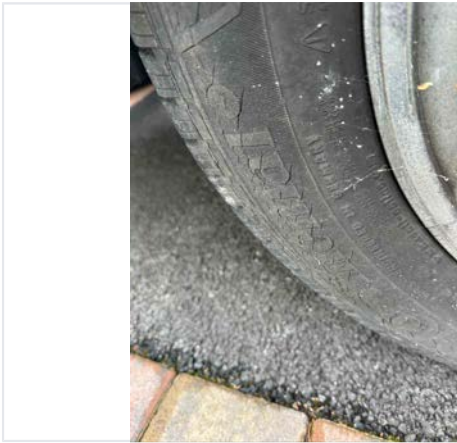
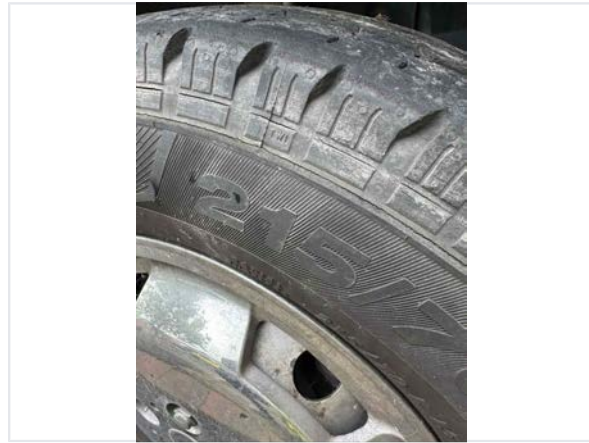
Windscreen	No damage
Alloy Wheels	N/A
Tyres illegal/cracking/out of date	Yes
Tyre Further Info	All tyres are cracking (not dated)

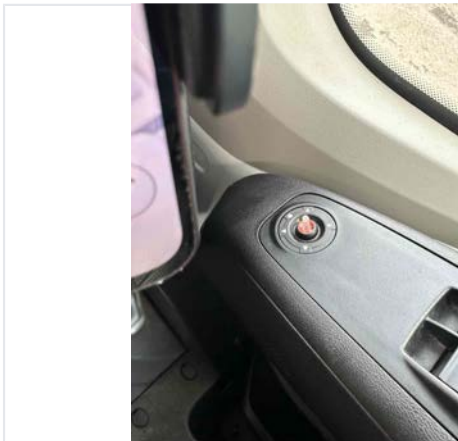
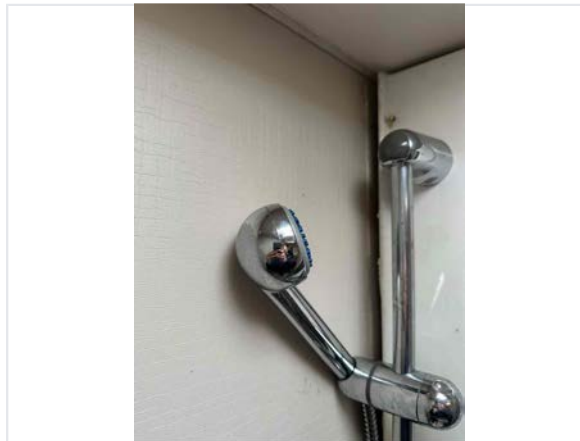
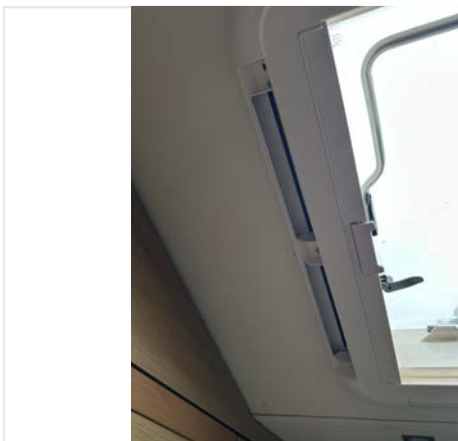
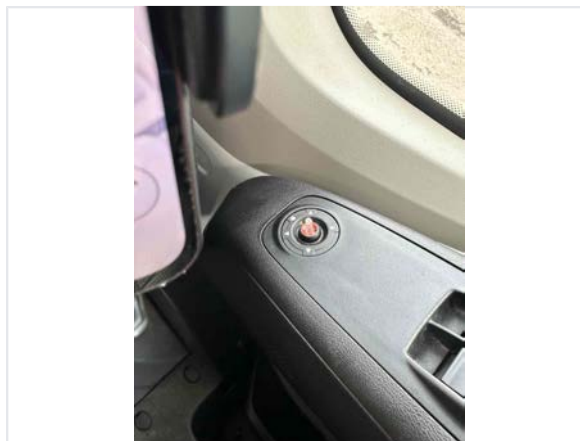
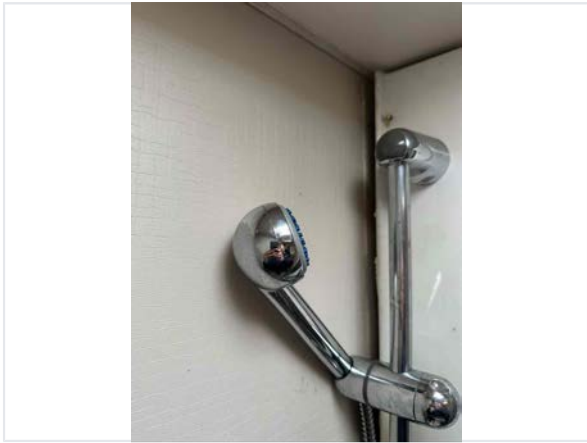
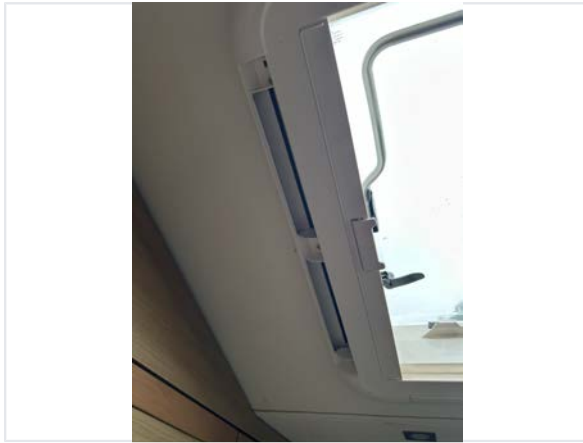
Internal Extras	Cab curtains, Carpets, Multifunction steering wheel, Oven
Other Extras	N/A
Electrics turn on	Yes
Control panel damaged	No
Stereo turn on	Yes
Smell or signs of smoking	No
Cushions correct	Yes
Boiler present	Yes
Overhead lockers ready	Yes
Internal Damage	Yes
Damage Info	Trim missing at side of skylight // Shower panel coming away from wall // Knob missing on mirror adjuster

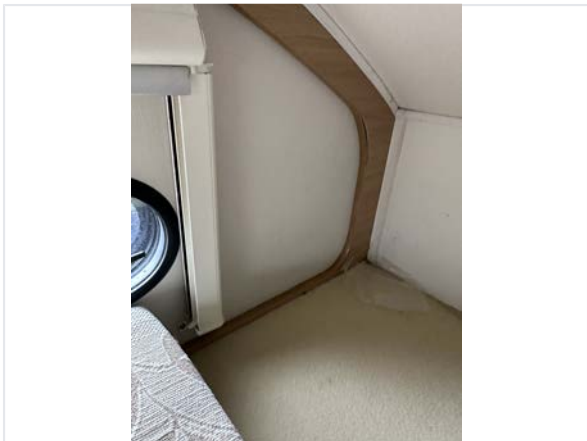
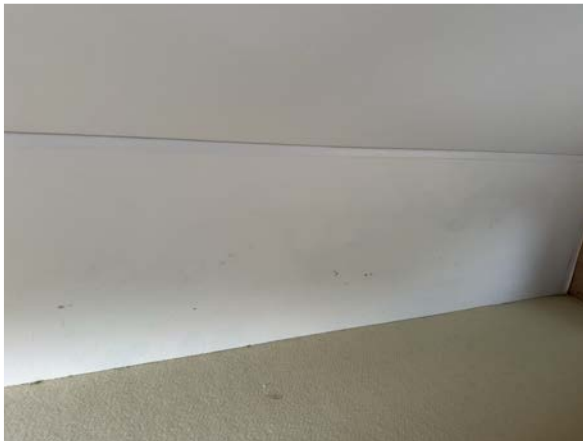
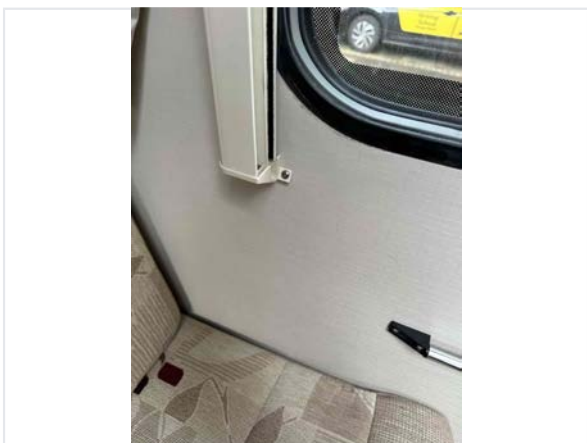
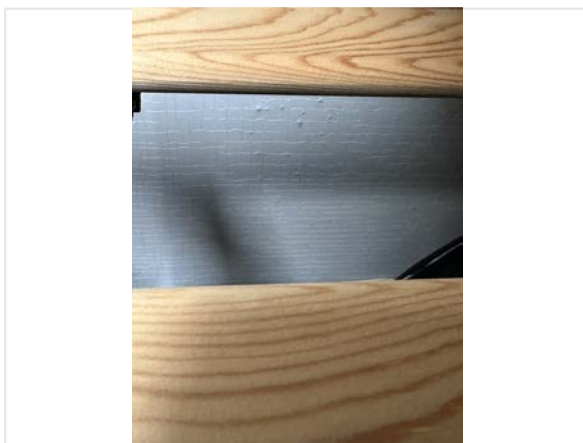
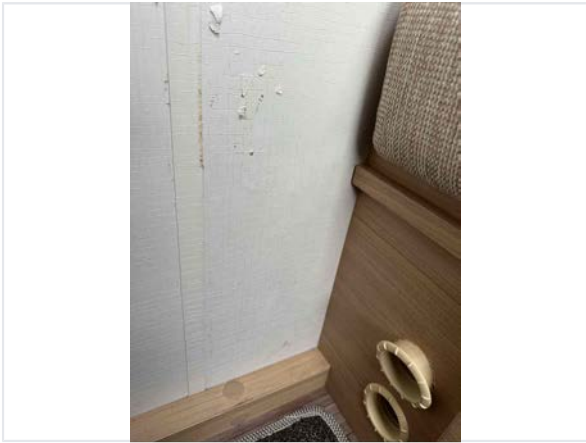
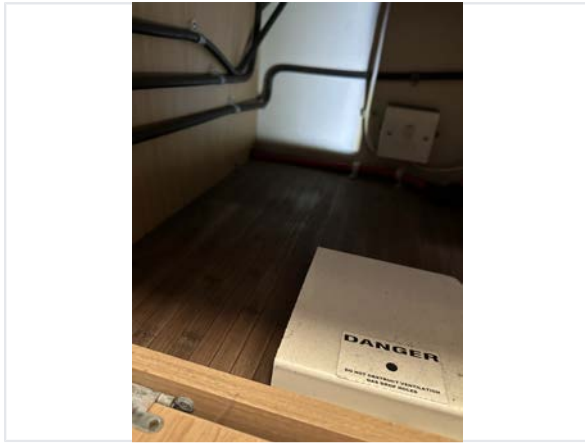
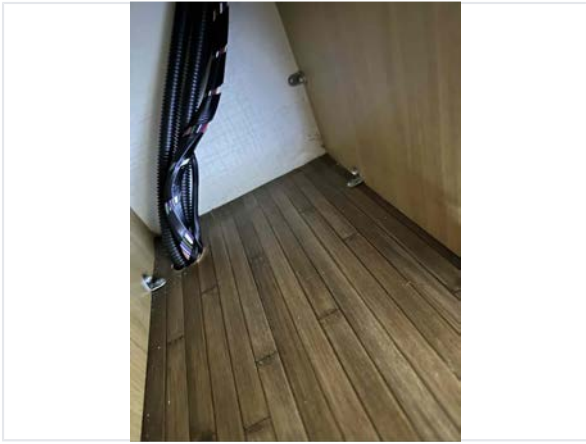
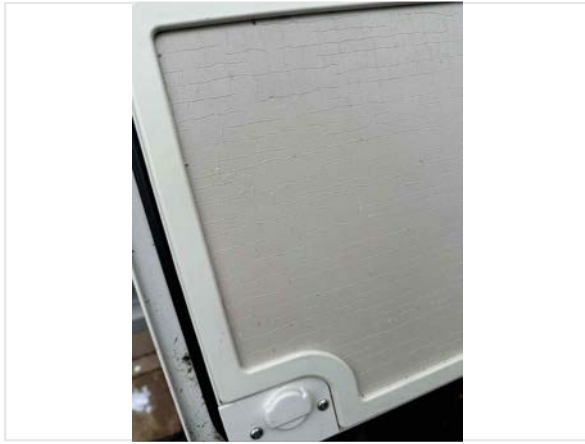
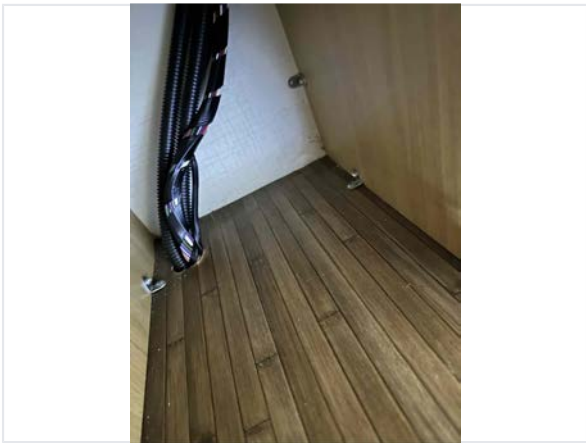
Damp (visible/soft)	Yes
Damp Info	Blue staining on NS and front overcab // Soft and pimpling O/S wall under window and pimpling on wall under forward facing seats // Swollen lower O/S wall between seats // Soft lower rear wall under kitchen area // Pimpling cassette locker door
Floor damp/spongy/damaged	Yes
Floor Info	Soft floor NSR corner
