CMS MOTORHOME INSPECTION FORM

Make & Model	Swift Escape 624
Reg Number - NO GAP	FN63SYA
HPI Clear	Yes
VAT	No
Engine Size	2.3
BHP	130
Transmission	Manual
Vehicle Weight (kg)	3300
Miles or KM	Miles
Mileage	71847
Confirm miles (within 5,000)	Yes
Is Mileage Warranted	Yes
Engine Keys Count	2
V5 present	Yes
V5 VIN Match	Yes

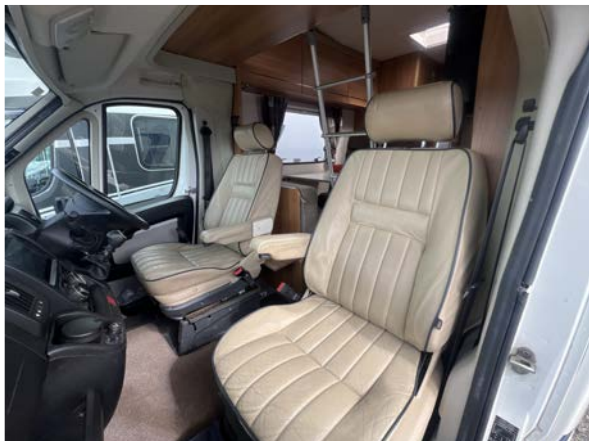
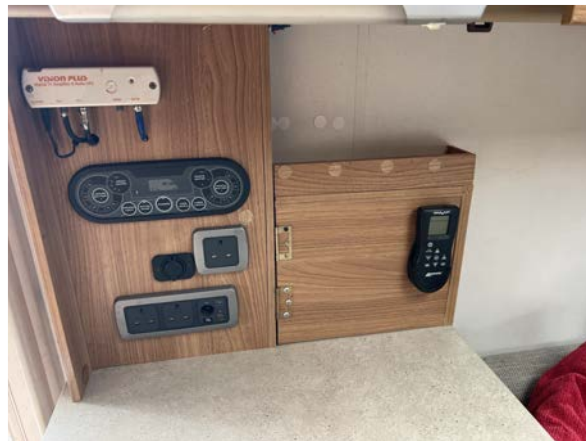
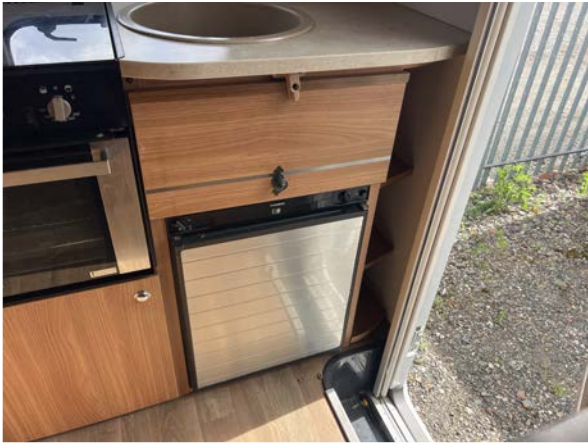
Does internal look original?	No
Notes	Cab seats non standard // fridge changed // woodwork modified in places
Berths	4
Belts	4
Bed Options	Bench Seats
Lounge Layout	Full Dinette
Layout Correct	Yes
Further Comments	N/A

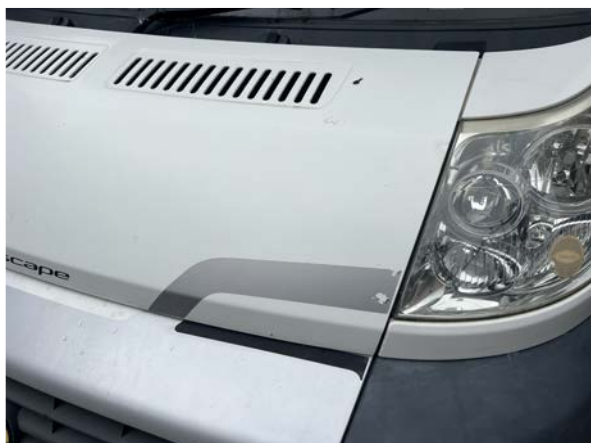
External Extras	Air Suspension, Alloys, Awning, BBQ point, Bike Rack, Reversing camera, Tow bar, Gaslow, Satellite dish, Solar panel, Tv Aerial
Other External Extras	N/A
Decals	Need attention
Decals Further Info	NS bonnet decal flake

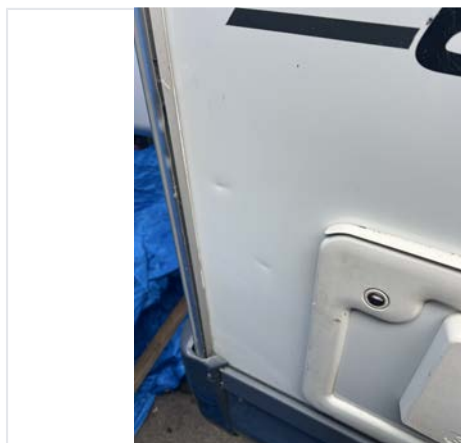
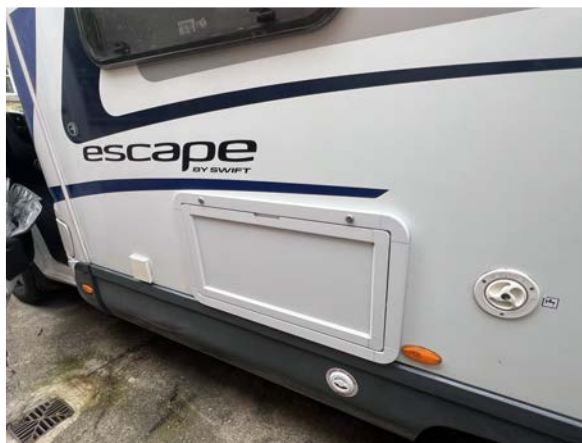
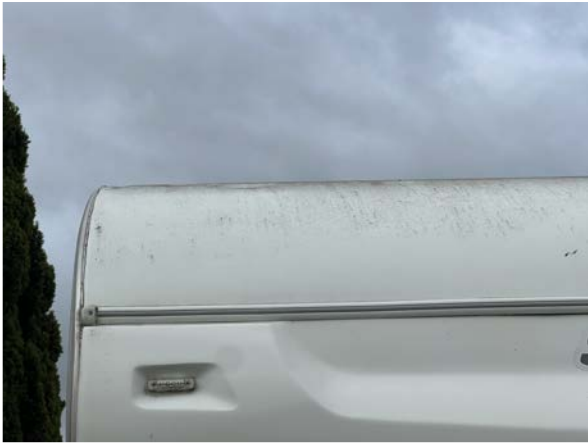
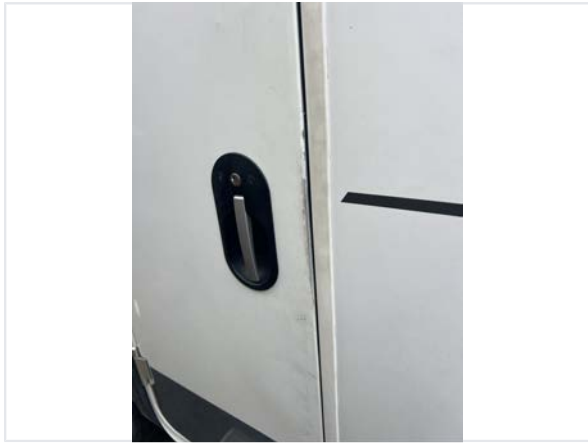
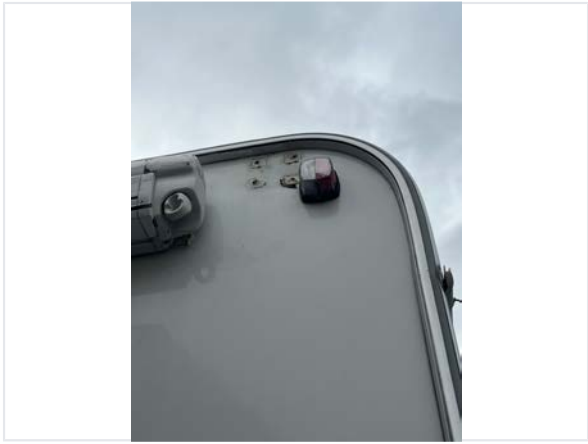
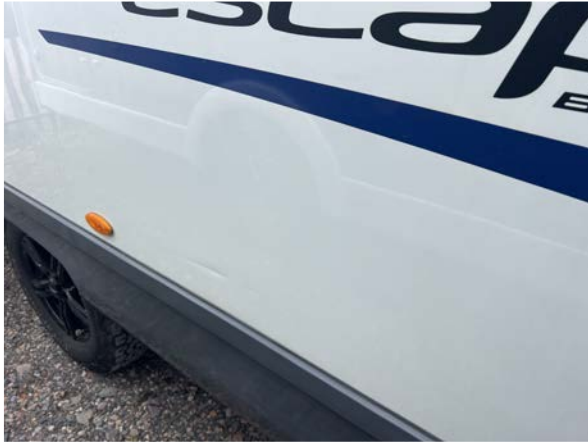
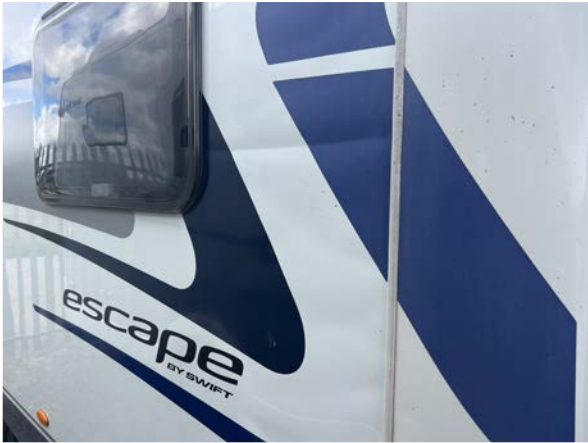
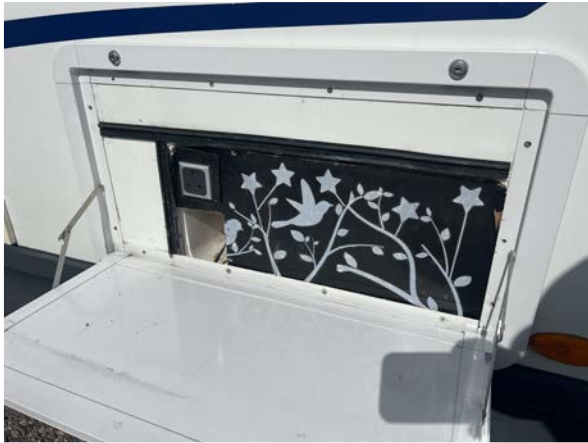
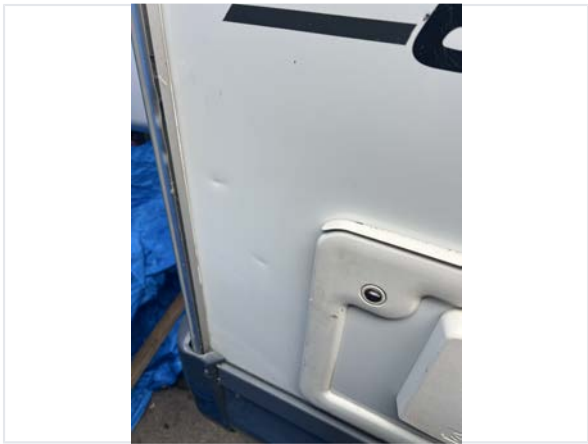
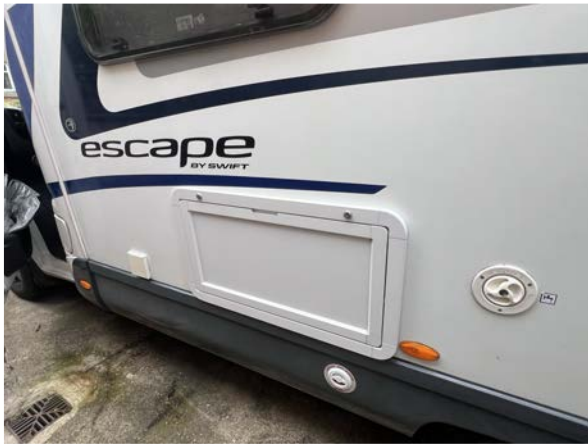
Any Damage Found	Yes
Damage Further Info	OS dent // OSR small dents behind cassette locker // NSR corner damage // NS locker door changed // dent to OS o/cab // NSR high level // crease to front of OS dinette window // leisure battery's reboxed

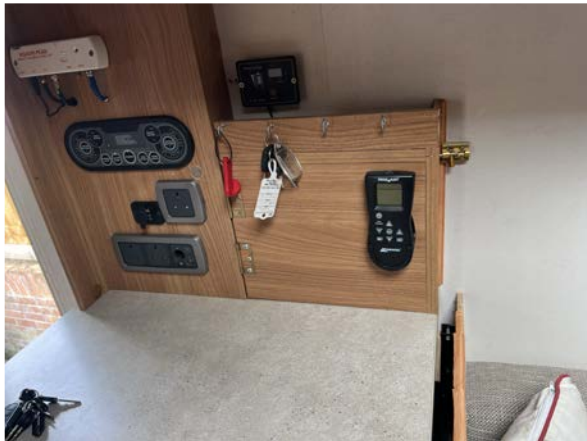
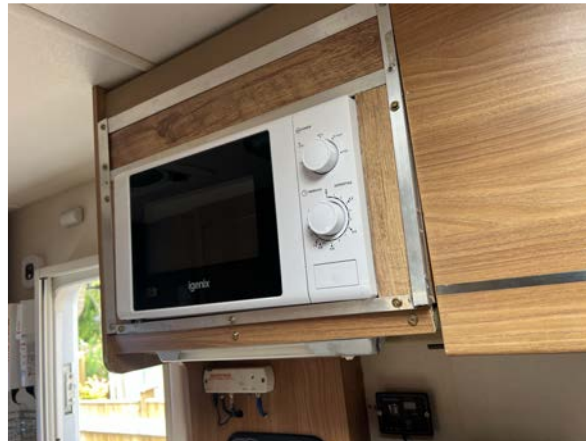
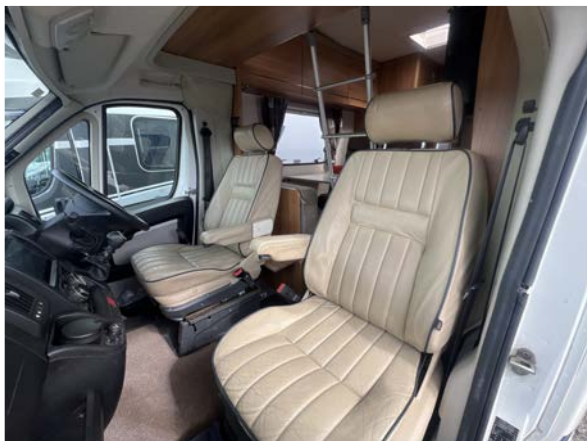
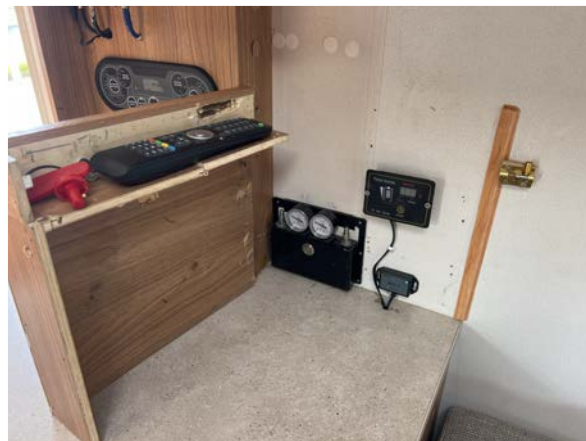
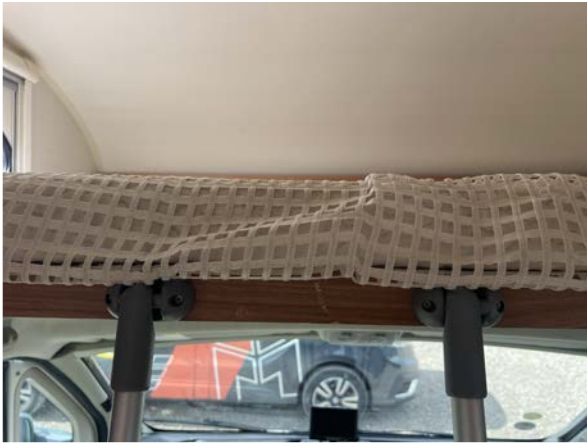
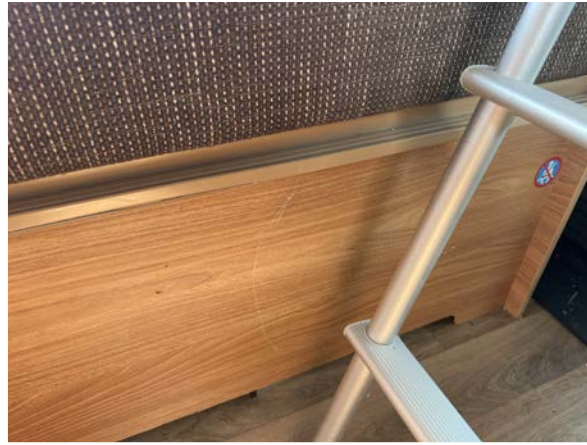
Internal Extras	cab A/C, Bluetooth, Cab blinds, Oven, Tv(s), Climate control, Diesel heater, Upgraded stereo
Other Extras	N/A
Electrics turn on	Yes
Control panel damaged	No
Stereo turn on	Yes
Smell or signs of smoking	No
Cushions correct	Yes
Boiler present	Yes
Overhead lockers ready	Yes
Internal Damage	Yes
Damage Info	Wood work / displays modified // cab seats aftermarket // areas of wood finish damage

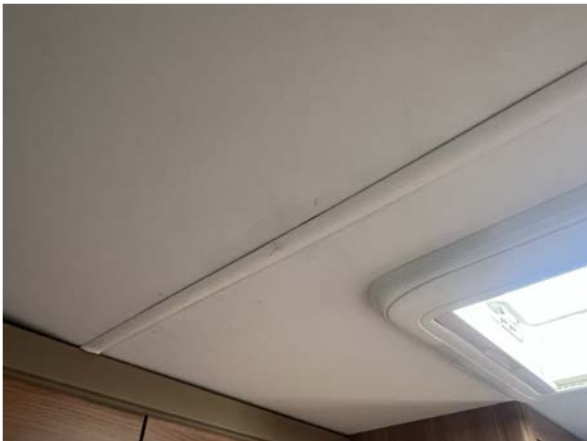
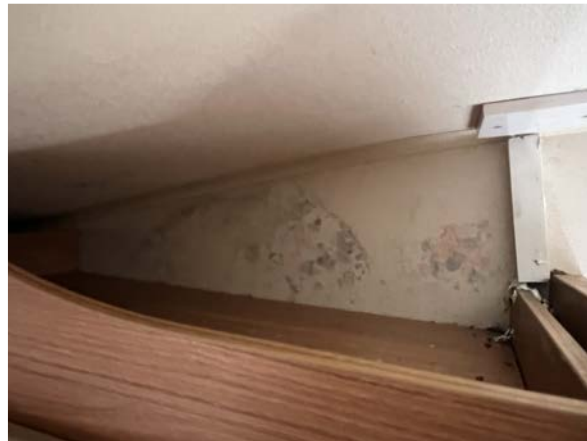
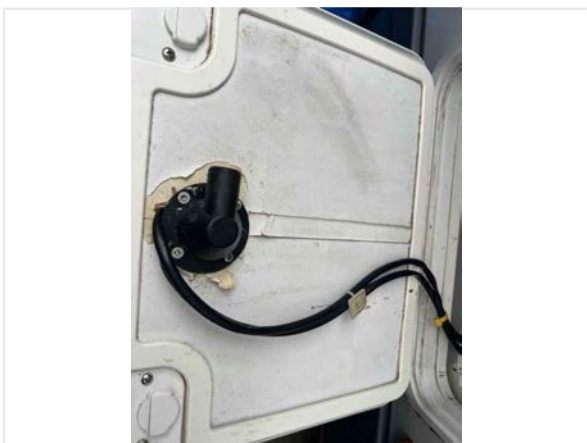
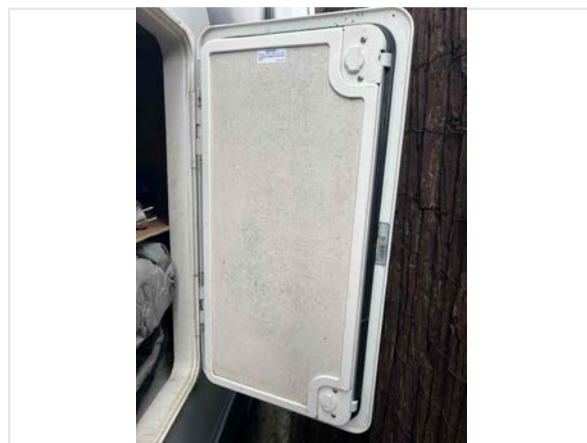
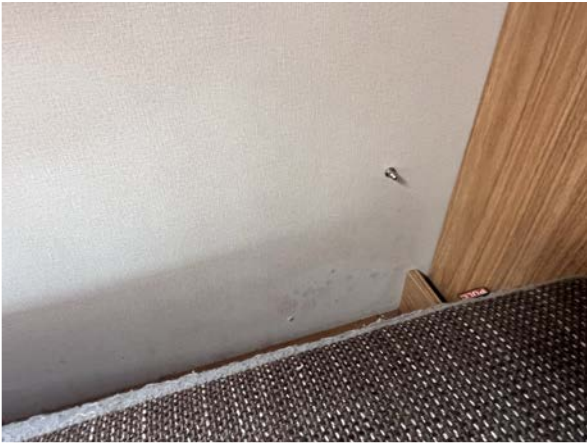
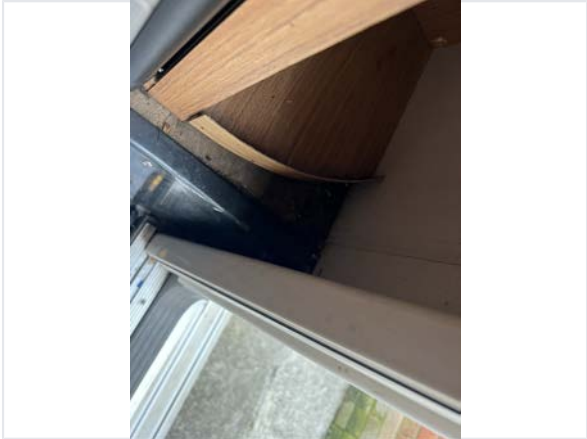
Damp (visible/soft)	Yes
Damp Info	Staining and pimpling in roof behind centre skylight // stain in NS high level wall above cupboards // staining in both OS locker doors // light stains behind front edge of NS bench cushions
Floor damp/spongy/damaged	Yes
Floor Info	Small area of swelling in floor behind Hab door step
