CMS MOTORHOME INSPECTION FORM

Make & Model	Elddis Autoquest 120
Reg Number - NO GAP	HX10EZL
HPI Clear	Yes
VAT	No
Engine Size	2.2
BHP	99
Transmission	Manual
Vehicle Weight (kg)	3000
Miles or KM	Miles
Mileage	35298
Confirm miles (within 5,000)	Yes
Is Mileage Warranted	Yes
Engine Keys Count	2
V5 present	Yes
V5 VIN Match	Yes

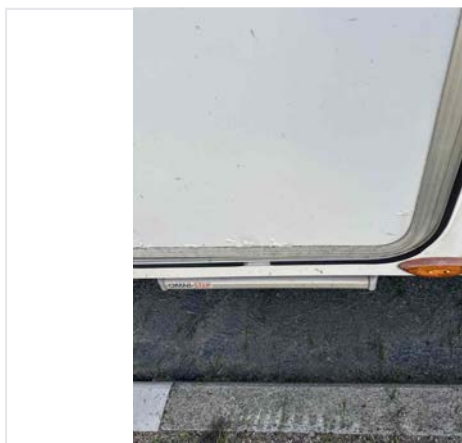
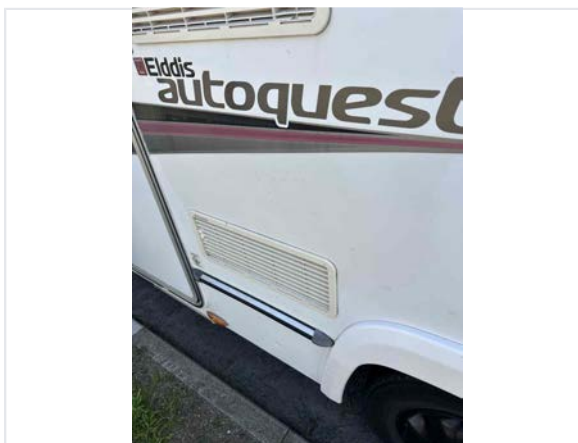
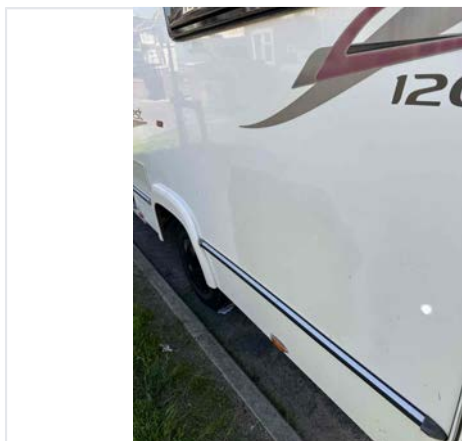
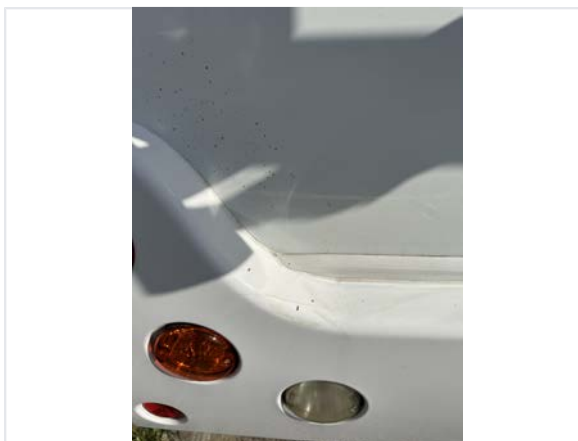
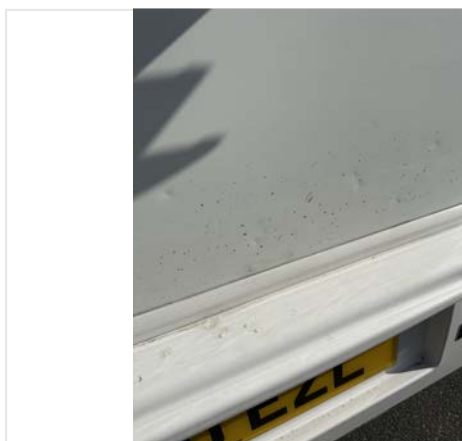
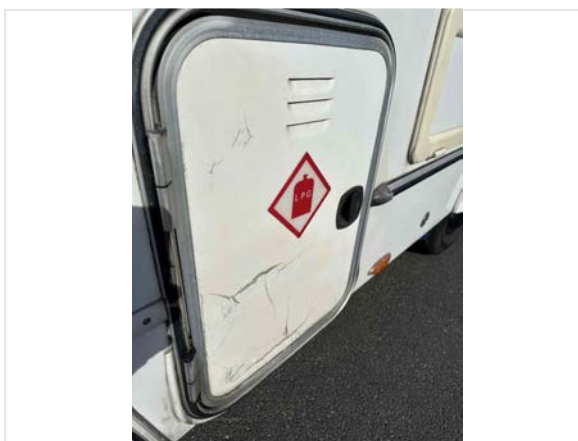
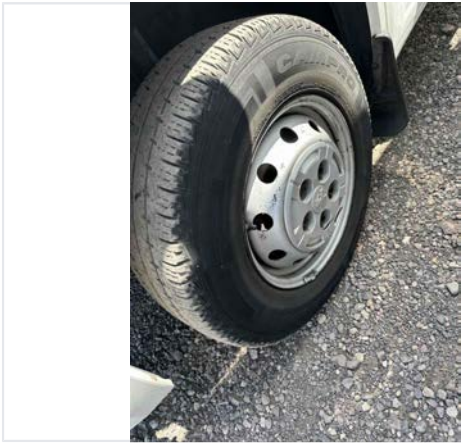
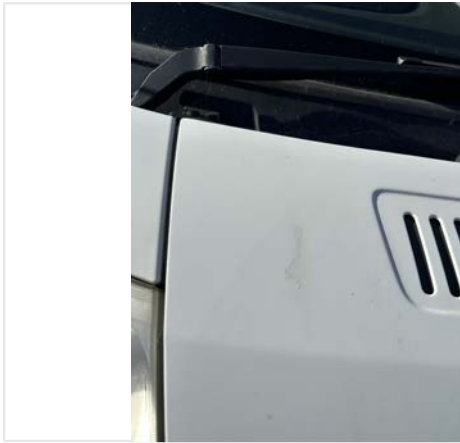
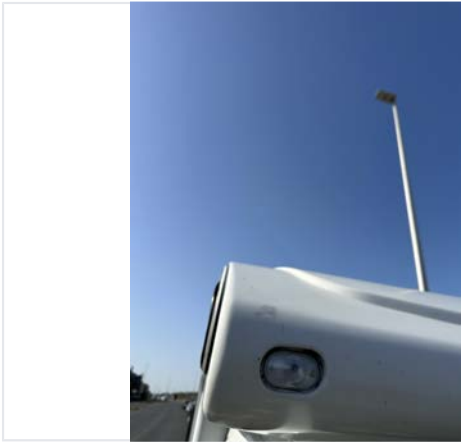
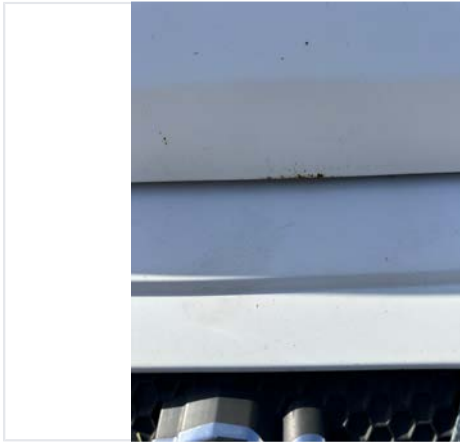
External Extras	Bike Rack, Electric step, Reversing camera, Solar panel, Tv Aerial
Other External Extras	N/A
Decals	Good
Any Damage Found	Yes
Damage Further Info	Paint mark on bonnet and rust under lip of bonnet // Mark on OS overcab // Bobbling on bottom of habitation door // Pitting and two patches of delamination on NS panel // 3-4 small dinks on NS panel // Areas of pitting on rear // Hairline crack on NSR bumper // Marks on gas locker door

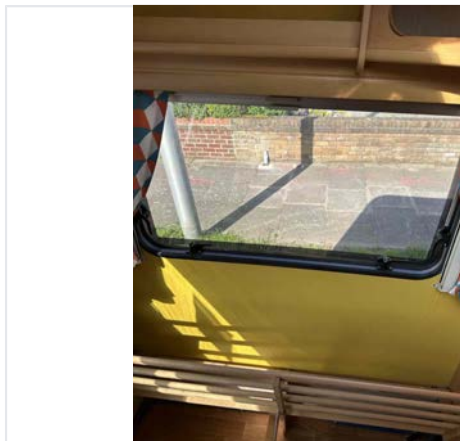
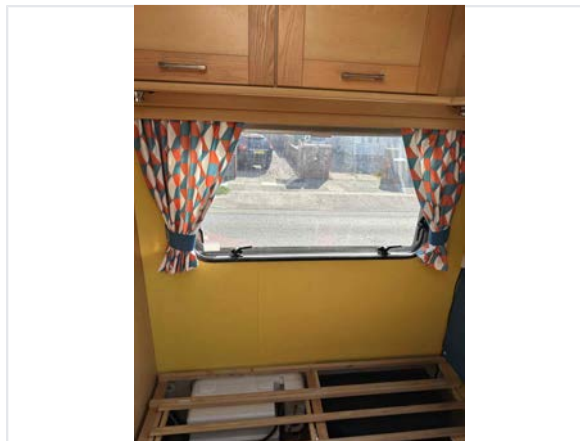
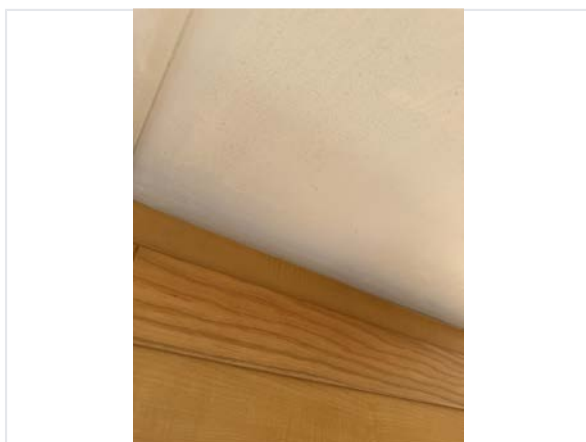
Internal Extras	Multifunction steering wheel, Oven, Cab curtains
Other Extras	N/A
Electrics turn on	Yes
Control panel damaged	No
Stereo turn on	Yes
Smell or signs of smoking	No
Cushions correct	Yes
Boiler present	Yes
Overhead lockers ready	Yes
Internal Damage	Yes
Damage Info	Rear walls have been painted yellow // Roof has been painted

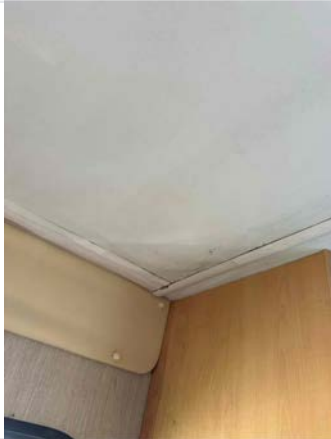
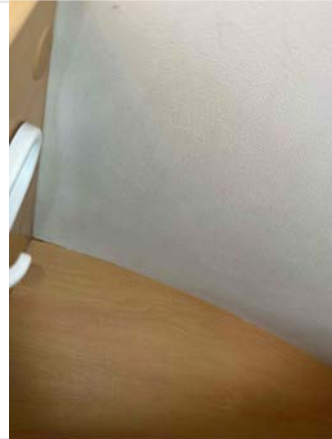
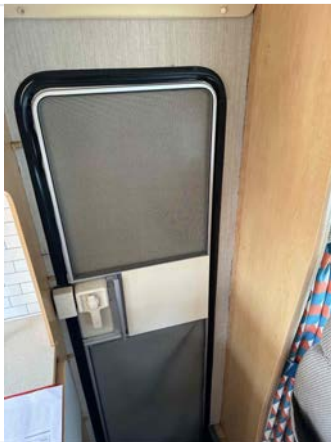
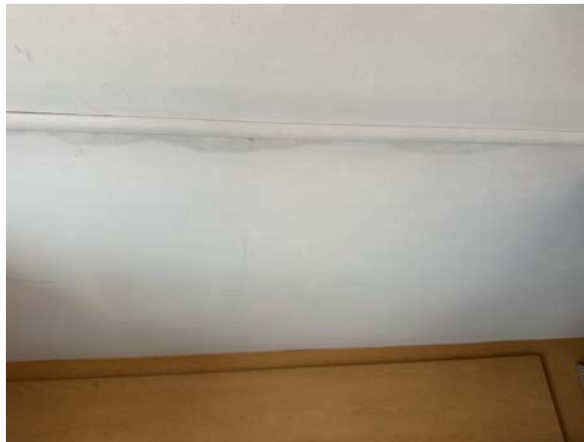
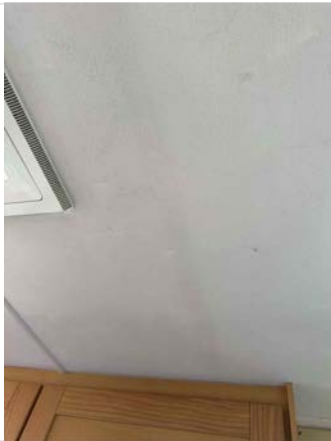
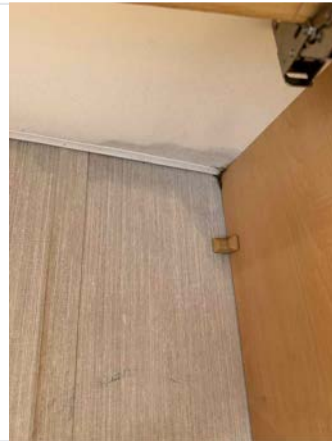
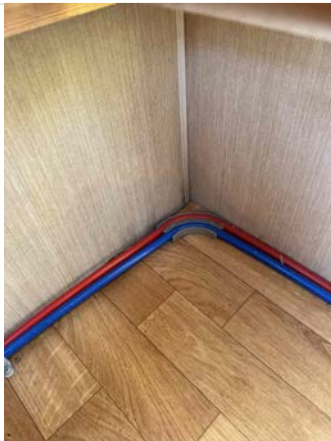
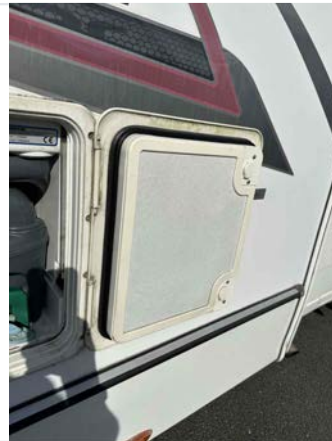
Damp (visible/soft)	Yes
Damp Info	Roof above habitation door running into NS overcab is soft // Wall right side of habitation door is soft // Stain on roof before overcab // Stain on roof in front of middle vent //N/S

wall is overhead lockers is stained // Staining to lower walls NSR corner under bench // Cassette locker soft

Floor next to habitation door is soft
