CMS MOTORHOME INSPECTION FORM

Make & Model	Burstner Lyseo Harmony TD 734
Reg Number - NO GAP	HX18DMU
HPI Clear	Yes
VAT	No
Engine Size	2.3L
BHP	148
Transmission	Manual
Vehicle Weight (kg)	4T
Miles or KM	Miles
Mileage	27966
Confirm miles (within 5,000)	Yes
Is Mileage Warranted	Yes
Engine Keys Count	2
V5 present	Yes
V5 VIN Match	Yes

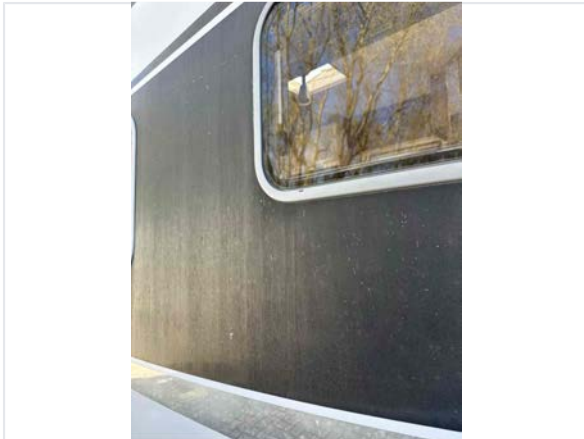
External Extras	Awning, Alloys, BBQ point, Electric step, Front fog lights, Gaslow, Reversing camera, Solar panel
Decals	Need attention
Decals Further Info	NS decals very fine cracking

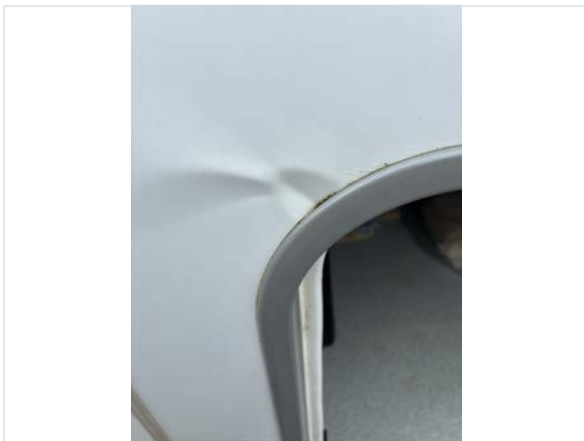
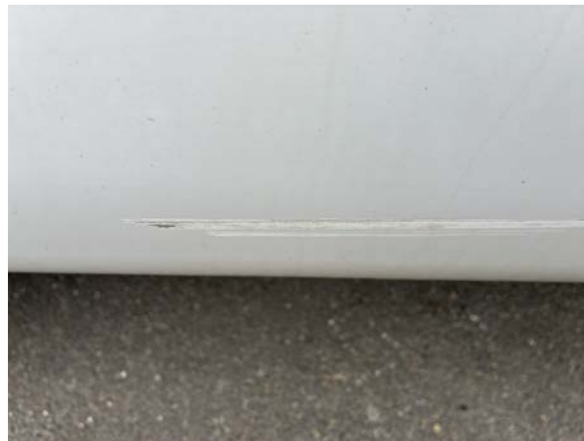
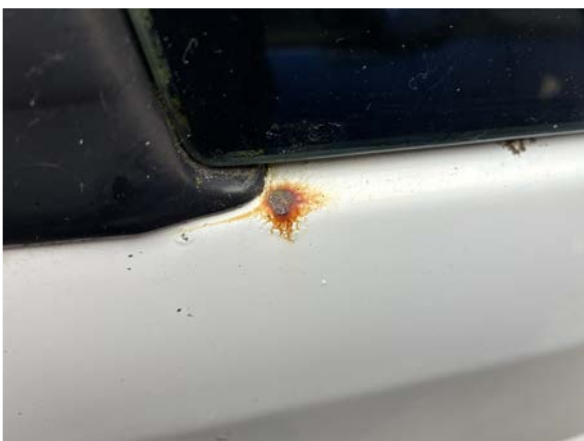
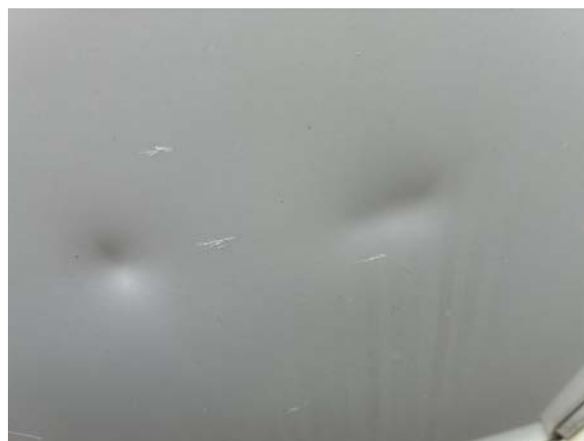
Any Damage Found	Yes
Damage Further Info	Crease above off side garage door // Rust spot on drivers door // two small dents on NS lower panel // Scratch on off side skirt near rear wheel

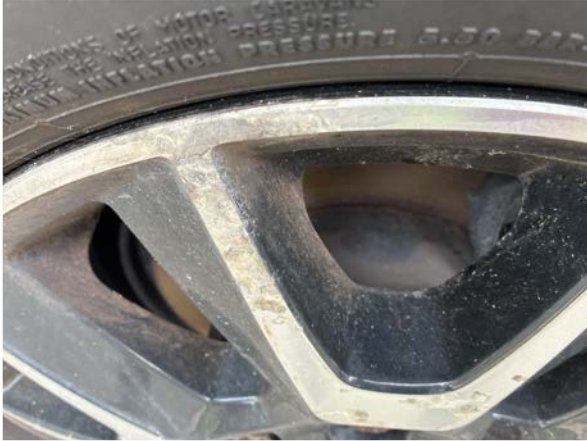
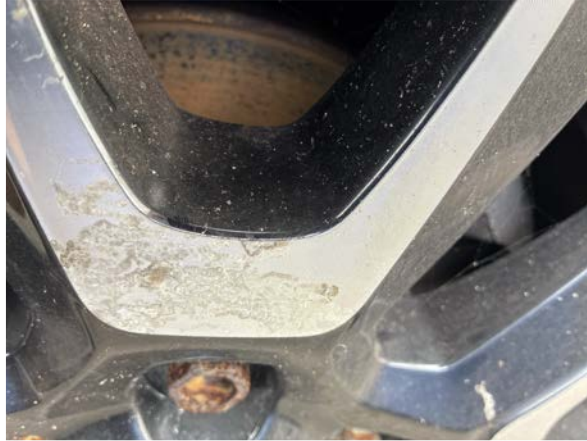
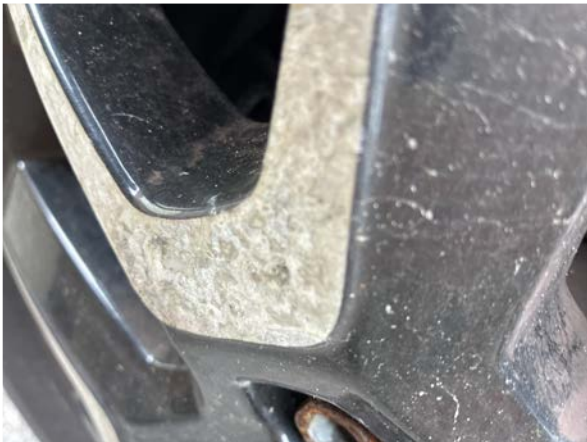
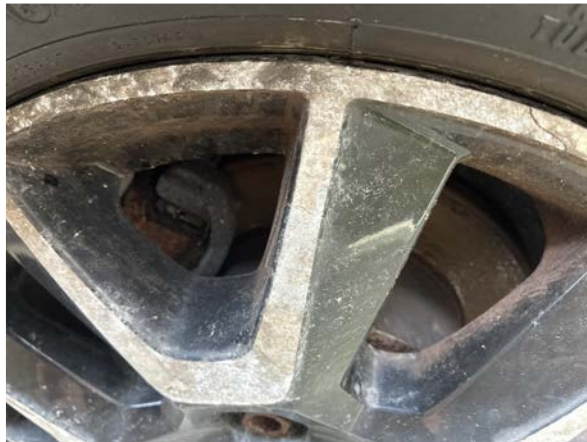
Alloy Wheels	Need attention
Alloy Further Info	All four showing oxidation
