CMS MOTORHOME INSPECTION FORM

Make & Model	Elddis Sunseeker 200
Reg Number - NO GAP	WJ06GBE
HPI Clear	Yes
VAT	No
Engine Size	2.2
BHP	100
Transmission	Manual
Vehicle Weight (kg)	3400
Miles or KM	Miles
Mileage	40308
Confirm miles (within 5,000)	Yes
Is Mileage Warranted	Yes
Engine Keys Count	1
V5 present	Yes
V5 VIN Match	Yes

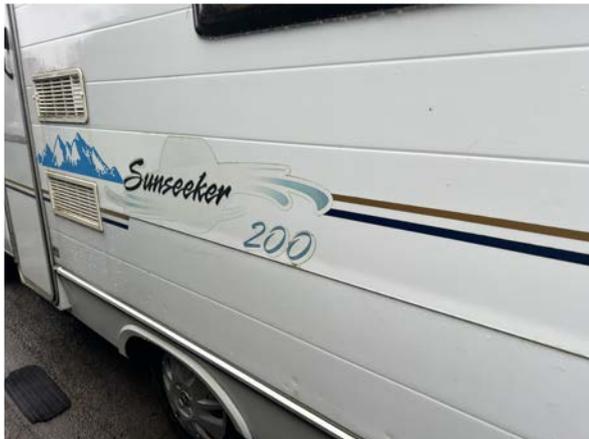
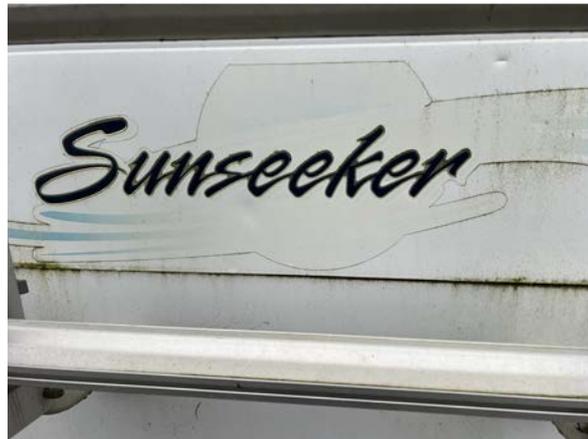
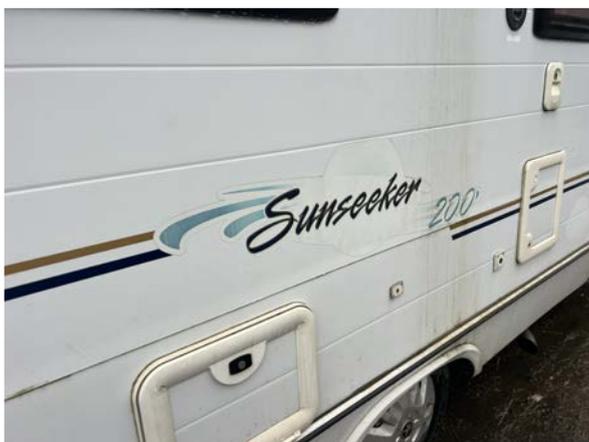
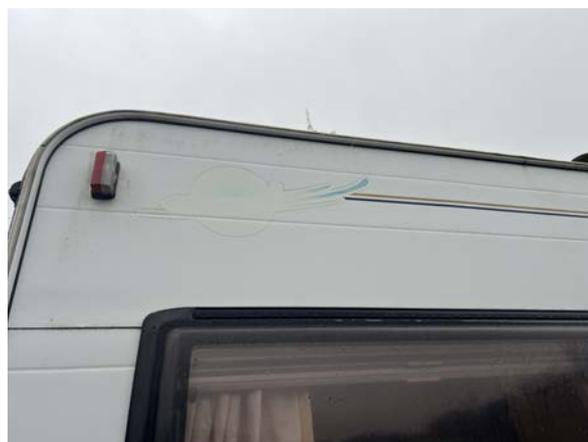
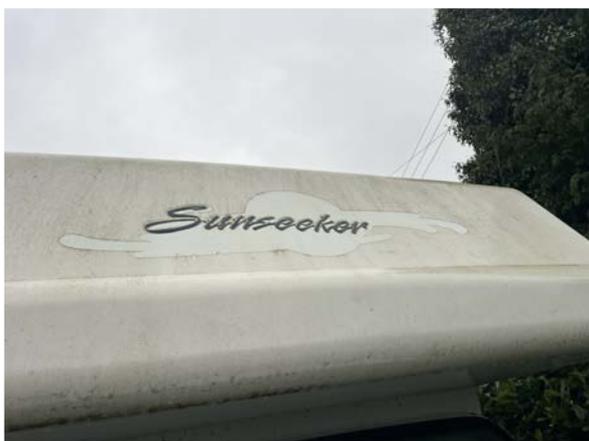
External Extras	Awning, Bike Rack, Reversing camera, Tow bar, Manual step, Tv Aerial
Decals	Need attention
Decals Further Info	Age related fading

Any Damage Found	Yes
Damage Further Info	OSF scuff // paint peel to bonnet // scattered small dents on either side // Delamination on O/S // Rust on tow bar // end cap of awning is missing // Damage to NSF top corner

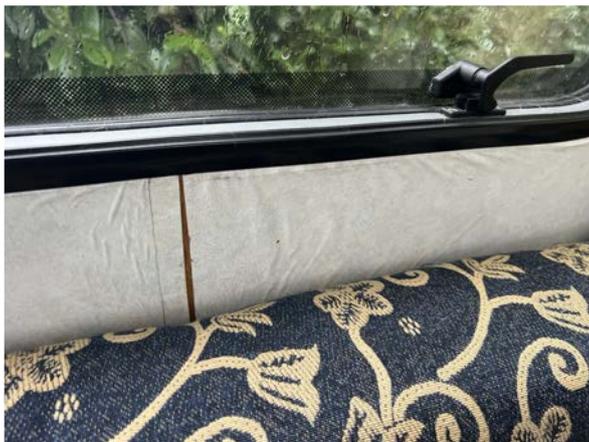
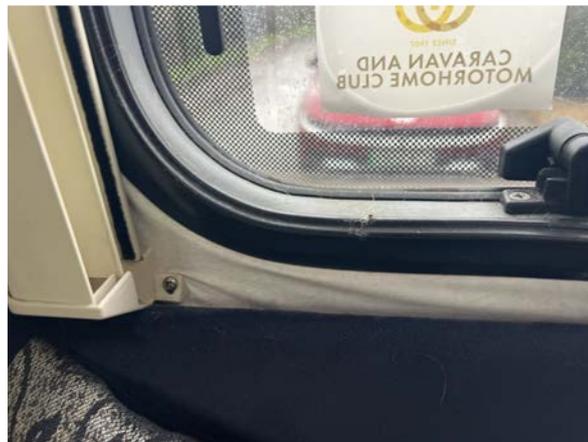
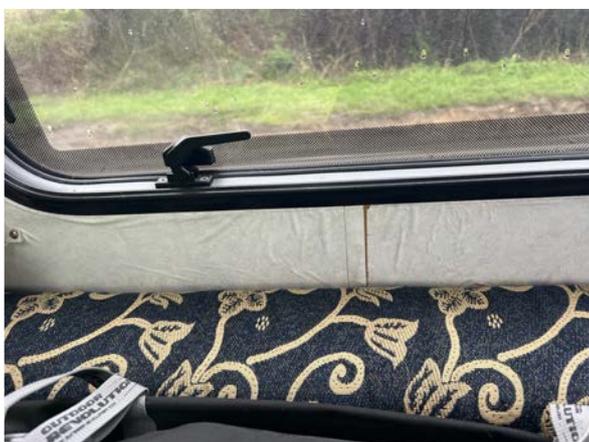
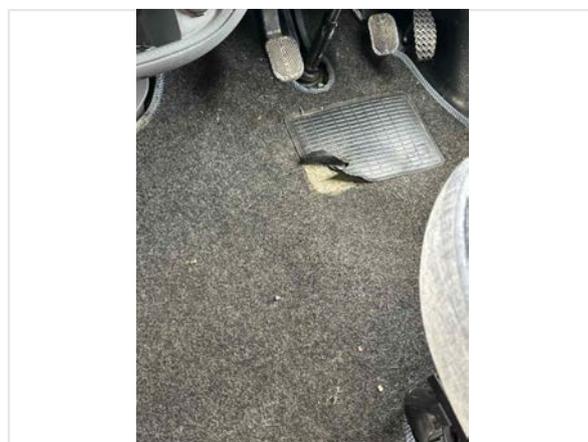
Internal Extras	Cab curtains, Awning (Porch or Safari), Oven, Upgraded stereo
Other Extras	N/A
Electrics turn on	Yes
Control panel damaged	No
Stereo turn on	Yes
Smell or signs of smoking	No
Cushions correct	Yes
Boiler present	Yes
Overhead lockers ready	Yes
Internal Damage	Yes
Damage Info	Paper shrink around windows // paper dropped on overcab roof // rip on floor mat on driver side

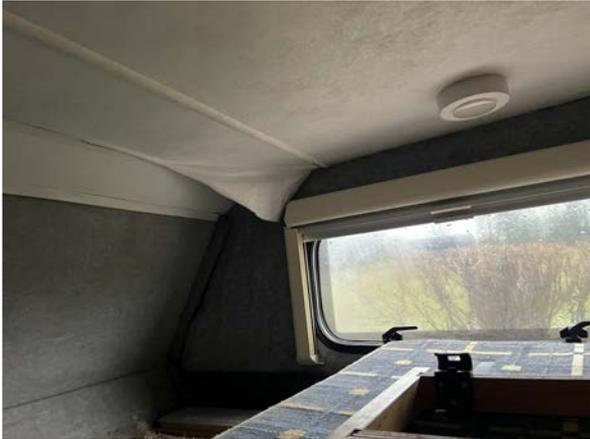
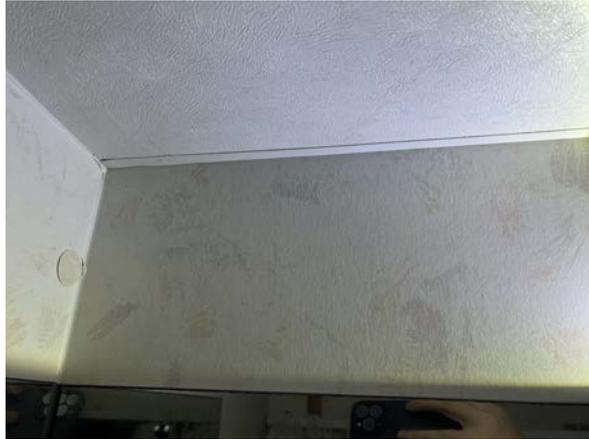
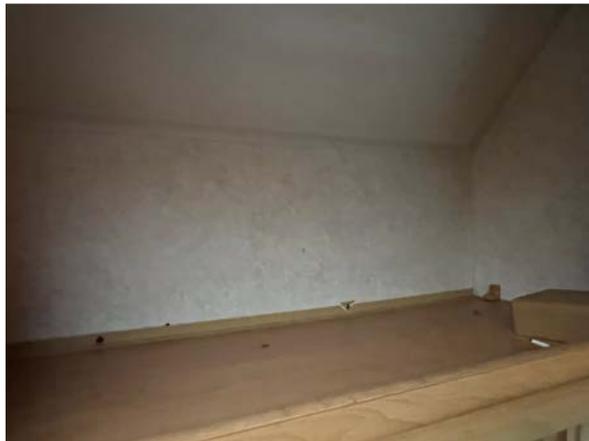
Damp (visible/soft)	Yes
---------------------	-----

Floor damp/spongy/damaged	Yes
Floor Info	Floor damaged under OS bench to outer edge // floor slightly swollen around entry step
