CMS MOTORHOME INSPECTION FORM

Make & Model	Elddis Autoquest 130
Reg Number - NO GAP	YN08OYM
HPI Clear	Yes
VAT	No
Engine Size	2.2L
BHP	100
Transmission	Manual
Vehicle Weight (kg)	3.5T
Miles or KM	Miles
Mileage	42216
Confirm miles (within 5,000)	Yes
Is Mileage Warranted	Yes
Engine Keys Count	2
V5 present	Yes
V5 VIN Match	Yes

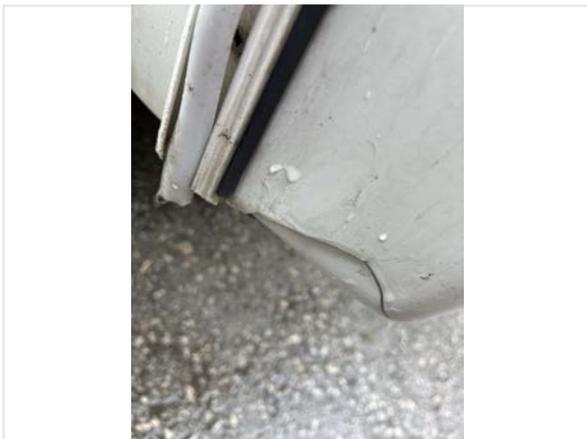
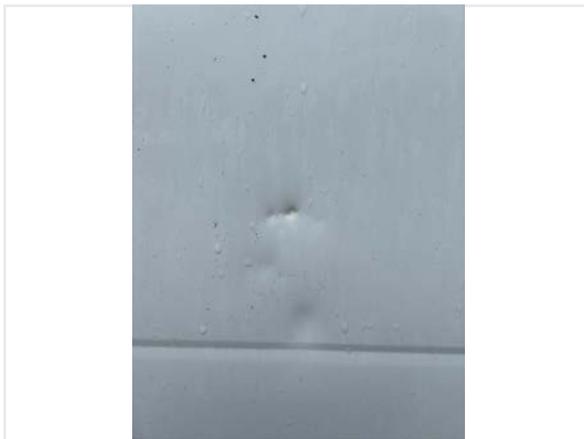
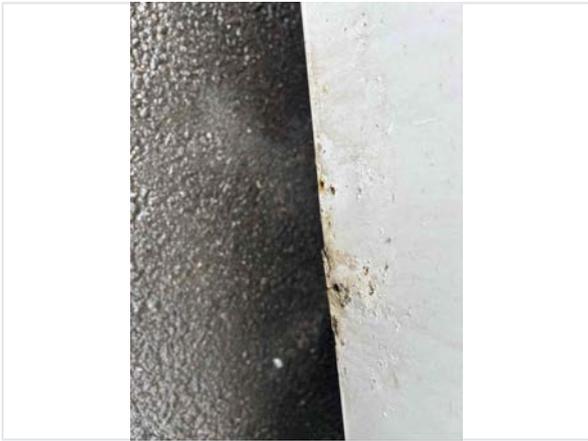
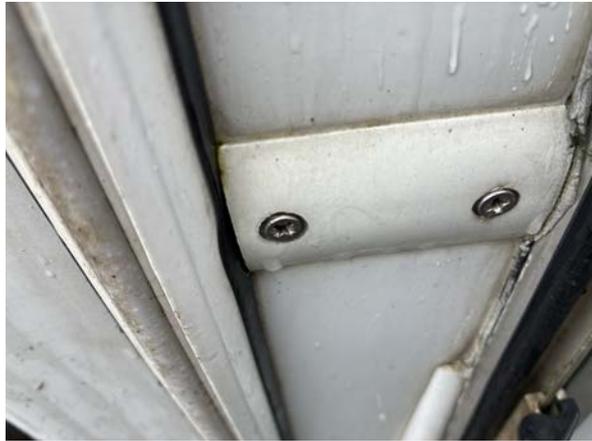
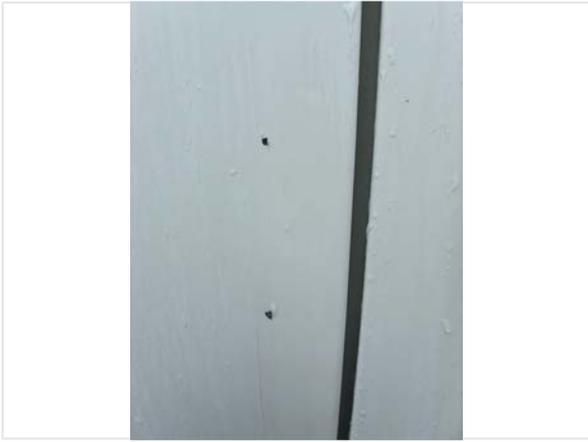
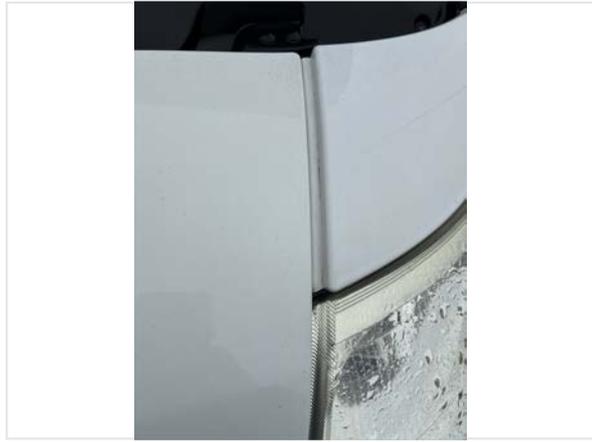
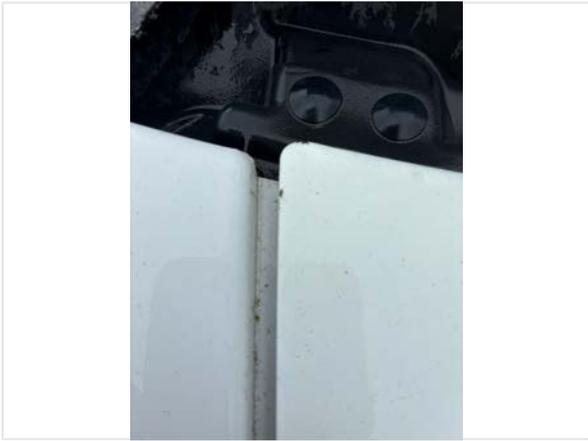
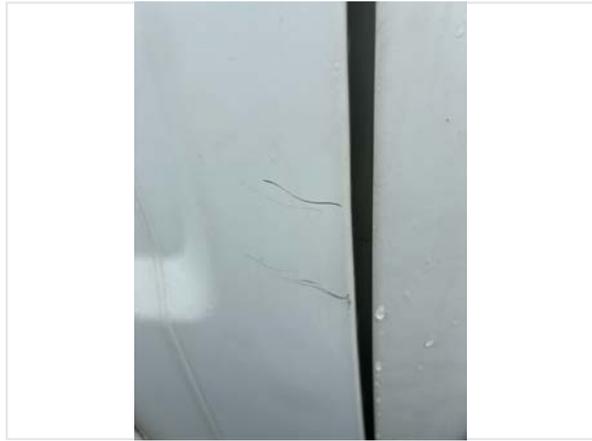
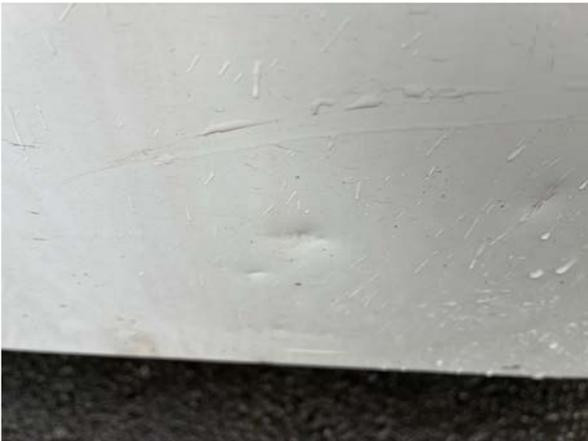
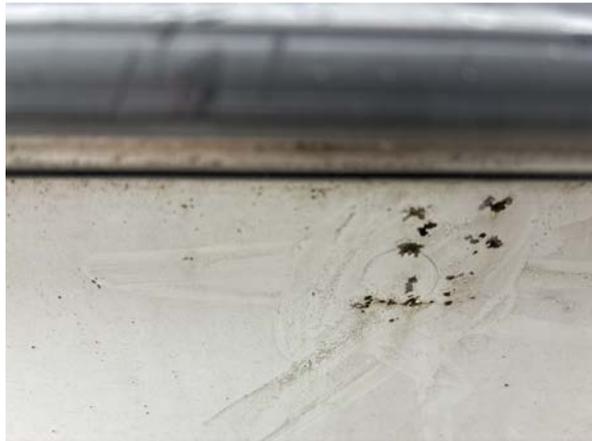
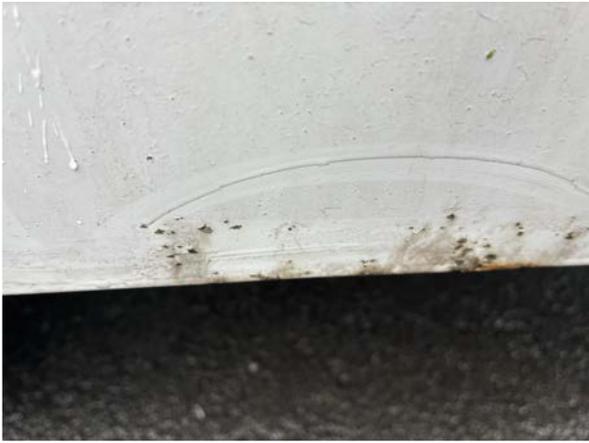
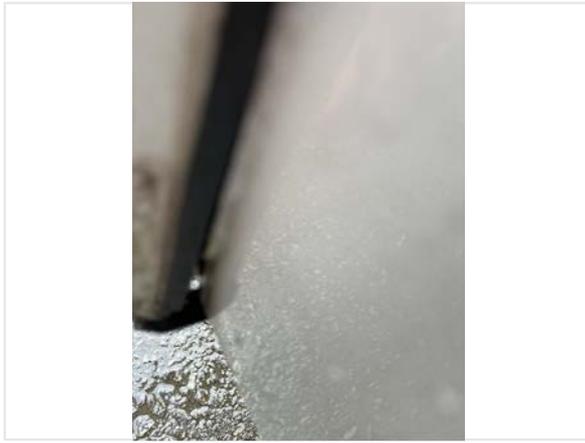
Any Damage Found	Yes
Damage Further Info	<p>Near side bottom of Bumper cracked Dent on near side (Hab door damage) Stone chips on near side door Bonnet well out of line Scratch on Bonnet Scratches just behind drivers door Paint peel on column behind drivers door plus dents Rust bubbling both in front and behind off side wheel Poor sealant on bottom edge of bumper off side</p>

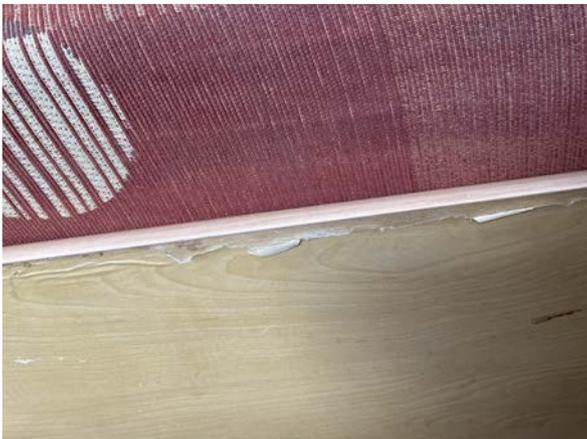
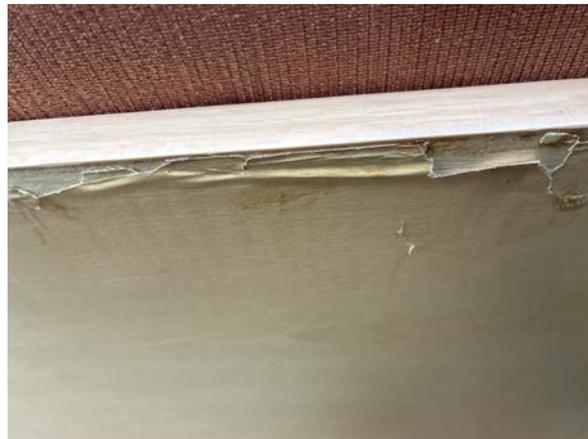
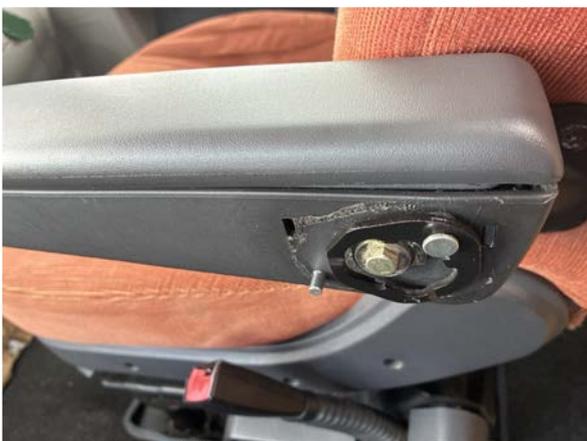
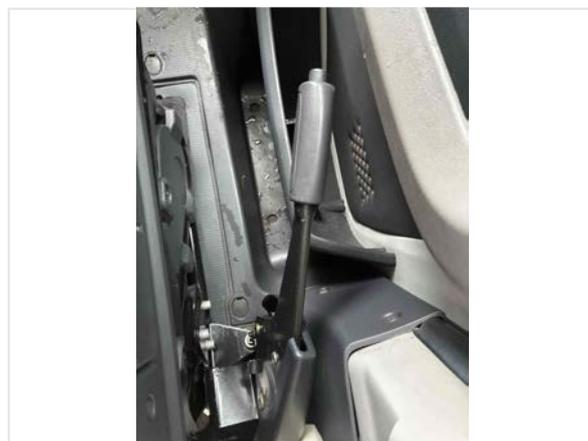
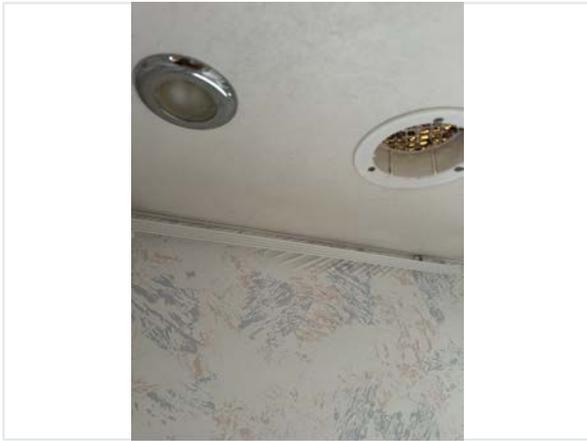
Internal Extras	Cab curtains, Multifunction steering wheel, Oven
Other Extras	N/A
Electrics turn on	Yes
Control panel damaged	No
Stereo turn on	Yes
Smell or signs of smoking	No
Cushions correct	Yes
Boiler present	N/A
Overhead lockers ready	Yes
Internal Damage	Yes
Damage Info	Hand brake damaged (bent) // Drivers armrest damaged // Lamination on side of off side Bench seat // Passenger side recliner control broken off // Rippled wallpaper in bathroom

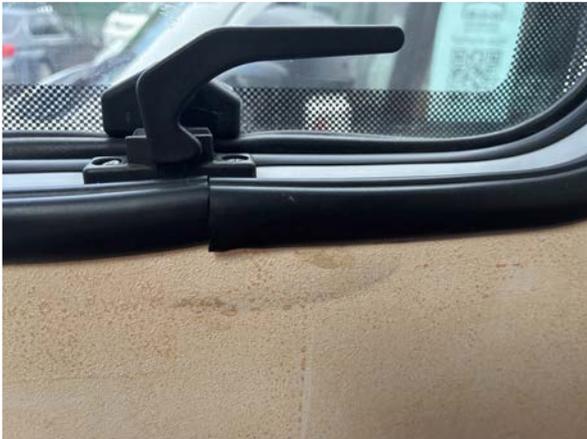
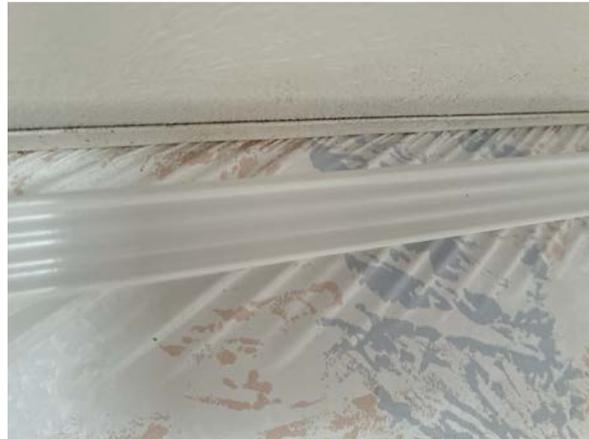
Damp (visible/soft)	Yes
Damp Info	Discoloured under window
Floor damp/spongy/damaged	No
