CMS MOTORHOME INSPECTION FORM

Make & Model	Compass Envoy 115
Reg Number - NO GAP	MX07NYF
HPI Clear	Yes
VAT	No
Engine Size	2.2
BHP	99
Transmission	Manual
Vehicle Weight (kg)	3000
Miles or KM	Miles
Mileage	41505
Confirm miles (within 5,000)	Yes
Is Mileage Warranted	Yes
Engine Keys Count	2
V5 present	Yes
V5 VIN Match	Yes

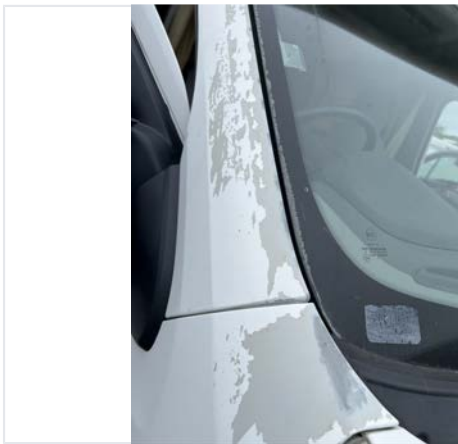
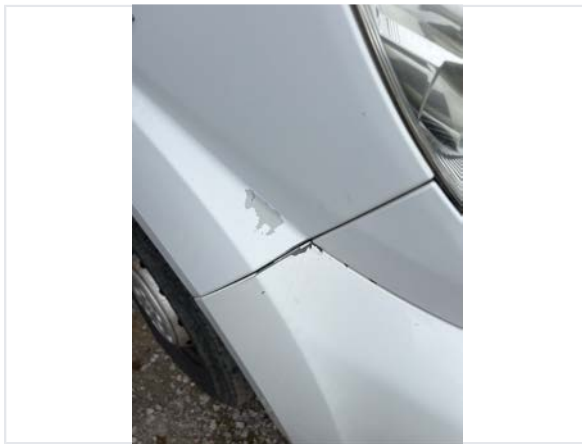
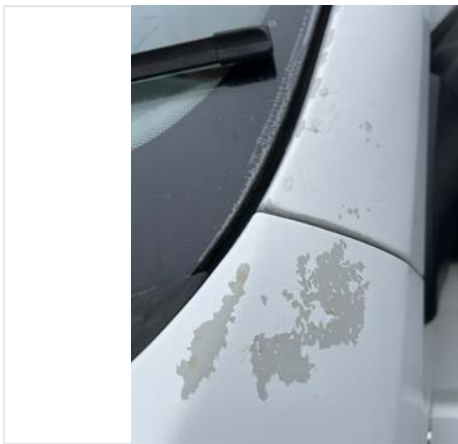
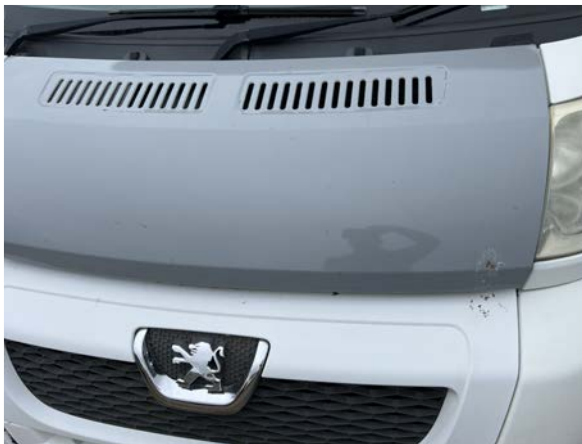
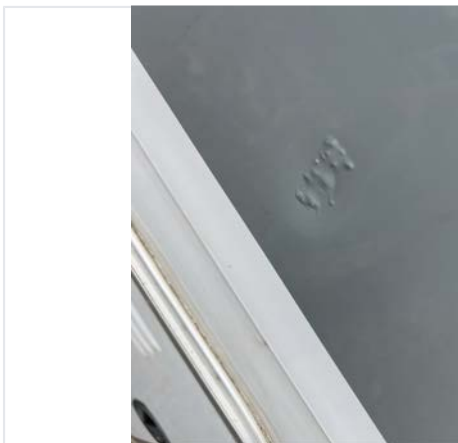
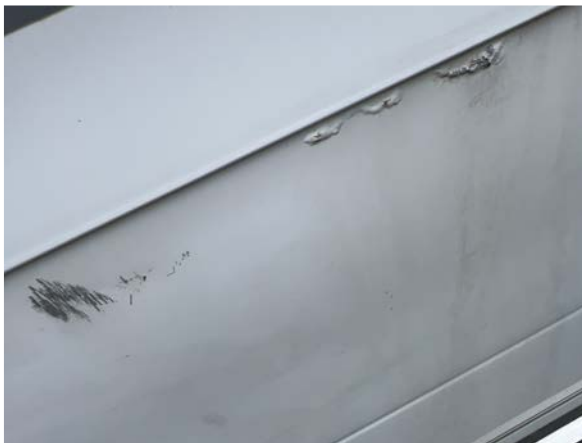
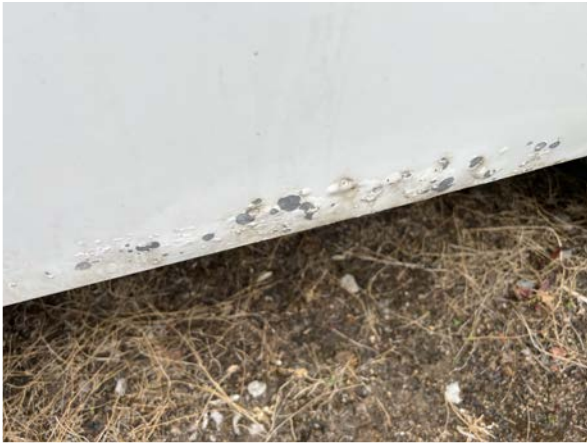
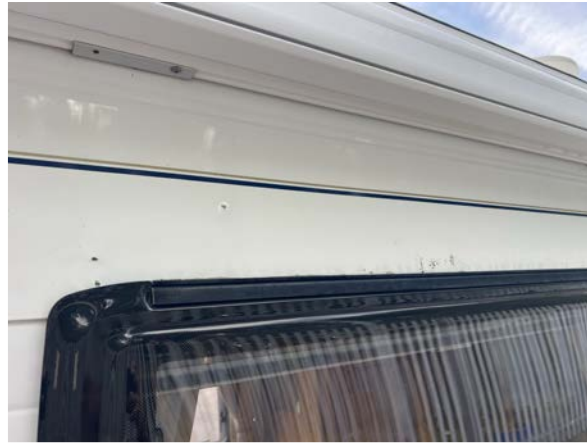
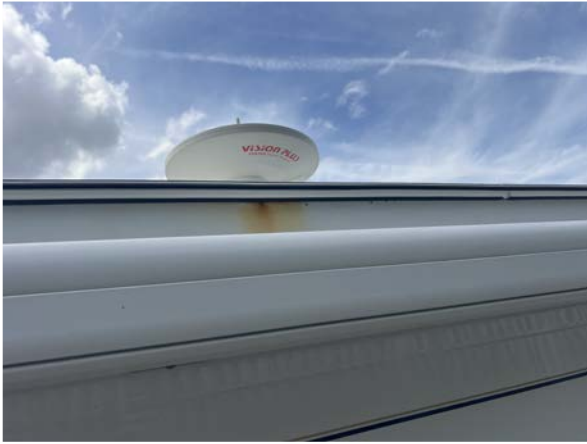
External Extras	Awning, Tv Aerial, Tow bar, Bike Rack, Solar panel, Satellite dish, Manual step
Other External Extras	N/A
Decals	Good
Any Damage Found	Yes
Damage Further Info	Paint flake to bonnet and A posts // n/s body corrosion // o/s body corrosion // bonnet wrapped

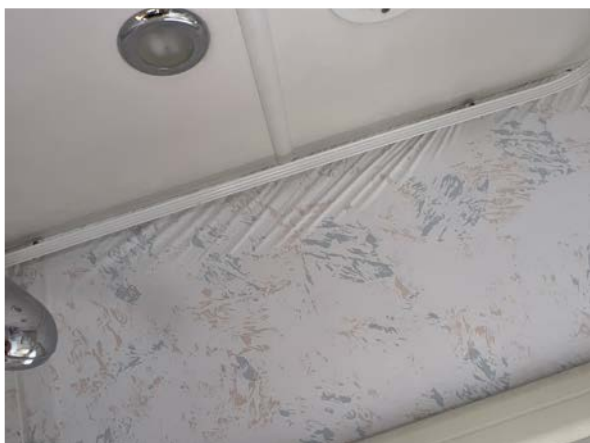
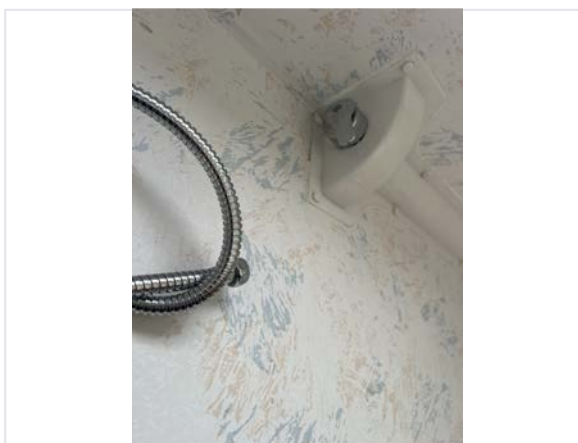
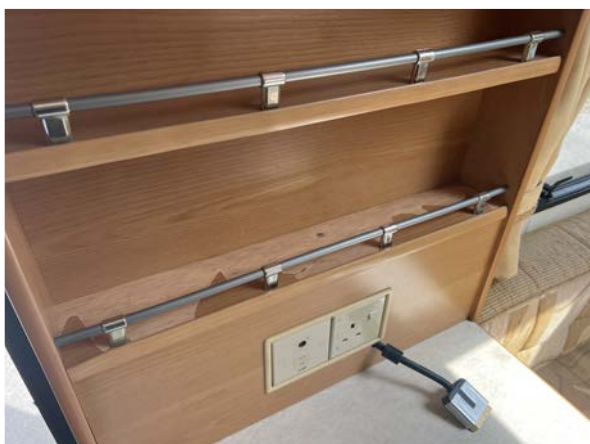
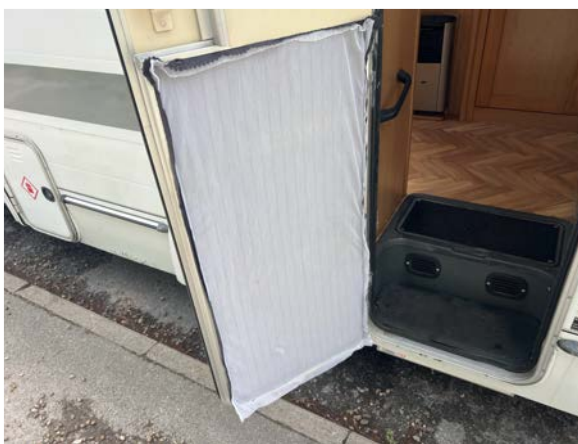
Internal Extras	Cab curtains, Heated mirrors, Multifunction steering wheel, Oven
Other Extras	N/A
Electrics turn on	Yes
Control panel damaged	No
Stereo turn on	Yes
Smell or signs of smoking	No
Cushions correct	Yes
Boiler present	Yes
Overhead lockers ready	Yes
Internal Damage	Yes
Damage Info	Paper peel to bathroom // shower hose snapped from tap // shelf finish damaged // fly screen repaired poorly

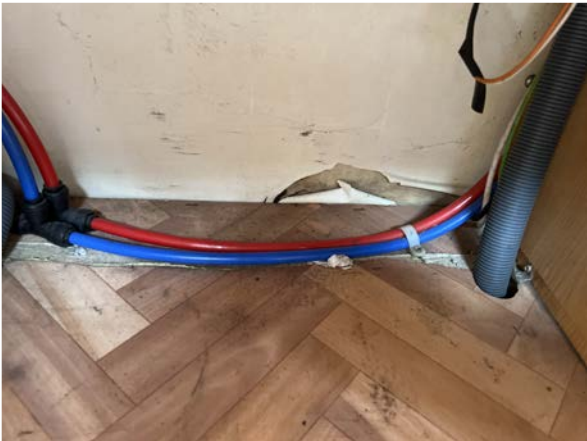
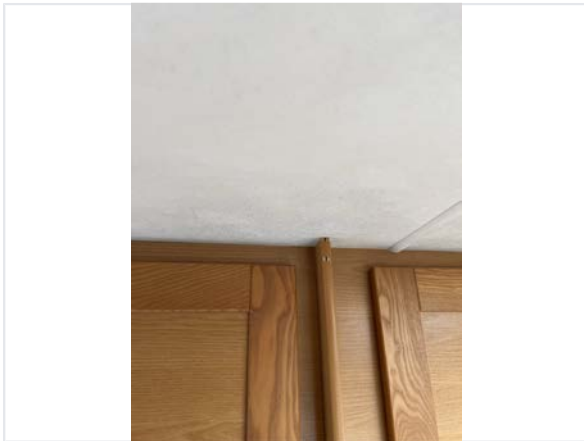
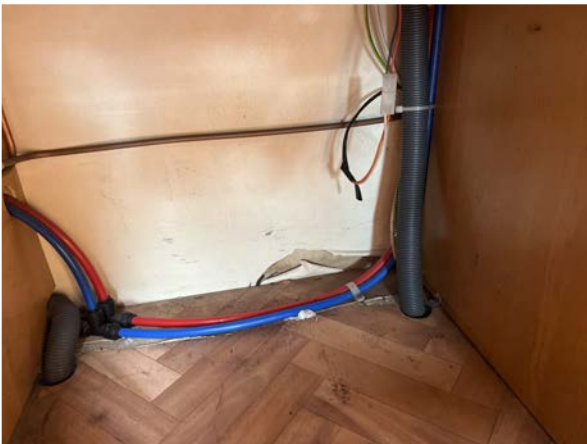
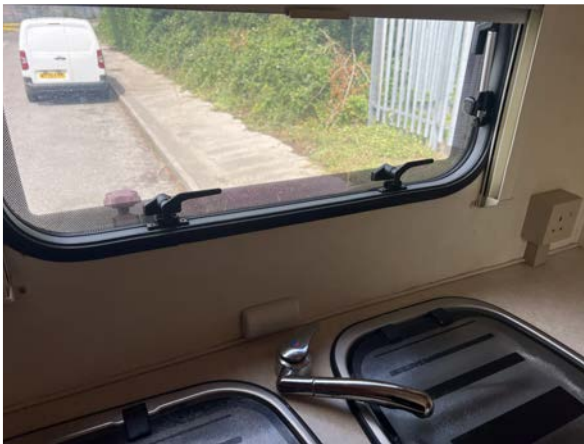
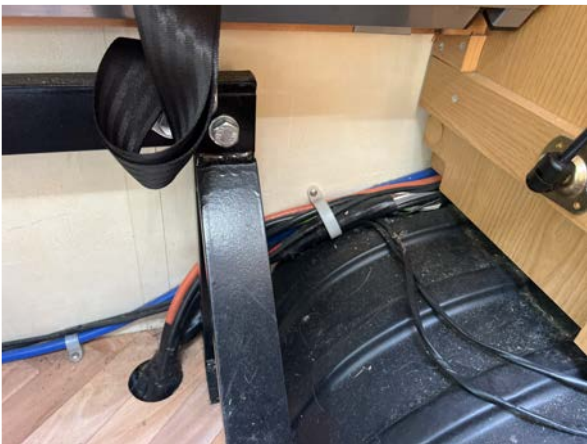
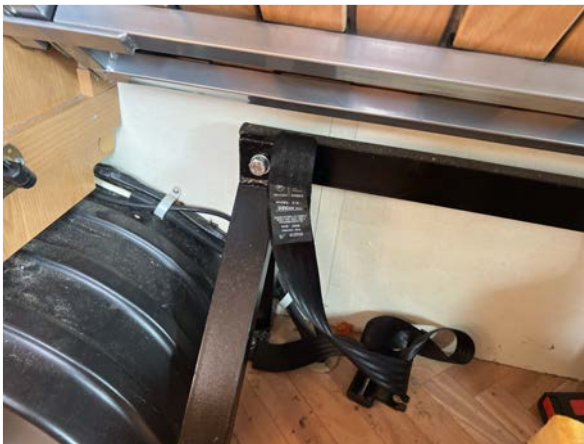
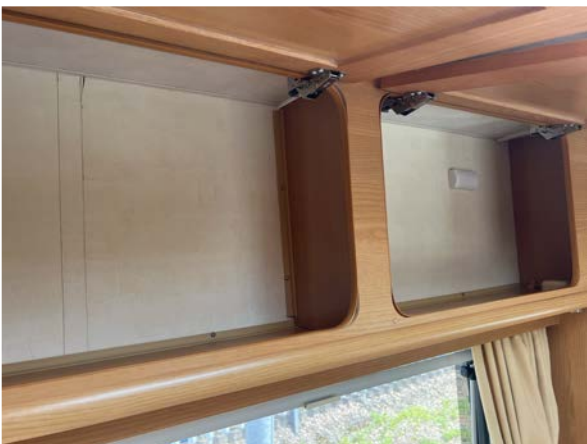
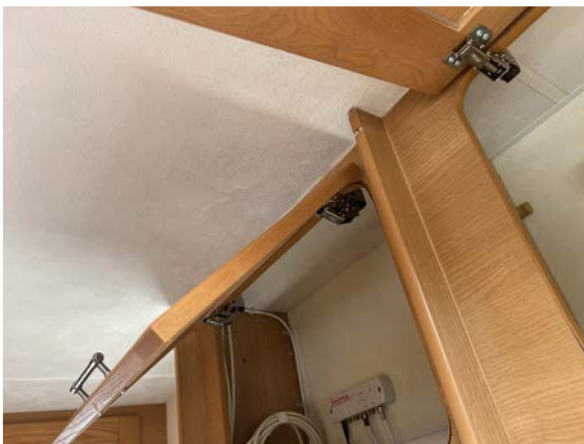
Rear wall under oven rotten - 99% // pimpling under kitchen window and swollen - 99% // soft wall around both arches under benches - 99% // soft roof around heater vent // wall swollen//Pimpling in NS high level cupboards // NS of roof staining // lower wall to rear side of Hab door stained
