## CMS MOTORHOME INSPECTION FORM

Make & Model	Autosleeper Orian Aquillas
Reg Number - NO GAP	MX55UWU
HPI Clear	Yes
VAT	No
Engine Size	2.8
BHP	130
Transmission	Manual
Vehicle Weight (kg)	3500
Miles or KM	Miles
Mileage	23880
Confirm miles (within 5,000)	Yes
Is Mileage Warranted	Yes
Engine Keys Count	1
V5 present	Yes
V5 VIN Match	Yes

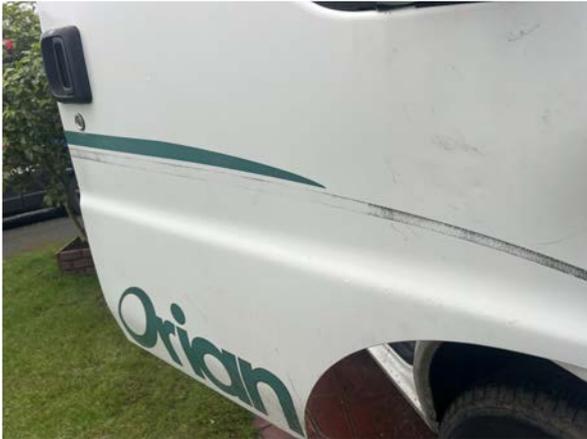
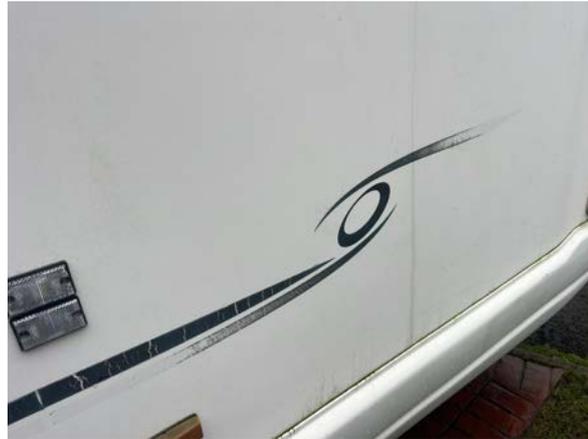
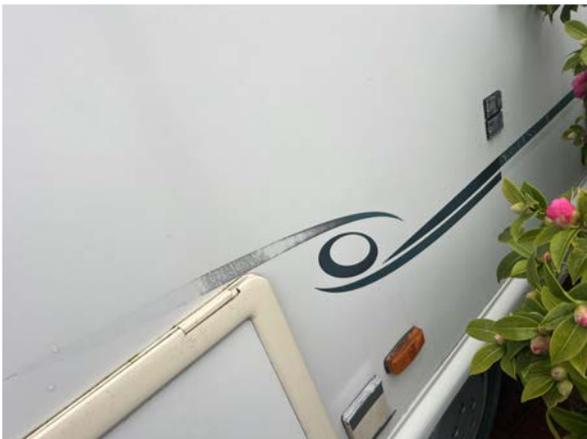
External Extras	Ladder, Bike Rack, Solar panel, Electric step, Awning, Tv Aerial, Reversing camera, Air Suspension
Decals	Need attention
Decals Further Info	Age related fading & perishing

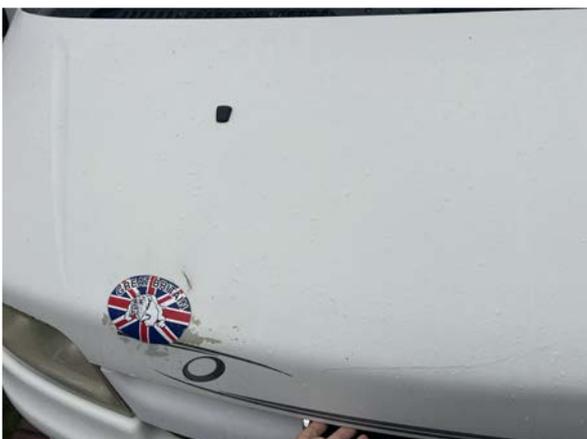
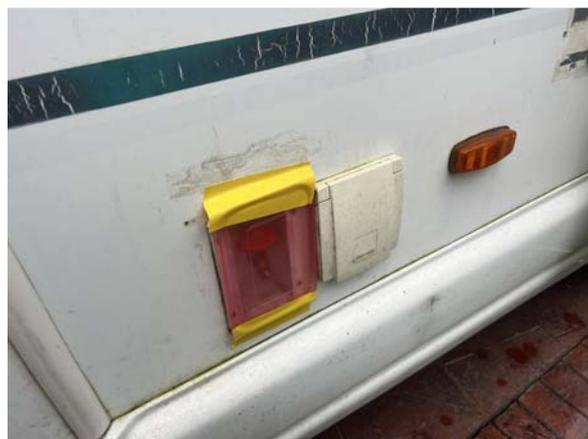
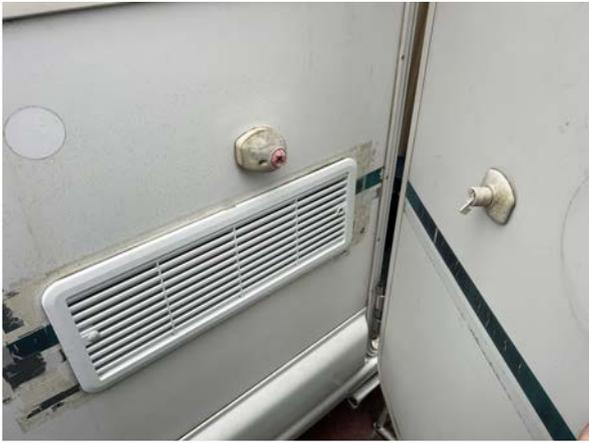
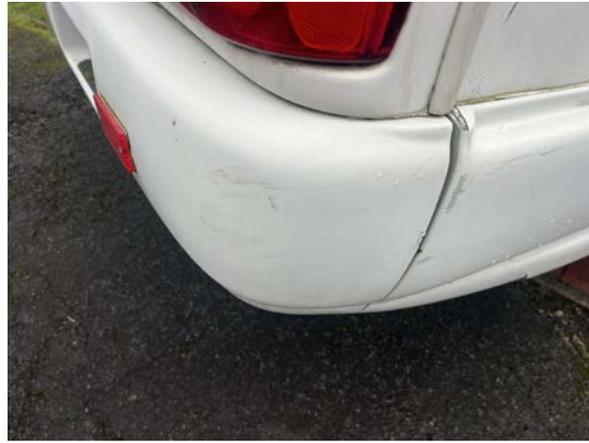
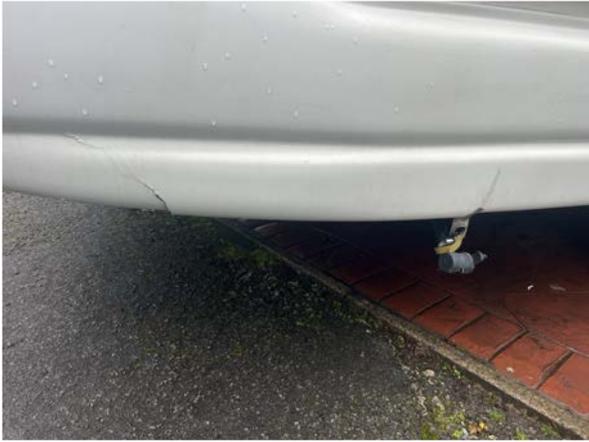
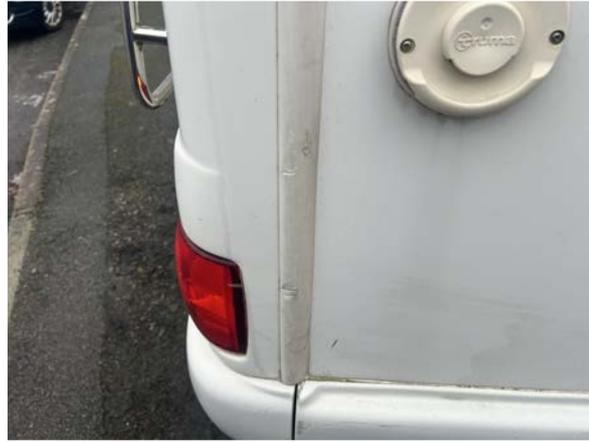
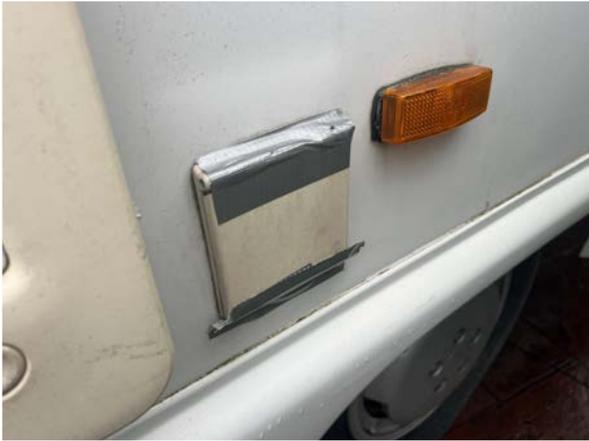
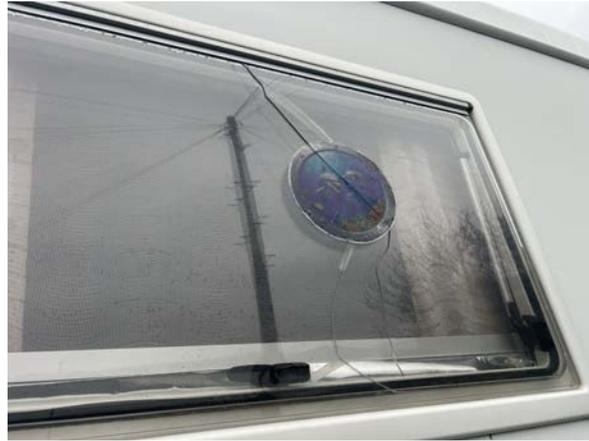
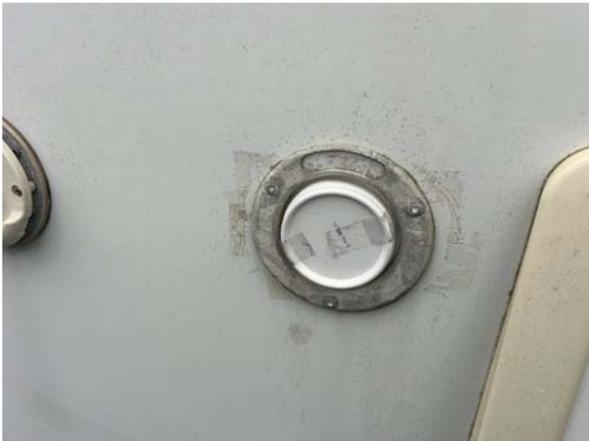
Any Damage Found	Yes
Damage Further Info	Paint peel on bonnet // Hab door clip broken // gas point flap replaced // OSR lower damage // OS rear window broken // water fill cap missing

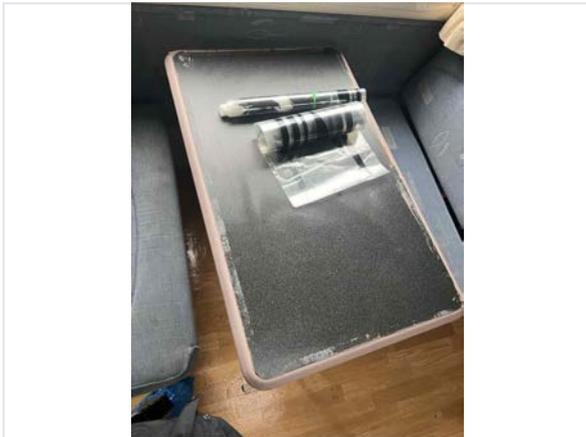
Internal Extras	Upgraded stereo, Oven, Tv(s), Cab curtains
Other Extras	N/A
Electrics turn on	Yes
Control panel damaged	No
Stereo turn on	Yes
Smell or signs of smoking	No
Cushions correct	Yes
Boiler present	Yes
Overhead lockers ready	Yes
Internal Damage	Yes
Damage Info	Table painted // sink top missing

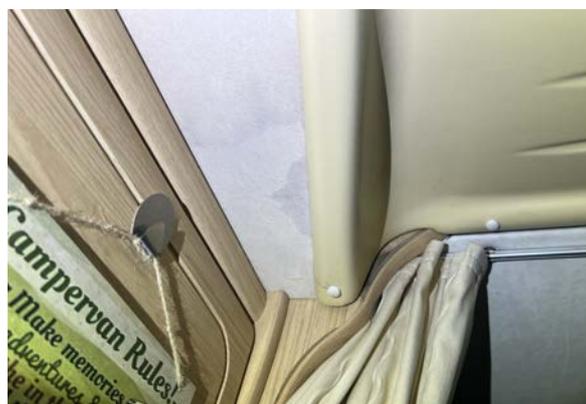
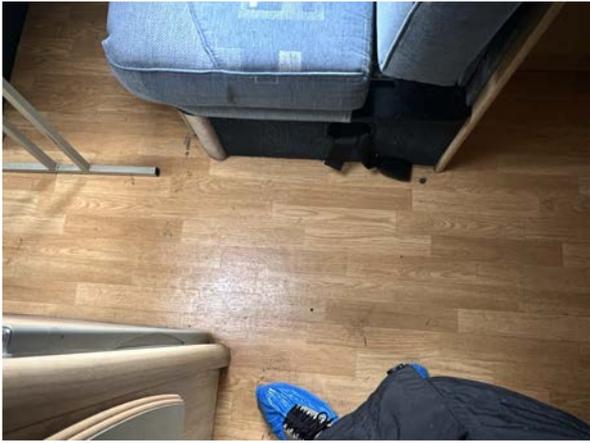
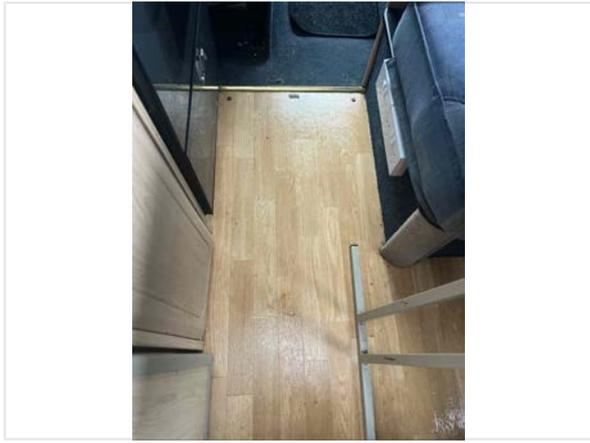
Damp (visible/soft)	Yes
Damp Info	Staining in roof to rear OS of big skylight // staining to roof NSF // staining in lower OS dinette fabric under window
Floor damp/spongy/damaged	Yes
Floor Info	Floor delaminated in most of walkway
