CMS MOTORHOME INSPECTION FORM

Make & Model	Geist Matterhorn
Reg Number - NO GAP	PO55LUF
HPI Clear	Yes
VAT	Yes
Engine Size	2.7
BHP	150
Transmission	Manual
Vehicle Weight (kg)	4600
Miles or KM	Miles
Mileage	36820
Confirm miles (within 5,000)	Yes
Is Mileage Warranted	Yes
Engine Keys Count	2
V5 present	Yes
V5 VIN Match	Yes

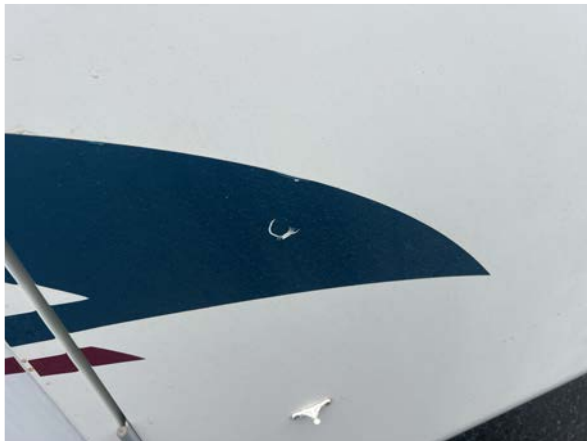
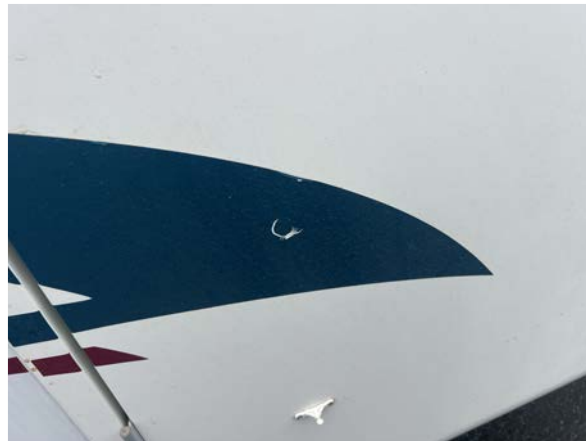
External Extras	Awning, Electric step, Ladder, Reversing camera, Roof rack, Tv Aerial, Bike Rack, Tow bar
Other External Extras	N/A
Decals	Need attention
Decals Further Info	N/A

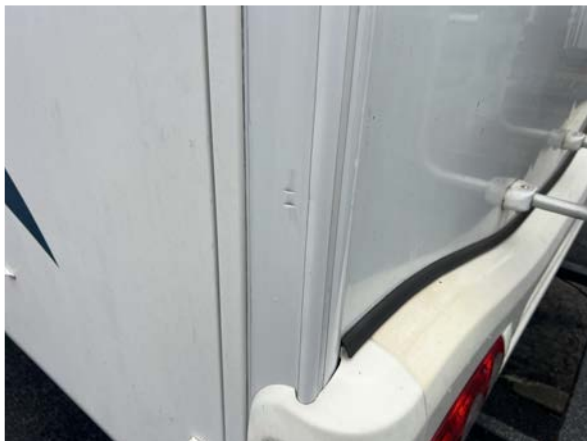
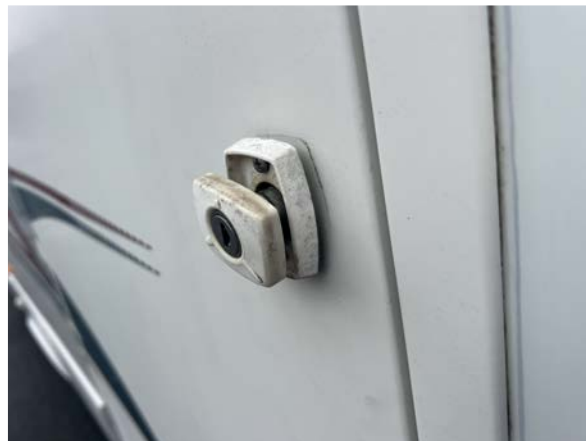
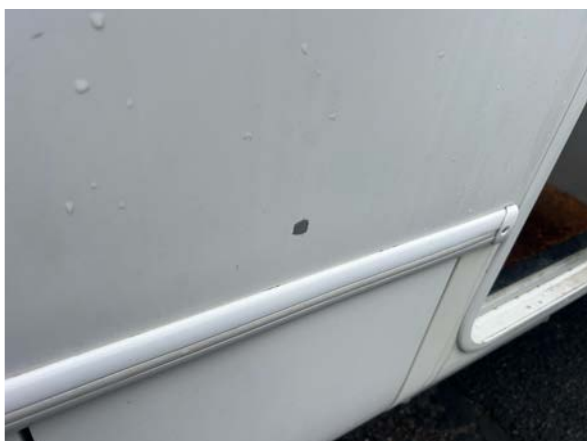
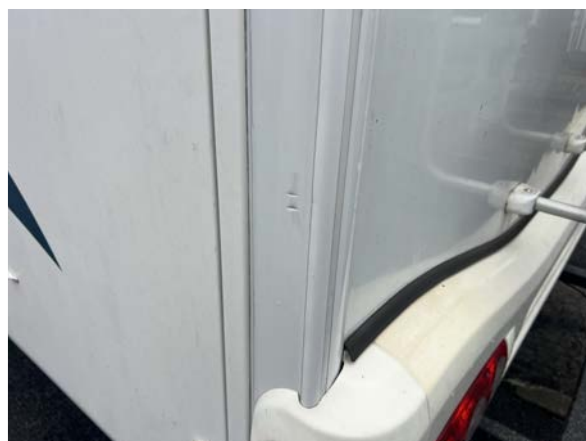
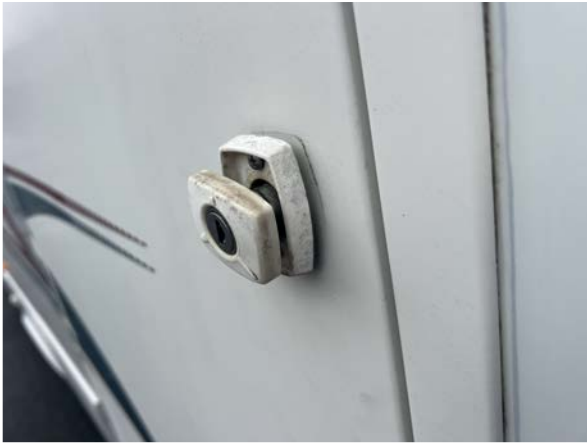
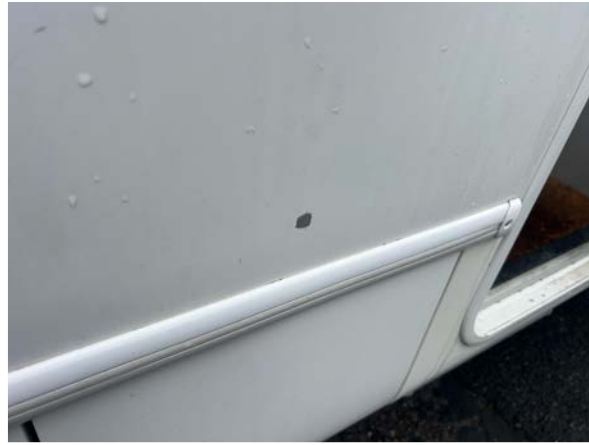
Any Damage Found	Yes
Damage Further Info	OSR impact // OSR top garage catch loose // small paint mark behind Hab door

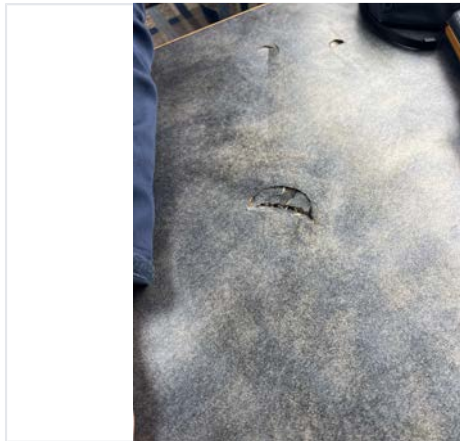
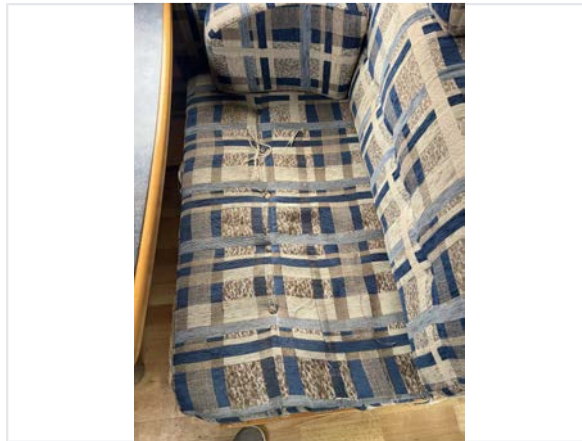
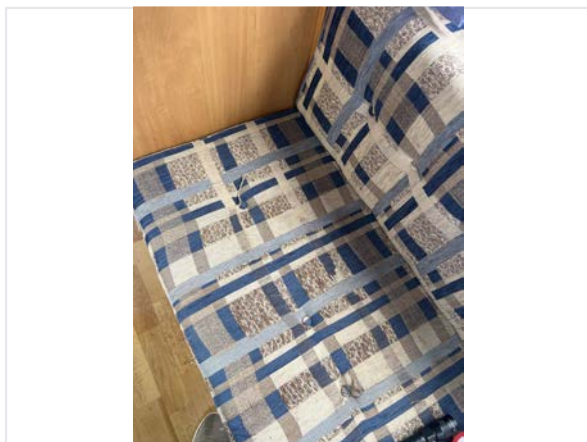
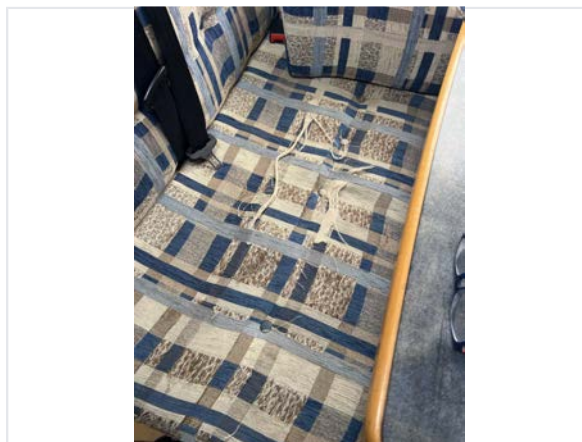
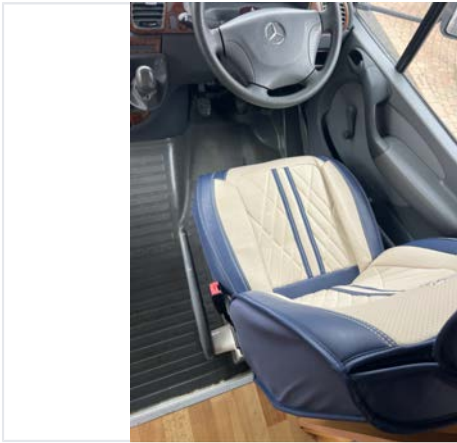
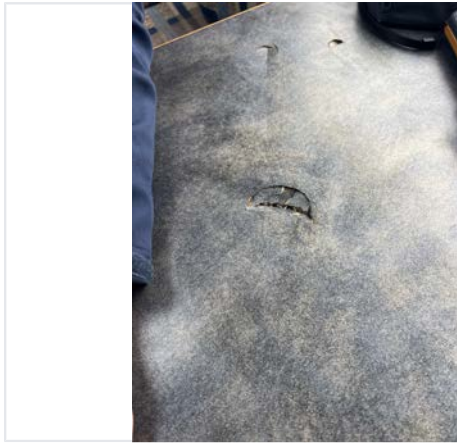
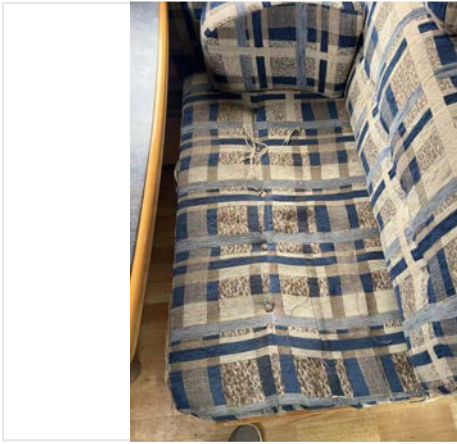
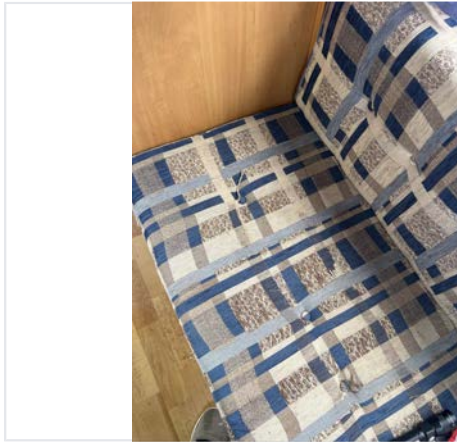
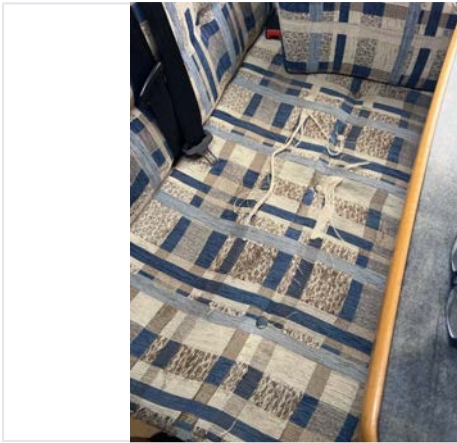
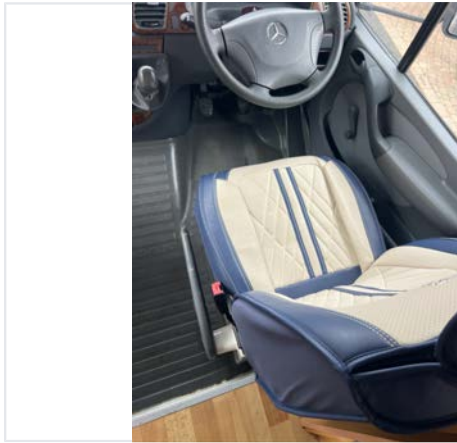
Internal Extras	Upgraded stereo, Oven, Cab curtains, Tv(s), Carpets, Alarm
Other Extras	N/A
Electrics turn on	Yes
Control panel damaged	No
Stereo turn on	Yes
Smell or signs of smoking	No
Cushions correct	Yes
Boiler present	Yes
Overhead lockers ready	Yes
Internal Damage	Yes
Damage Info	Damage to dinette table // dinette area cushions frayed // cab seats covered

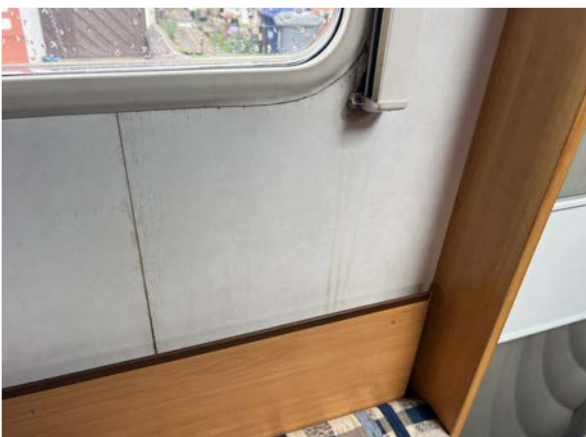
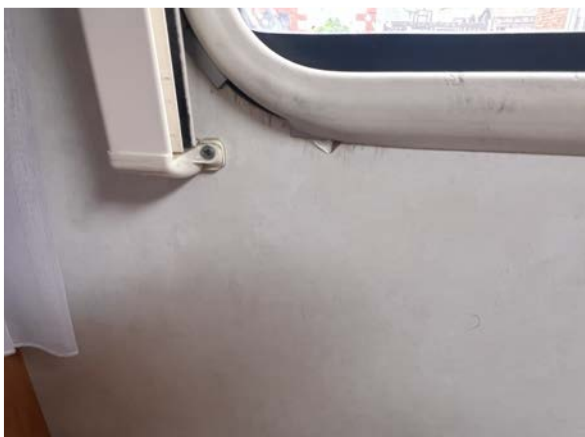
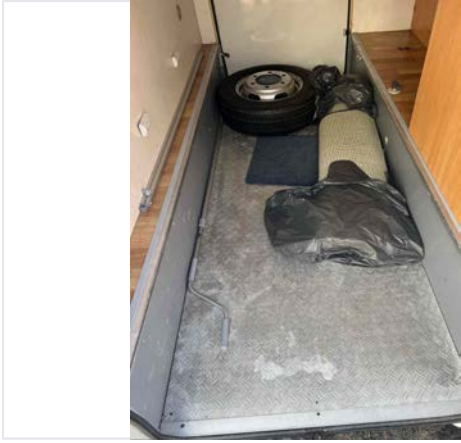
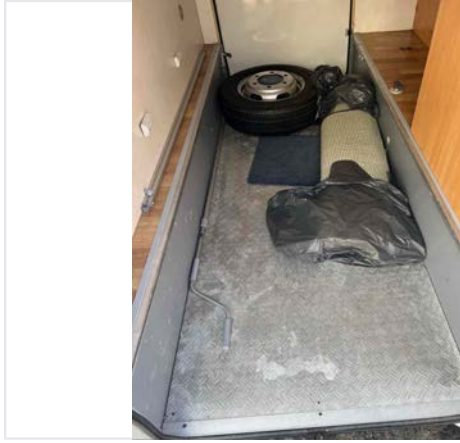
Damp (visible/soft)	Yes
Damp Info	OS dinette window lower rear corner rotten 99% // watermarks around lower corners of most window but low reading 6-14% // slightly stained in rear high level cupboards but low reading 14% // mark to NSF corner of front skylight but low reading // light staining to rear of bathroom skylight
Floor damp/spongy/damaged	No
