CMS MOTORHOME INSPECTION FORM

Make & Model	Lunar Cassini EB
Reg Number - NO GAP	PO68EFU
HPI Clear	Yes
VAT	No
Engine Size	2.3
BHP	130
Transmission	Manual
Vehicle Weight (kg)	3800
Miles or KM	Miles
Mileage	13380
Confirm miles (within 5,000)	Yes
Is Mileage Warranted	Yes
Engine Keys Count	2
V5 present	Yes
V5 VIN Match	Yes

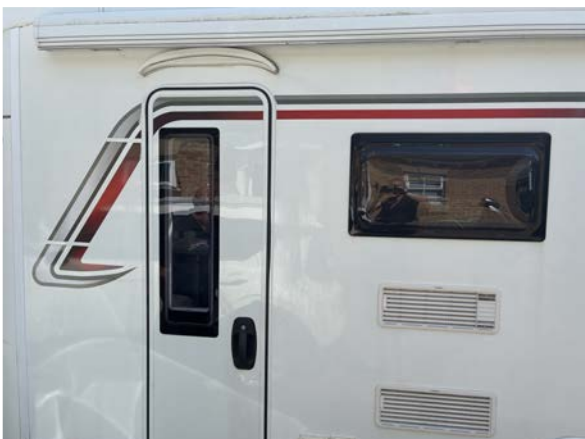
External Extras	Awning, BBQ point, Electric step, Reversing camera, Solar panel, Parking sensors, Tv Aerial
Other External Extras	N/A
Decals	Need attention
Decals Further Info	Lifting on some corners of the decals

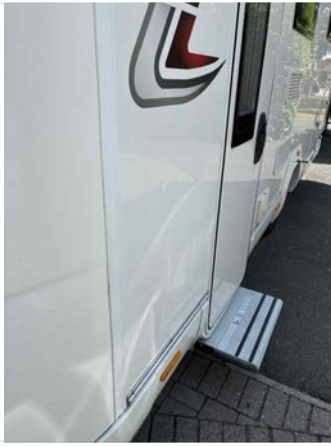
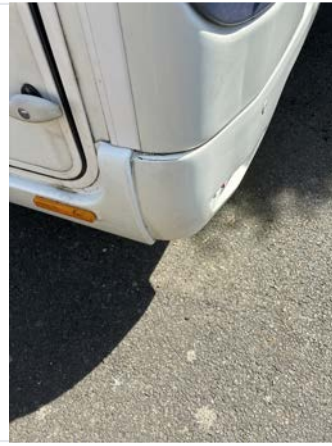
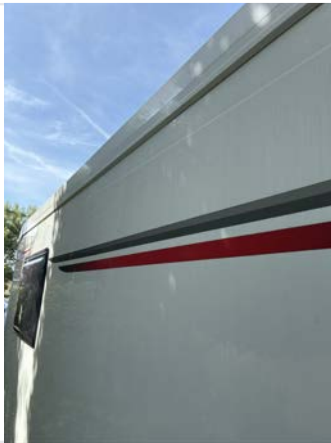
Any Damage Found	Yes
Damage Further Info	Dent ns to left of hab door // ns rear corner crack// high scratch on off side above window

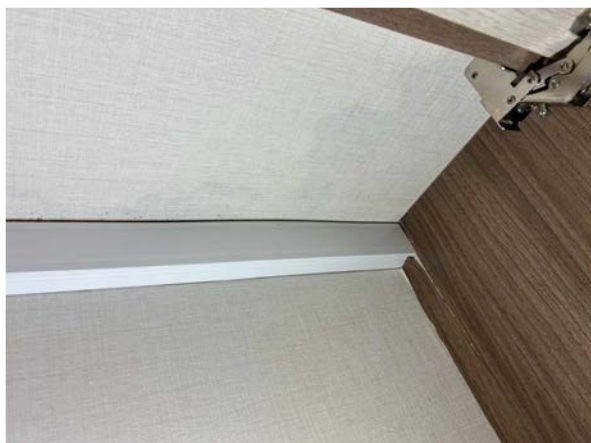
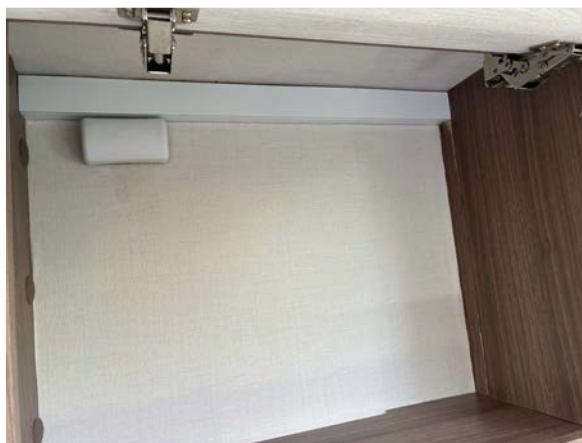
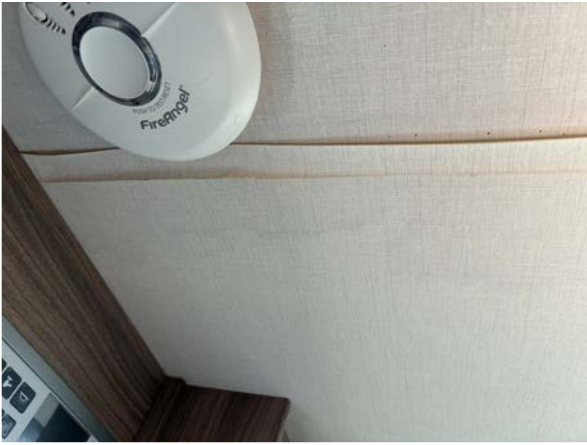
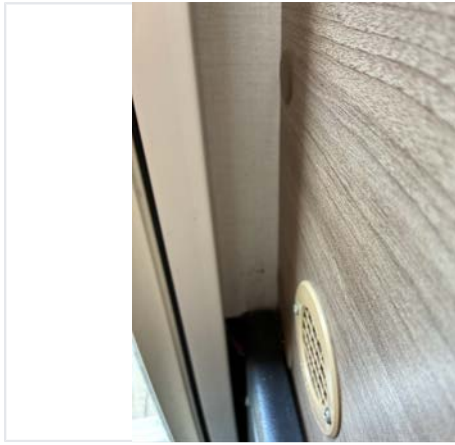
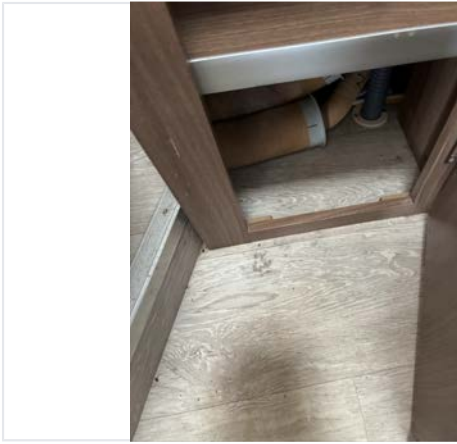
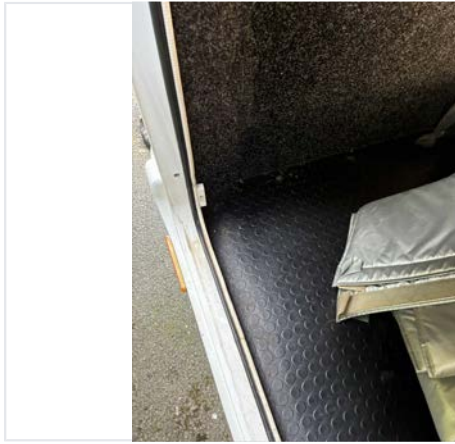
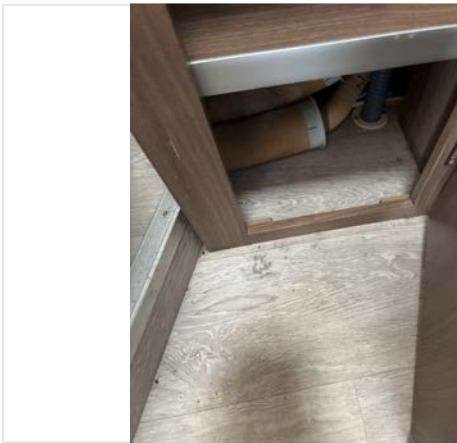
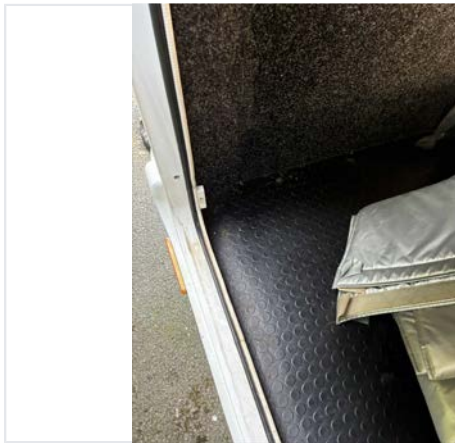
Damp (visible/soft)	Yes
Damp Info	Stains in ceiling above hab door ceiling and wall high readings , side of hab door, rear off side corner and ceiling blue stain. Bathroom floor high read in and off side garage floor
Floor damp/spongy/damaged	Yes
Floor Info	Soft in bathroom floor and os garage floor non visible
