## CMS MOTORHOME INSPECTION FORM

Make & Model	Bailey Approach 625
Reg Number - NO GAP	PX15ABN
HPI Clear	Yes
VAT	No
Engine Size	2.2litre
BHP	130bhp
Transmission	Manual
Vehicle Weight (kg)	3500 kg
Miles or KM	Miles
Mileage	9940
Confirm miles (within 5,000)	Yes
Is Mileage Warranted	Yes
Engine Keys Count	2
V5 present	Yes
V5 VIN Match	Yes

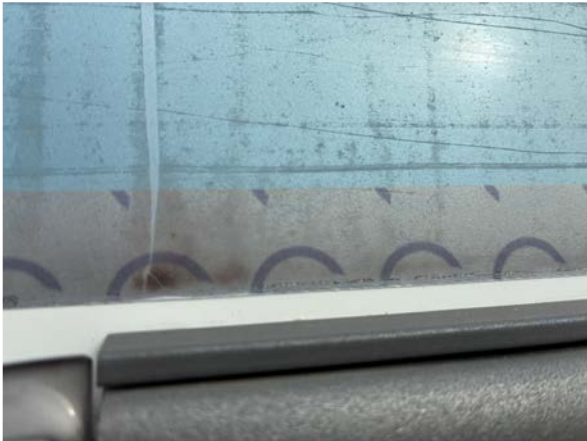
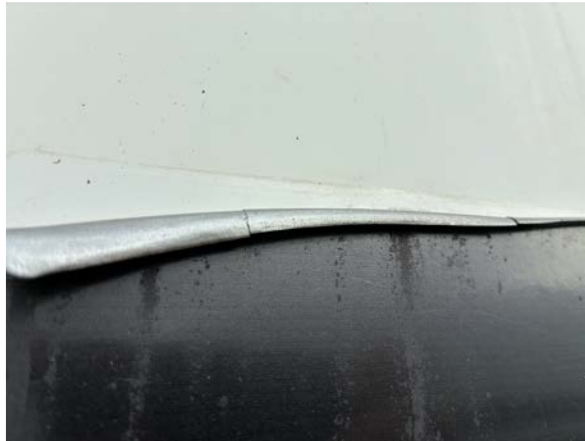
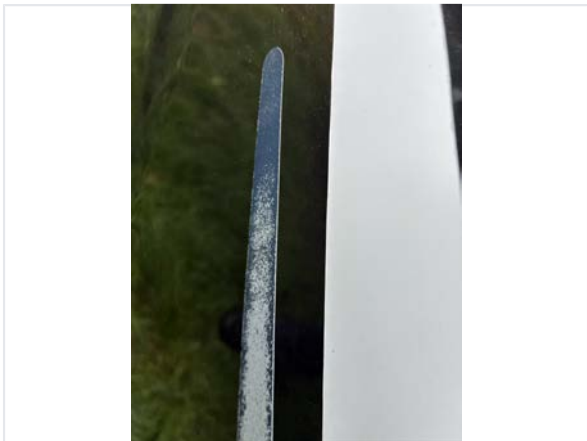
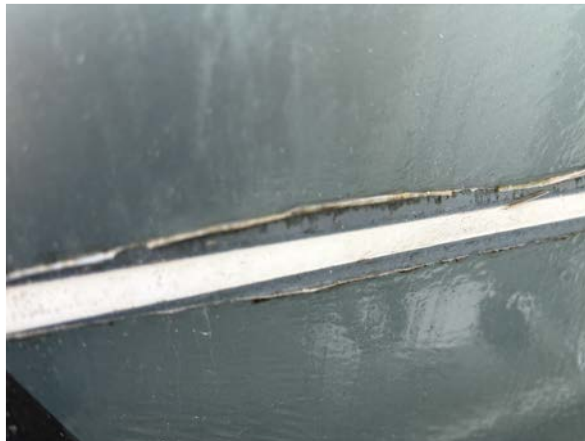
External Extras	Bike Rack, Reversing camera, Solar panel
Decals	Need attention
Decals Further Info	Decals peeling and fading

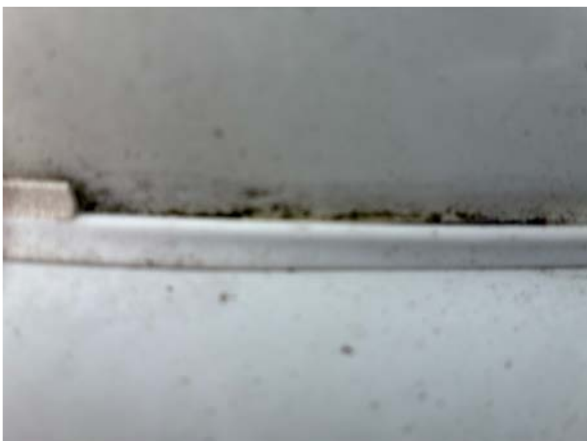
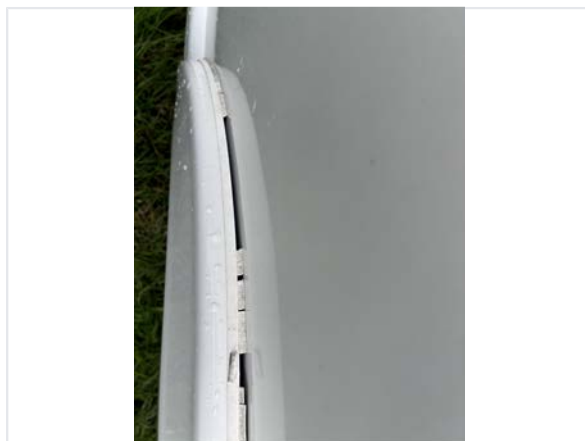
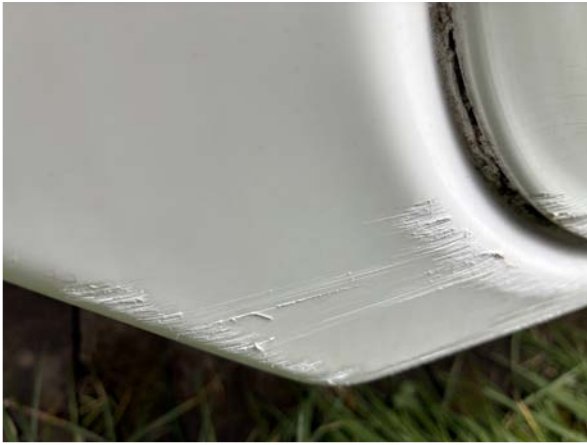
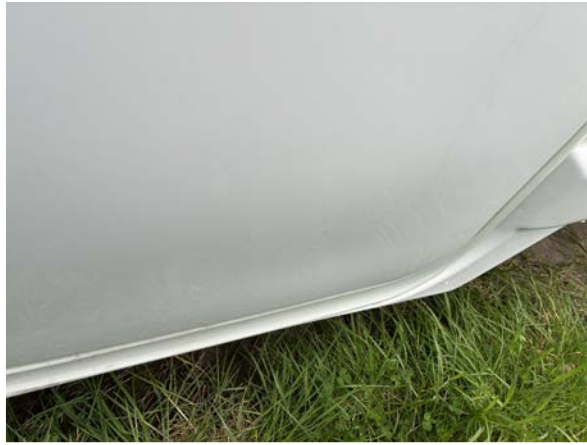
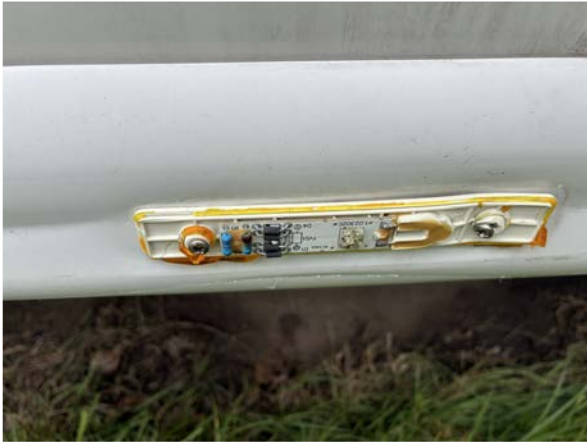
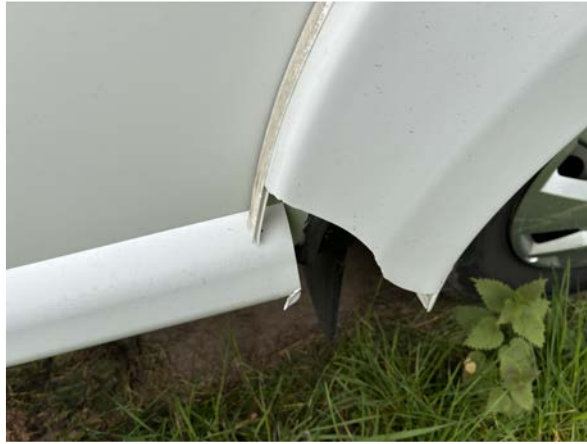
Any Damage Found	Yes
Damage Further Info	Wheel arch cracked and piece missing off side rear Hab door out of shape at the bottom plus scrapes just on hab door corner Near side wheel arch working loose Sealant loose on back panel

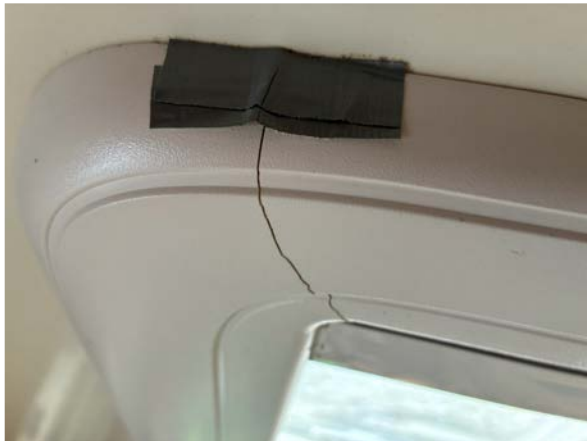
Internal Extras	Bluetooth, cab A/C, Cab blinds, Cruise control, DAB radio, Part leather, Oven, Multifunction steering wheel, Sat nav, Tv(s), Upgraded stereo
Other Extras	N/A
Electrics turn on	Yes
Control panel damaged	No
Stereo turn on	Yes
Smell or signs of smoking	No
Cushions correct	Yes
Boiler present	N/A
Overhead lockers ready	Yes
Internal Damage	Yes
Damage Info	Skylight cover cracked held together by tape

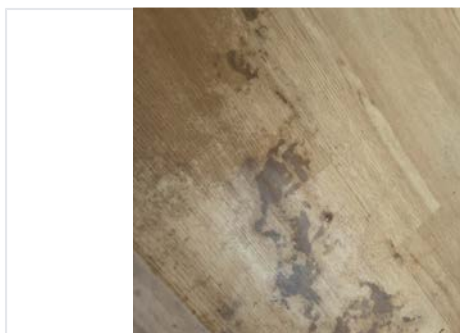
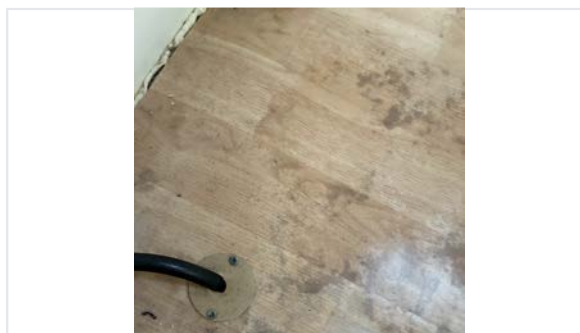
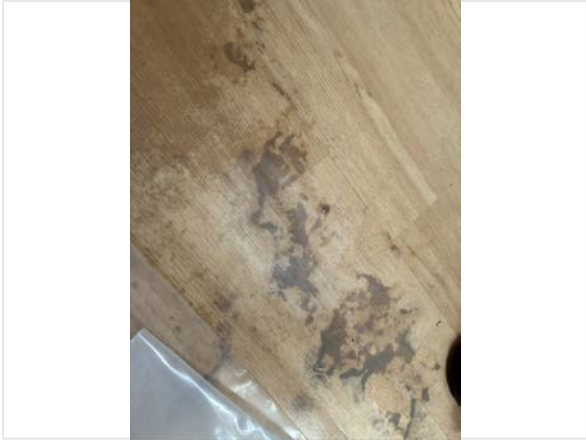
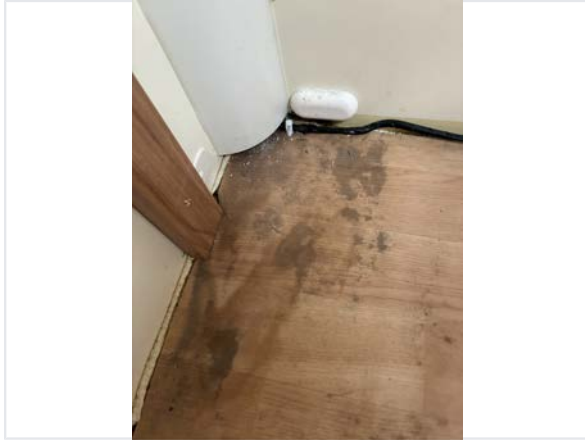
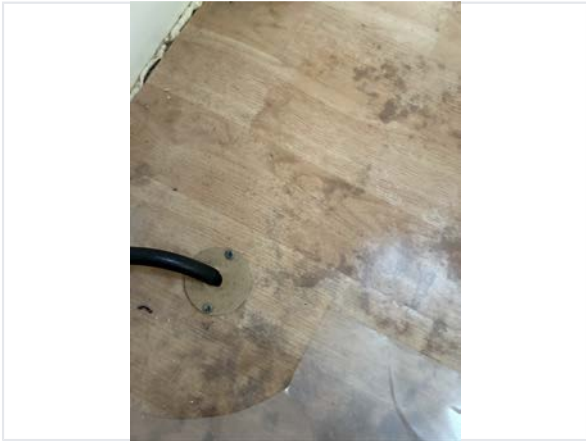
Damp (visible/soft)	Yes
Damp Info	Floor heavily moulded and discoloured Under both bench seats floor lifting and coming away from wall High readings under sink on floor and high readings throughout the floor where possible to test
Floor damp/spongy/damaged	Yes
Floor Info	As above
