CMS MOTORHOME INSPECTION FORM

Make & Model	Roller Team Auto-Roller 600
Reg Number - NO GAP	WA08CCF
HPI Clear	Yes
VAT	No
Engine Size	2.4litre
BHP	130
Transmission	Manual
Vehicle Weight (kg)	3500 kg
Miles or KM	Miles
Mileage	29916
Confirm miles (within 5,000)	Yes
Is Mileage Warranted	Yes
Engine Keys Count	2
V5 present	Yes
V5 VIN Match	Yes

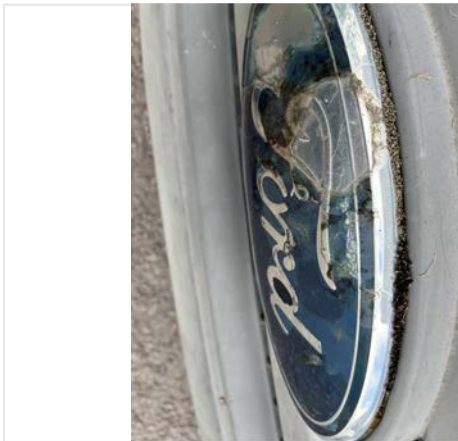
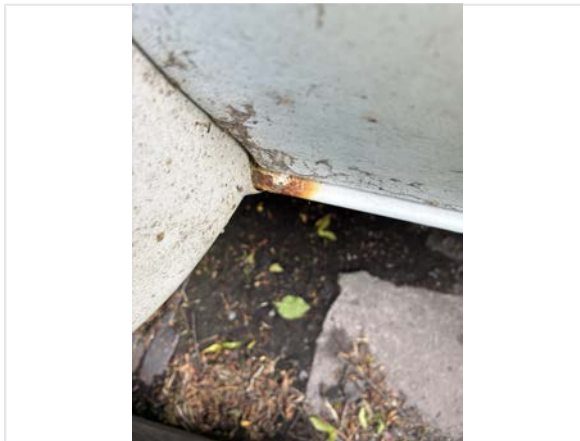
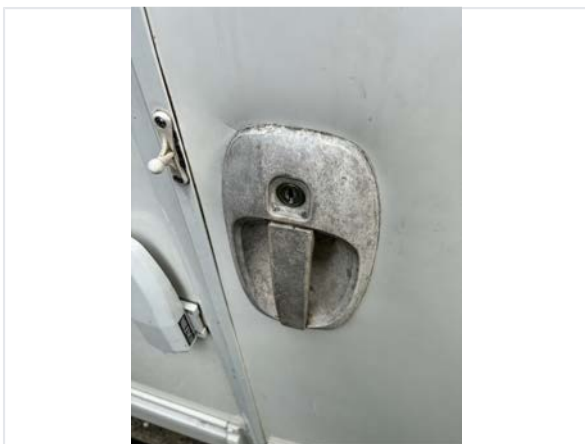
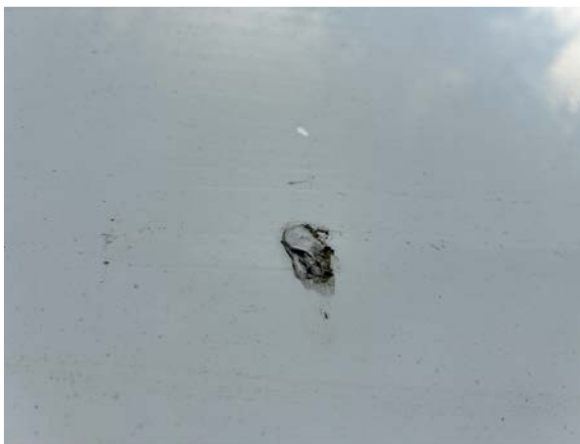
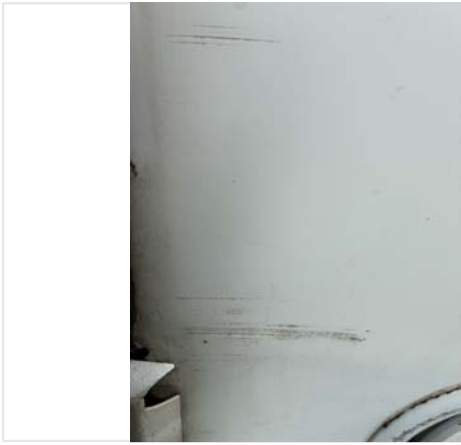
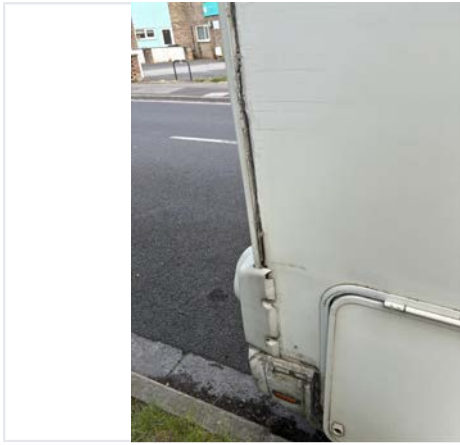
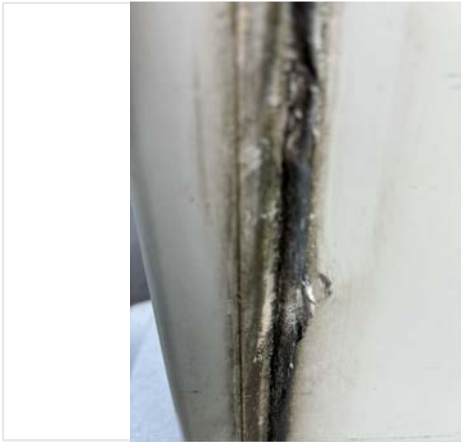
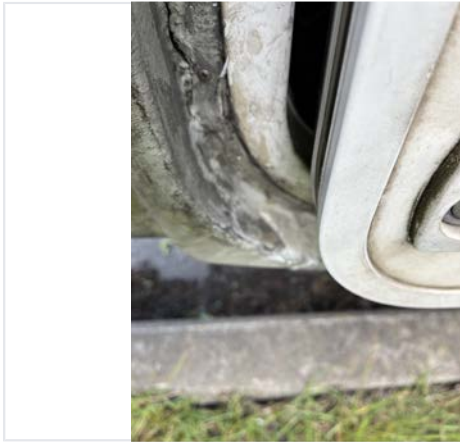
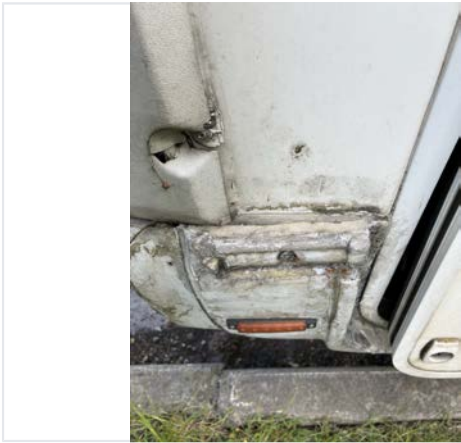
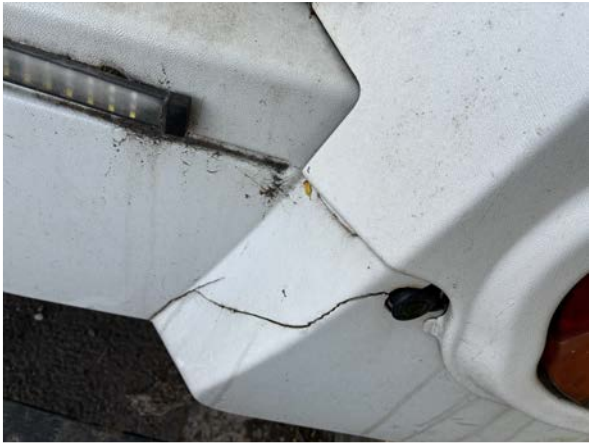
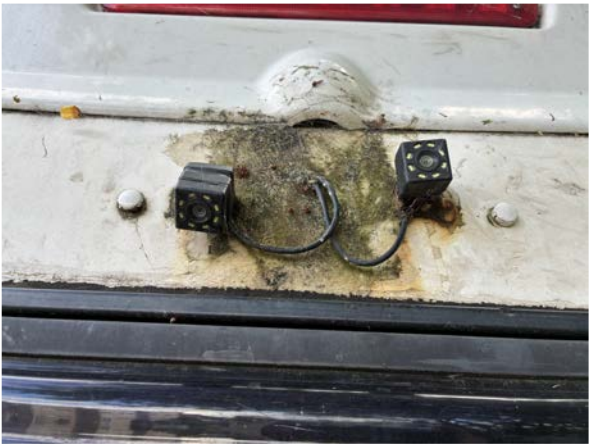
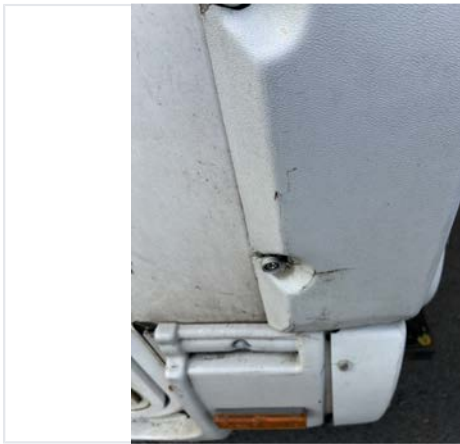
External Extras	Bike Rack, Air Suspension, Habitation door lock, Tow bar, Solar panel, Tv Aerial
Other External Extras	N/A
Decals	Good
Any Damage Found	Yes
Damage Further Info	<p>Poor repair to rear of vehicle Scratches to rear of vehicle off side Gouge in bodywork above rear window off side Hab door handle badly discoloured Rust bottom of drivers door Ford badge ruined on front Scratches near side above rear wheel Damage near side rear light cluster Damage around reverse camera on rear of vehicle</p>

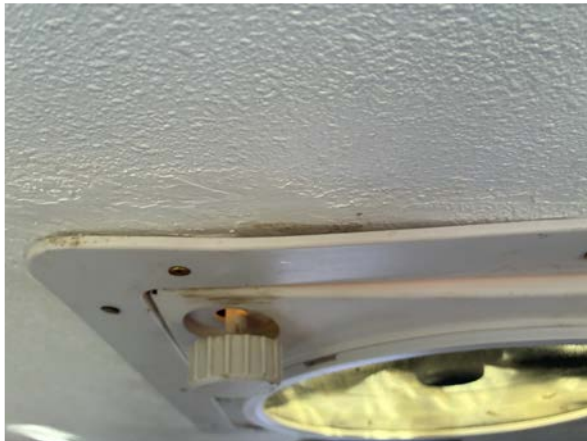
Internal Extras	Bluetooth, Multifunction steering wheel, Tv(s)
Other Extras	N/A
Electrics turn on	Yes
Control panel damaged	No
Stereo turn on	Yes
Smell or signs of smoking	No
Cushions correct	Yes
Boiler present	Yes
Overhead lockers ready	Yes
Internal Damage	Yes
Damage Info	Roof completely repainted Vent warped

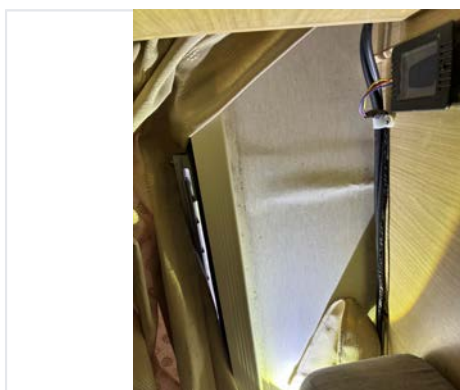
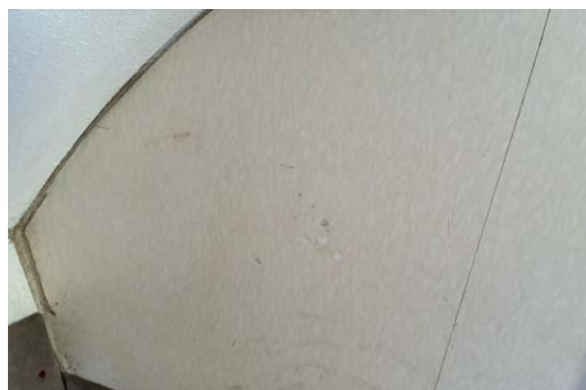
Damp (visible/soft)	Yes
Damp Info	99 reading with poor repair around roof fan 99 reading just behind over cab bed wall paper swollen and dimpled 99 reading and swollen wallpaper off side over cab bed wall paper 99 both rear corners
Floor damp/spongy/damaged	No
