## CMS MOTORHOME INSPECTION FORM

Make & Model	Elddis Autoquest 400
Reg Number - NO GAP	EU05BCZ
HPI Clear	Yes
VAT	No
Engine Size	2.2 litre
BHP	101 bhp
Transmission	Manual
Vehicle Weight (kg)	3500 kg
Miles or KM	Miles
Mileage	47552
Confirm miles (within 5,000)	Yes
Is Mileage Warranted	Yes
Engine Keys Count	2
V5 present	Yes
V5 VIN Match	Yes

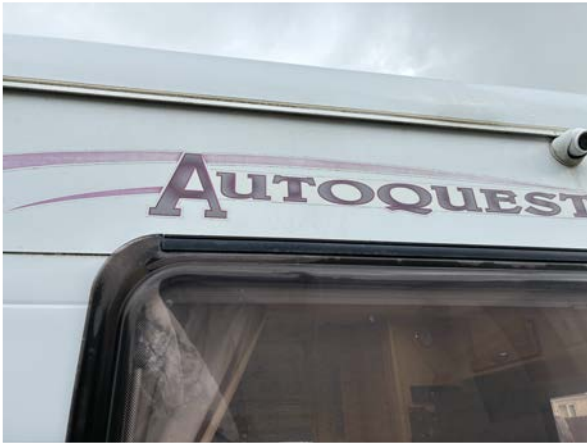
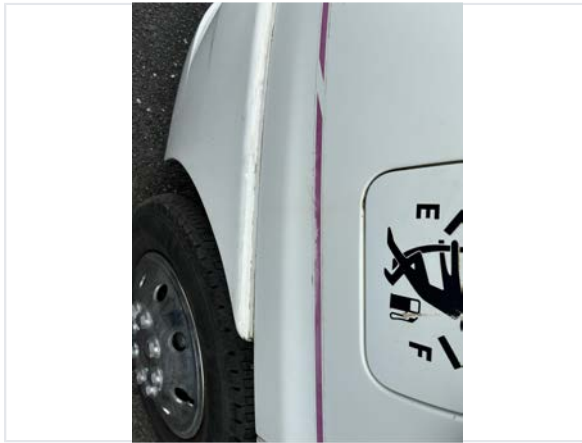
External Extras	Awning, Bike Rack, Manual step, Reversing camera, Solar panel, Tow bar, Tv Aerial
Other External Extras	N/A
Decals	Need attention
Decals Further Info	Fading due to age

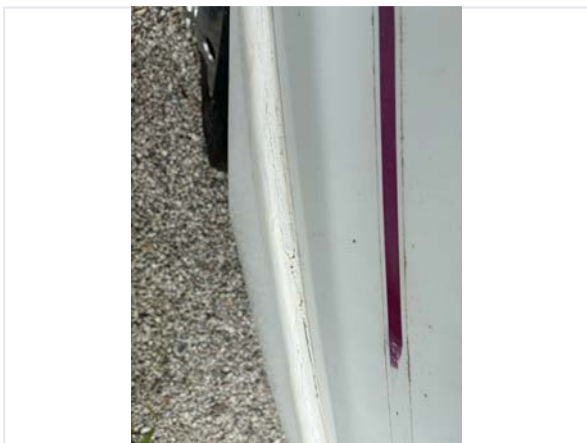
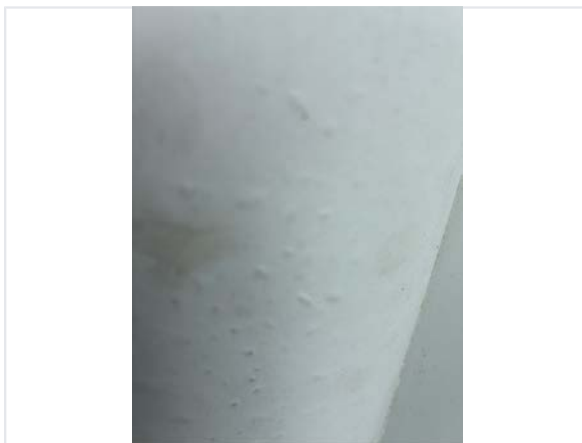
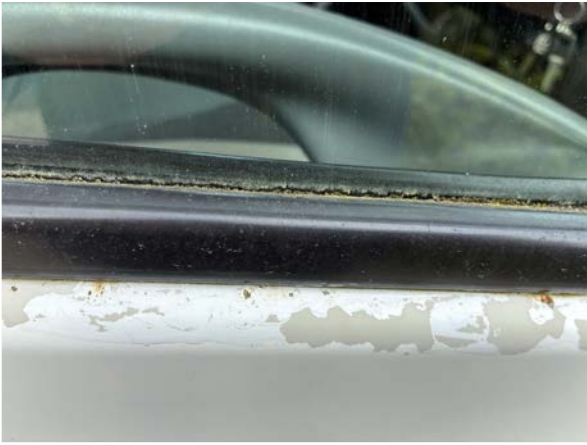
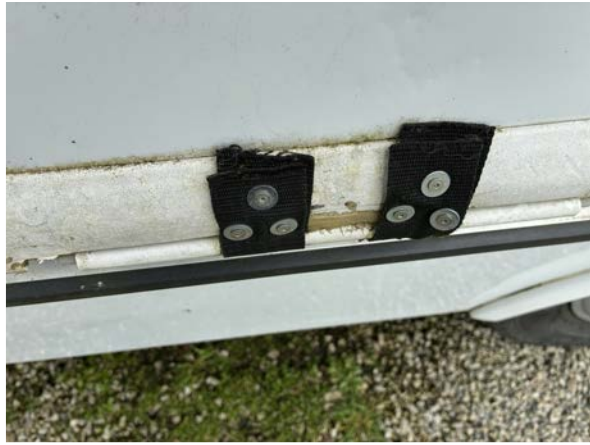
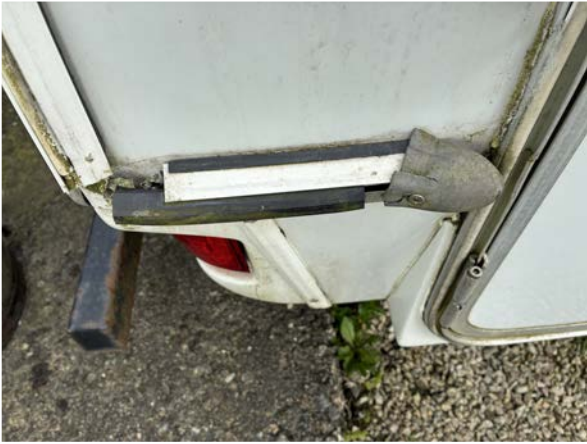
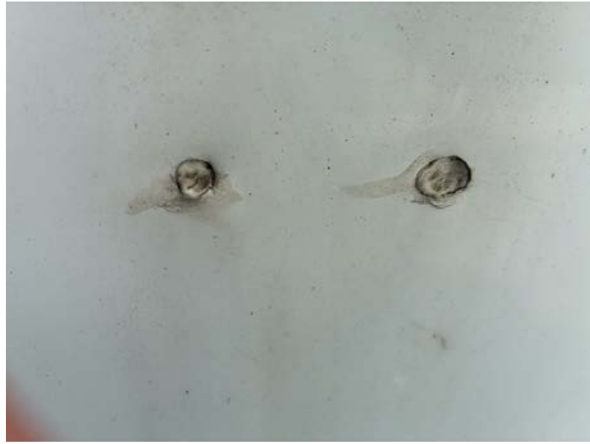
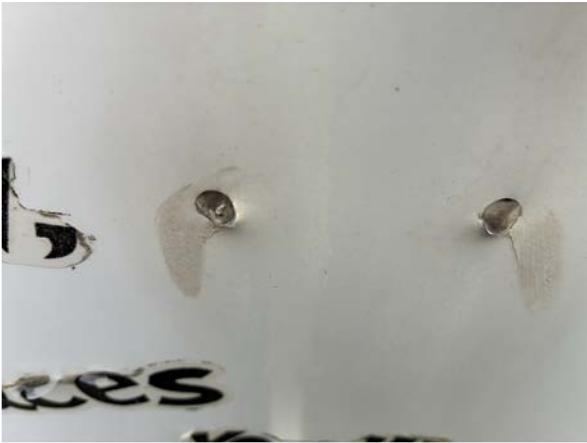
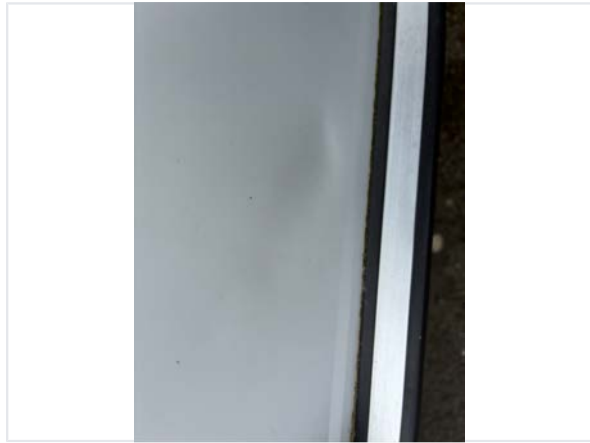
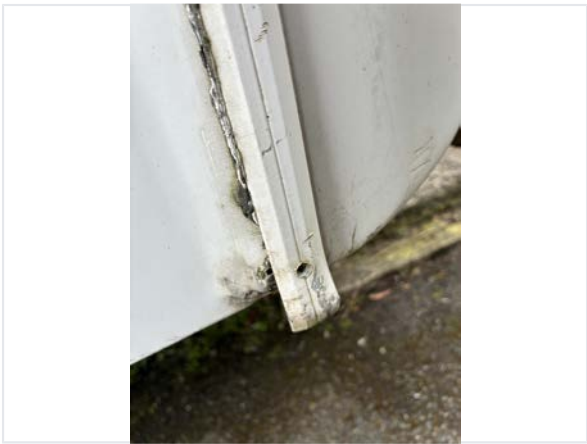
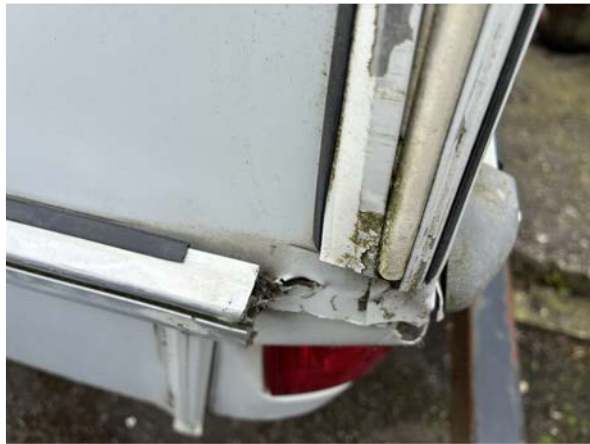
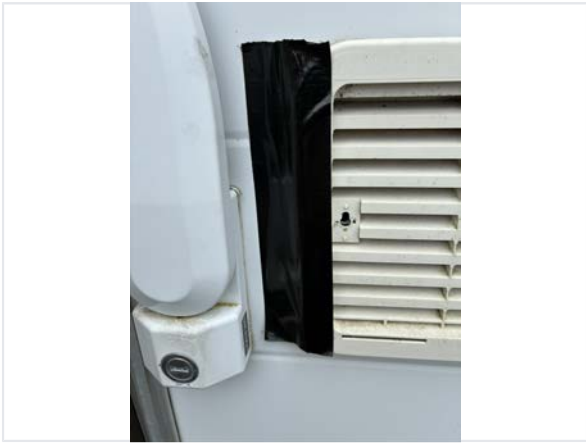
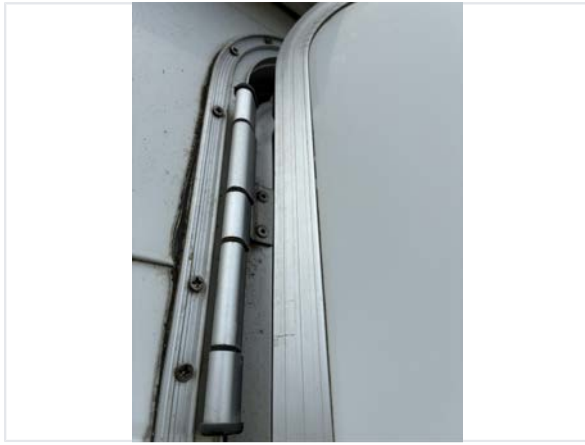
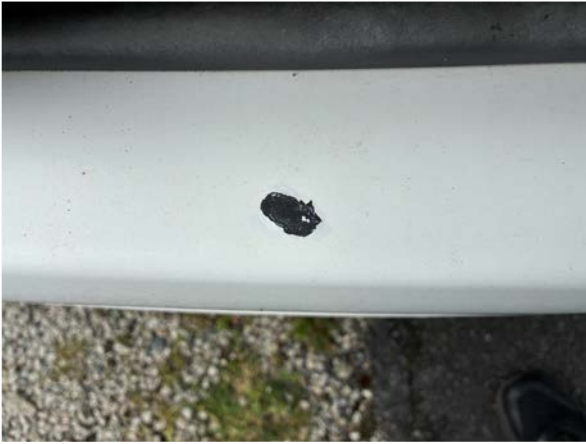
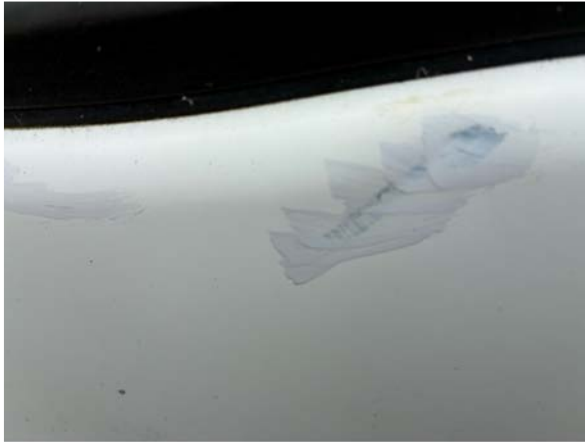
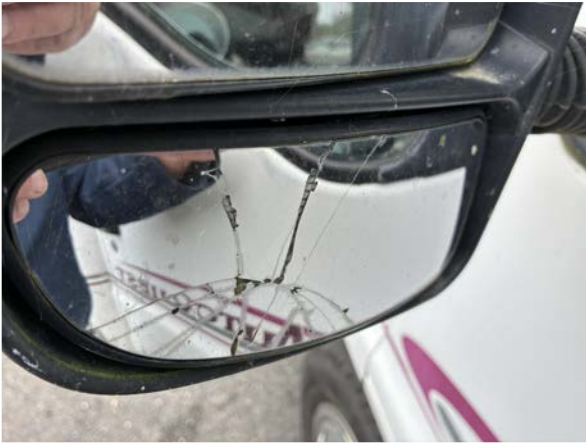
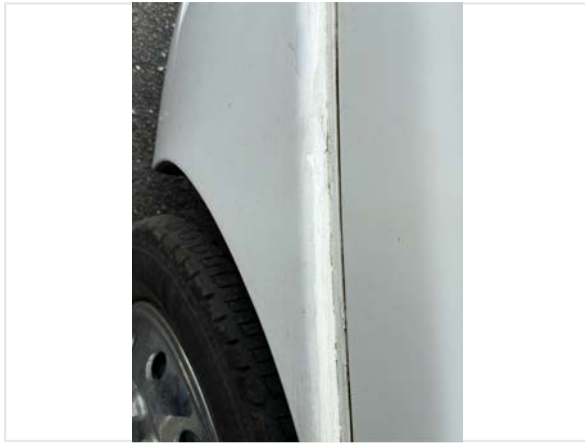
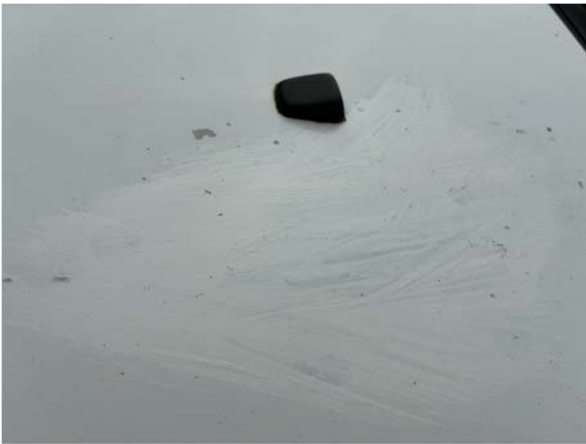
Any Damage Found	Yes
Damage Further Info	<p>Poor repair on near side front panel          Near side wing mirror cracked          Cracking on near side pillar behind door          Hab door damaged barely closes          Air vent damaged held on with tape          Rear wheel arch damaged near side pillar behind          Bottom skirt broken near side rear corner          Bike rack been moved causing damage          Dents to rear          Damage to off side rear corner          Rippling on off side panel behind door          Paint peeling on drivers door          Front bumper damaged on off          Side          Ariel broken          Age related bumps and scratches</p>

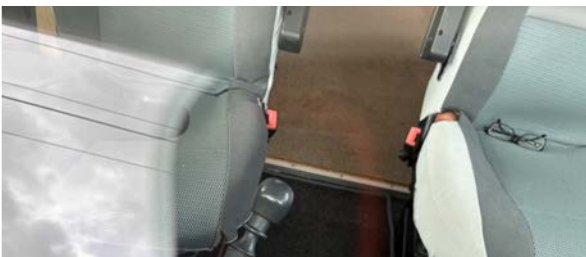
Windscreen

Chip(s) smaller than 10p

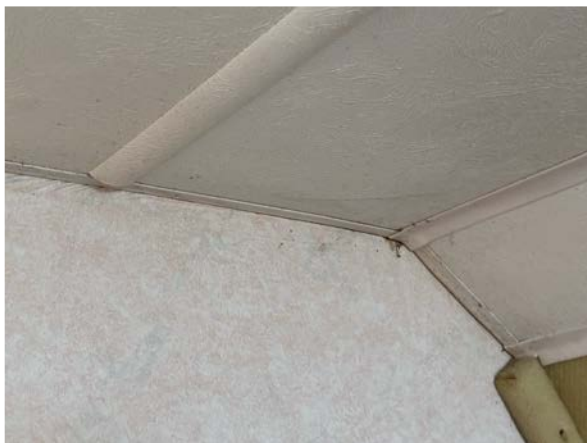
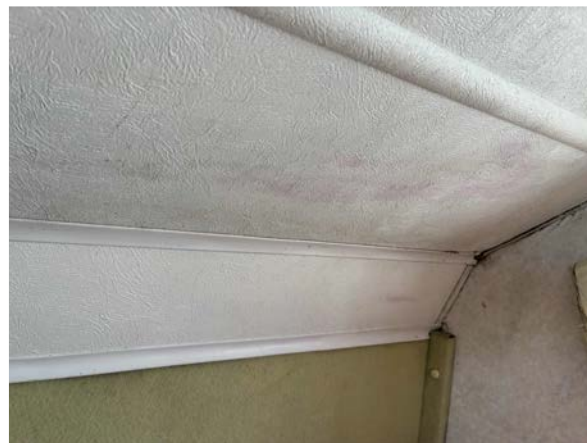
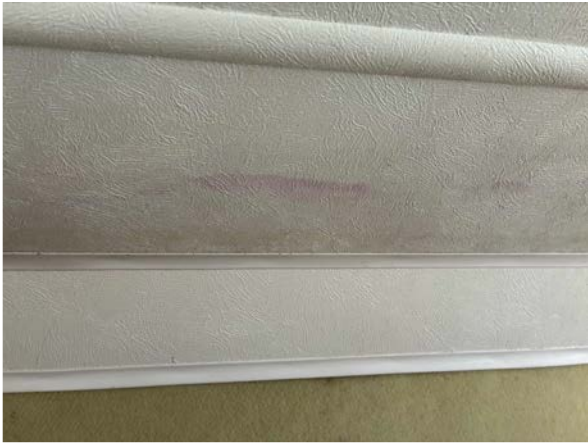
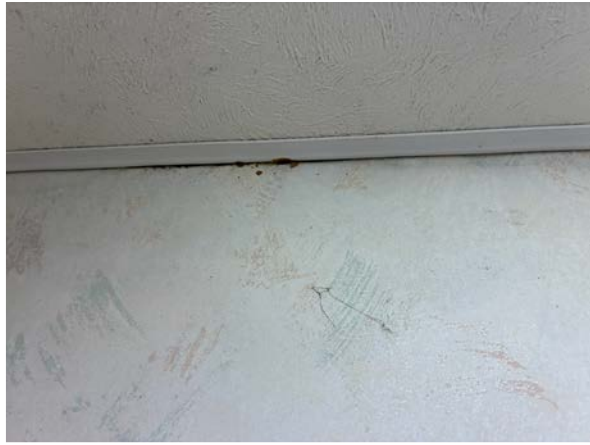
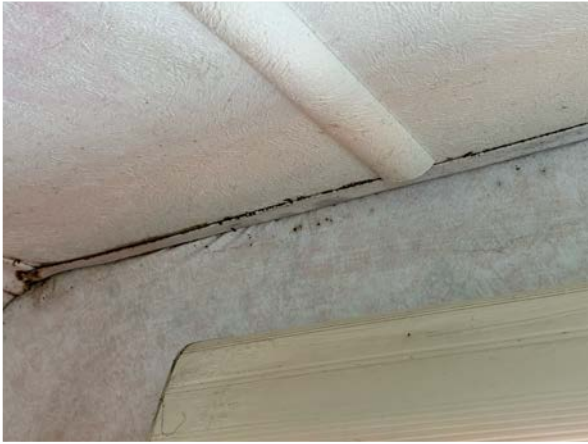
Damp (visible/soft)	Yes
Damp Info	Red staining on roof with 99 readings Blue staining and 99 readings on top of wash room wall
Floor damp/spongy/damaged	No
