## CMS MOTORHOME INSPECTION FORM

| Make & Model | Autotrail Dakota SE |
| Reg Number - NO GAP | WA04RXX |

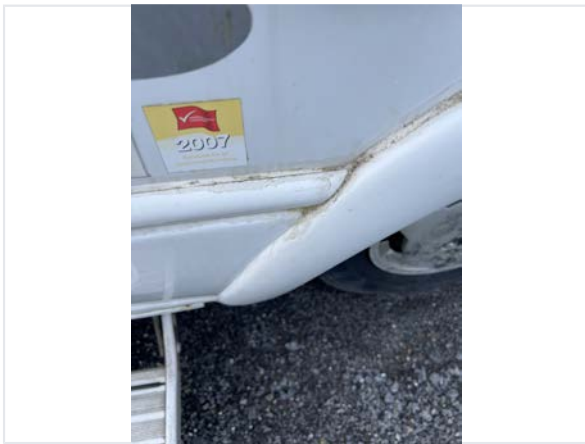
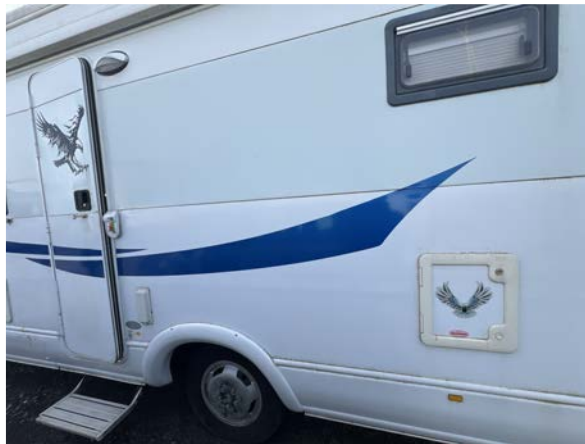
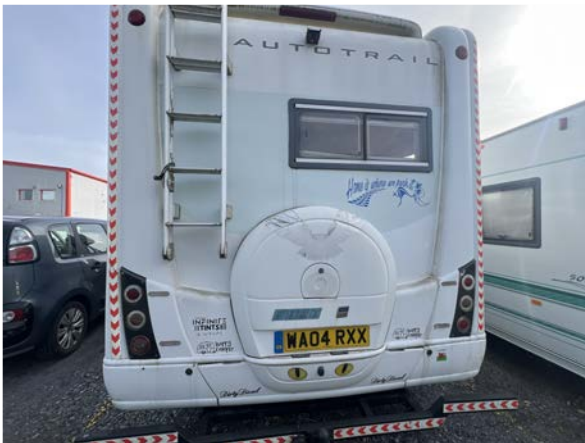
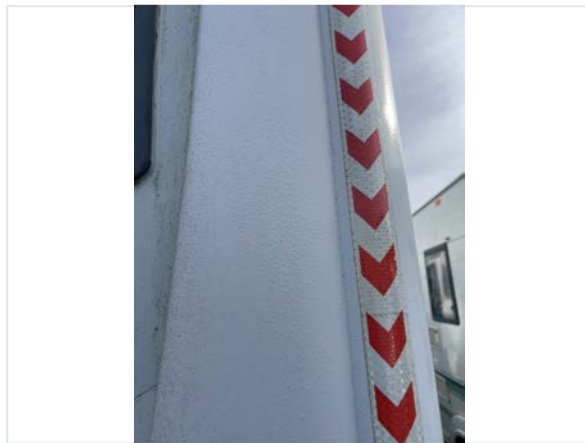
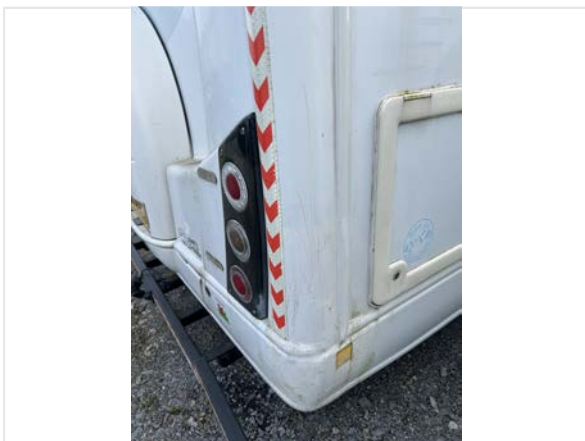
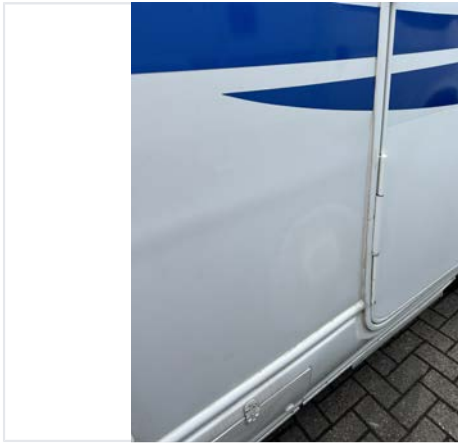
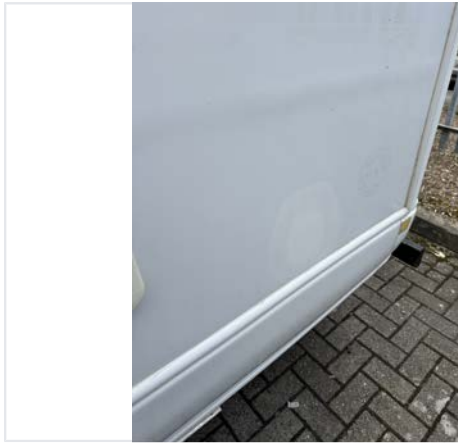
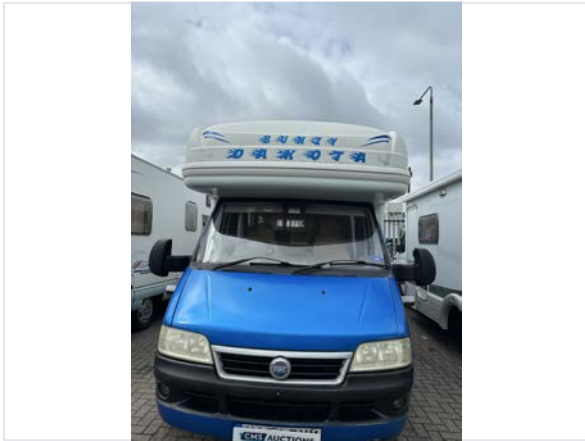
| Any Damage Found | Yes |
| Damage Further Info | Re sealed ns // scuff ns trim // stickers added // paint bubbling whole rear // stickers added rear // osr bumper damaged // paint bubbling os front // Two areas of delamination on NS // Cab is wrapped blue |

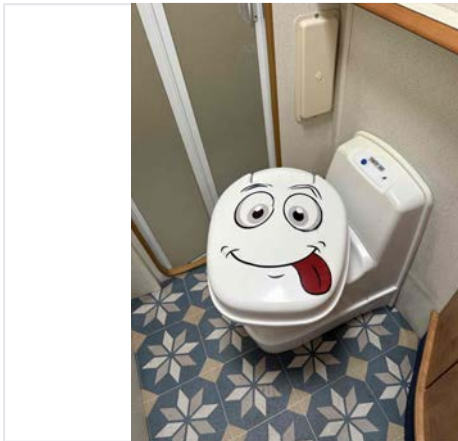
| Internal Damage | Yes |
| Damage Info | Toilet seat sticker // Rot on wood |

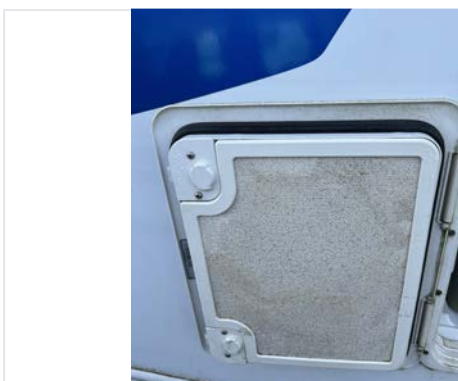
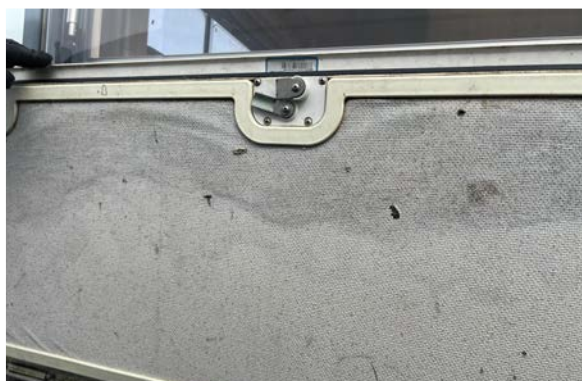
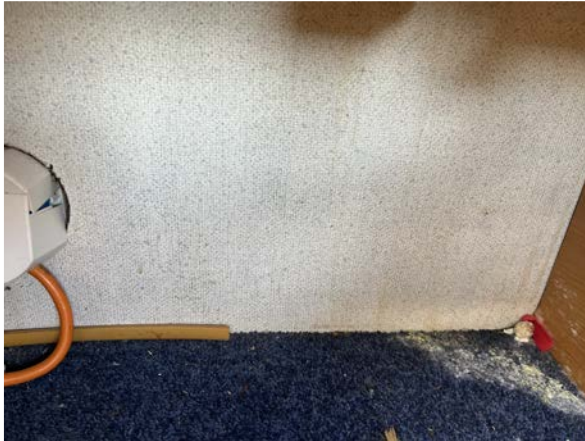
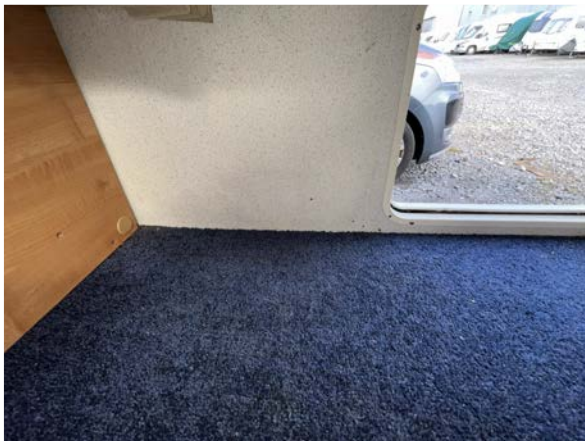
| Damp (visible/soft) | Yes |
| Damp Info | Staining ns locker // staining os locker // blue above cab // blue down ns panel // blue under ns bench seats // blue os panel // blue under os bench seats // blue in the bathroom // multiple blue areas along the ceiling // |
| Floor damp/spongy/damaged | Yes |
| Floor Info | Carpet fitted below both bench seats and under kitchen sink |
