CMS MOTORHOME INSPECTION FORM

Make & Model	Elddis Autoquest 120
Reg Number - NO GAP	HX10EZL
HPI Clear	Yes
VAT	No
Engine Size	2.2
BHP	99
Transmission	Manual
Vehicle Weight (kg)	3000
Miles or KM	Miles
Mileage	35298
Confirm miles (within 5,000)	Yes
Is Mileage Warranted	Yes
Engine Keys Count	2
V5 present	Yes
V5 VIN Match	Yes

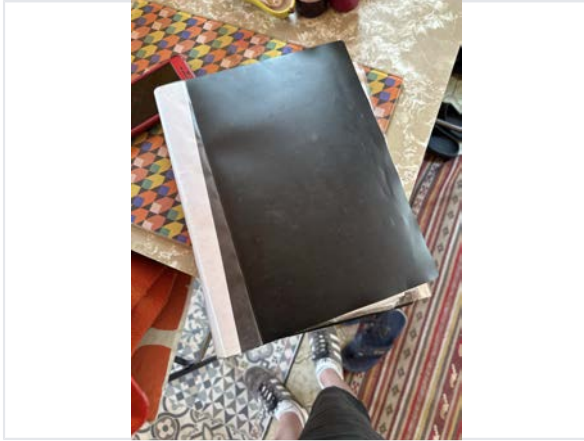
Manuals present	Yes
-----------------	-----

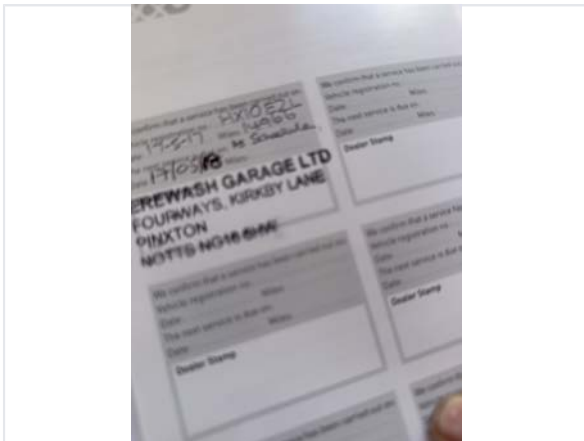
Engine Service History	Partial
Service Info	1 stamp
Date of Last Engine Service	17/05/2017
Cam belt changed	No
Habitation service reports	None
