CMS MOTORHOME INSPECTION FORM

Make & Model	Burstner Lyseo Harmony TD 734
Reg Number - NO GAP	HX18DMU
HPI Clear	Yes
VAT	No
Engine Size	2.3L
BHP	148
Transmission	Manual
Vehicle Weight (kg)	4T
Miles or KM	Miles
Mileage	27966
Confirm miles (within 5,000)	Yes
Is Mileage Warranted	Yes
Engine Keys Count	2
V5 present	Yes
V5 VIN Match	Yes

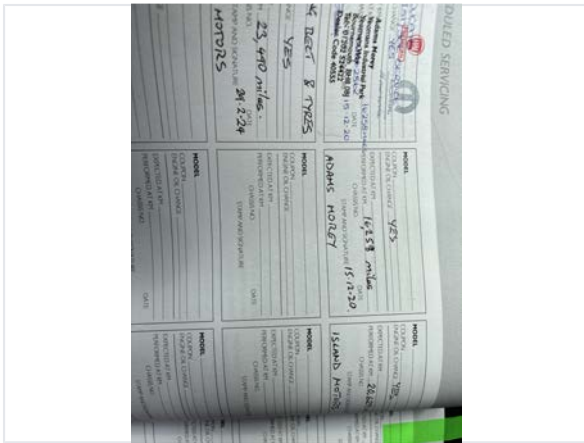
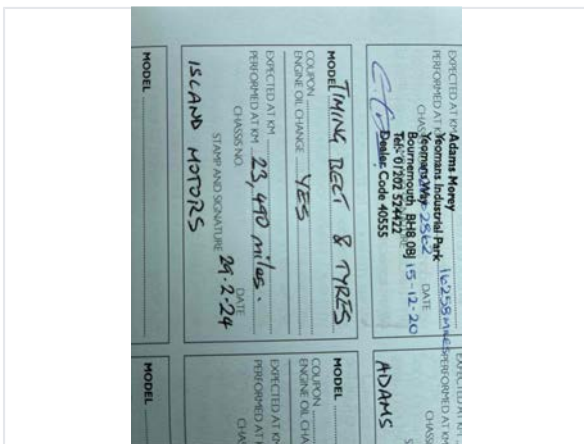
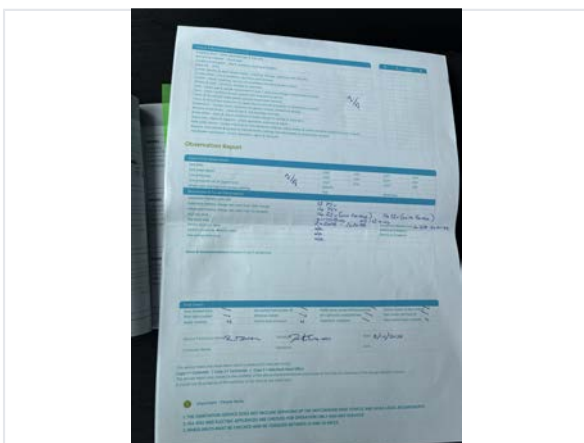
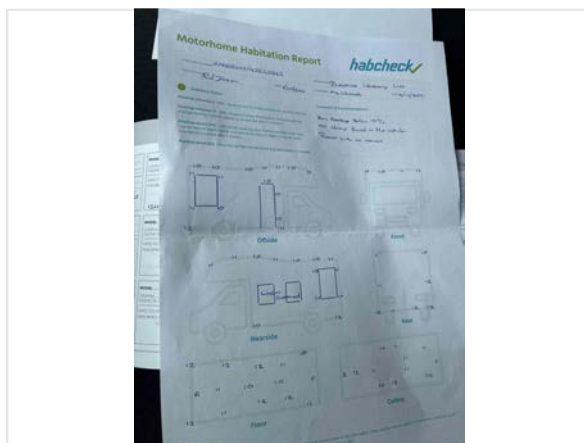
Manuals present	Yes
Engine Service History	Full
Service Info	Log book photo,d
Cam belt changed	Yes
Cam belt info	See pic above
Habitation service reports	Partial
Habitation Info	Last service photo,d
