CMS MOTORHOME INSPECTION FORM

Make & Model	Compass Envoy 115
Reg Number - NO GAP	MX07NYF
HPI Clear	Yes
VAT	No
Engine Size	2.2
BHP	99
Transmission	Manual
Vehicle Weight (kg)	3000
Miles or KM	Miles
Mileage	41505
Confirm miles (within 5,000)	Yes
Is Mileage Warranted	Yes
Engine Keys Count	2
V5 present	Yes
V5 VIN Match	Yes

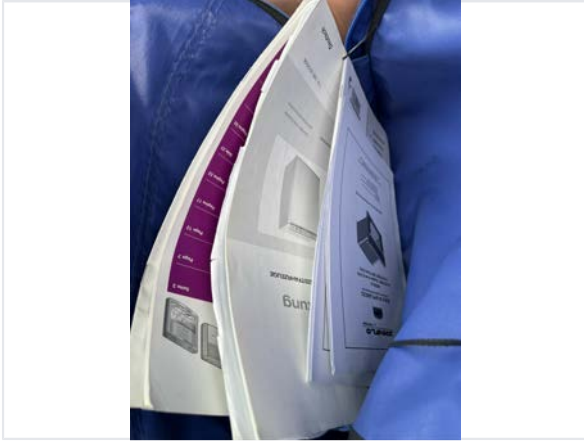
Manuals present	Yes
-----------------	-----

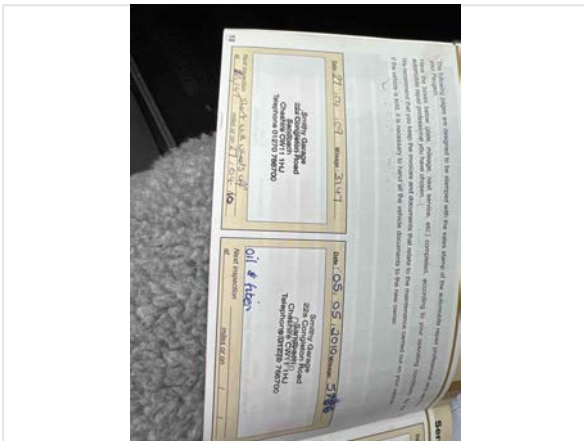
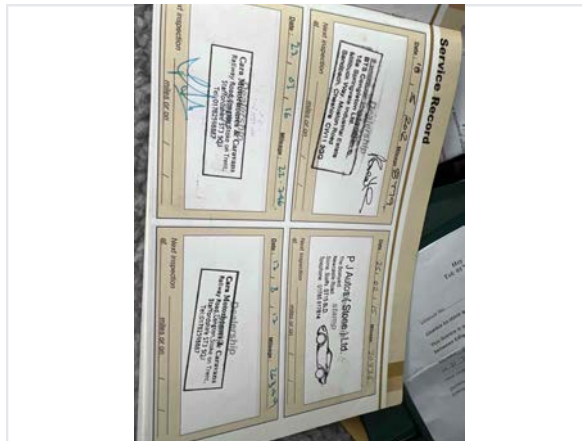
Engine Service History	Partial
Service Info	2017 last service
Date of Last Engine Service	N/A
Cam belt changed	N/A
Habitation service reports	None
