CMS MOTORHOME INSPECTION FORM

Make & Model	WildAx Constellation
Reg Number - NO GAP	FH54TXA
HPI Clear	Yes
VAT	No
Engine Size	2.2
BHP	103
Transmission	Manual
Vehicle Weight (kg)	3500
Miles or KM	Miles
Mileage	121144
Confirm miles (within 5,000)	Yes
Is Mileage Warranted	Yes
Engine Keys Count	1
V5 present	Yes
V5 VIN Match	Yes

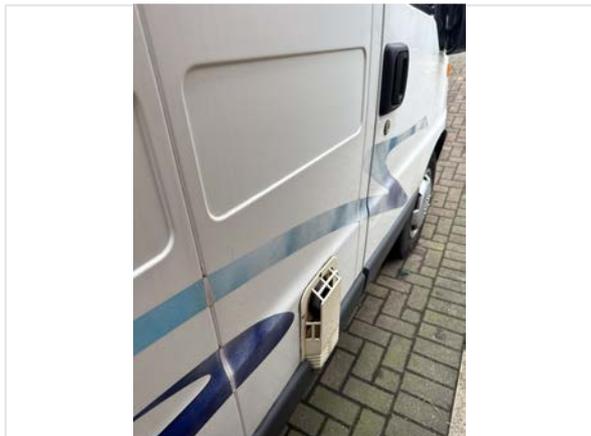
External Extras	Awning, Bike Rack
Decals	Need attention
Decals Further Info	Faded

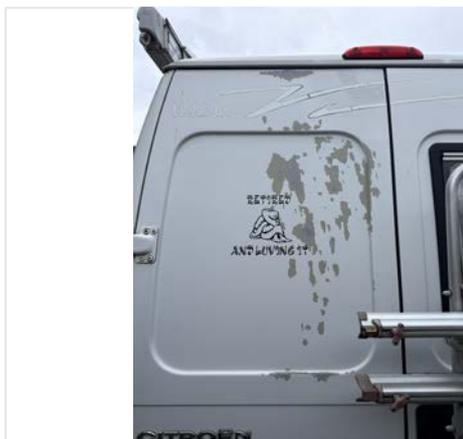
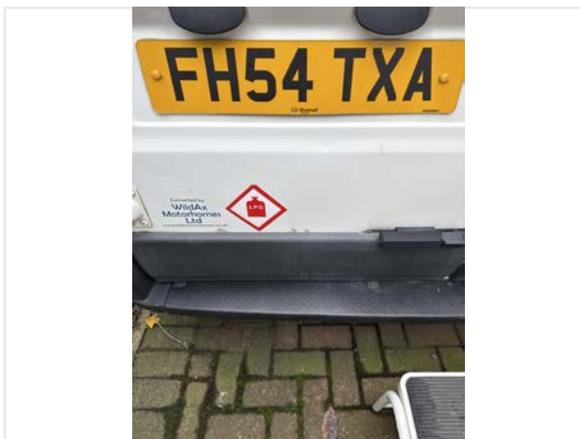
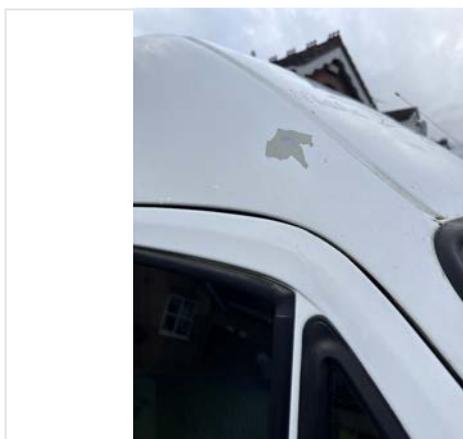
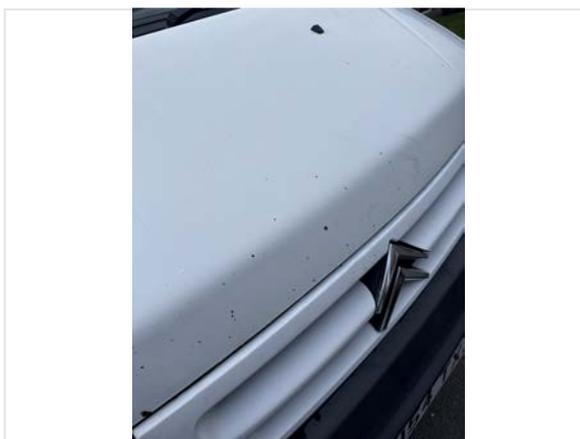
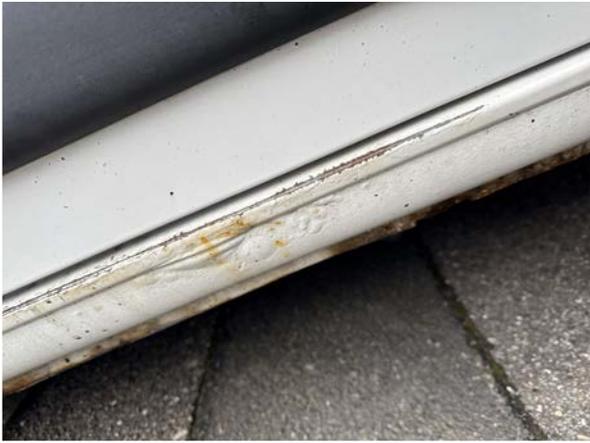
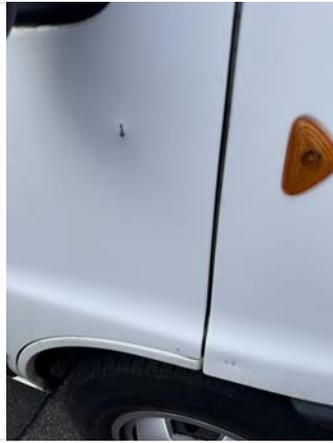
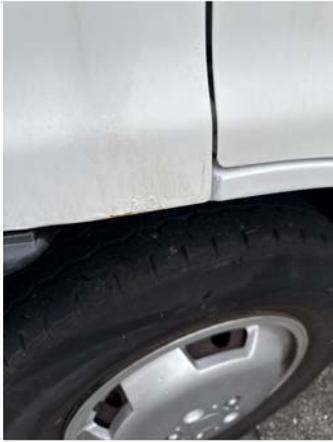
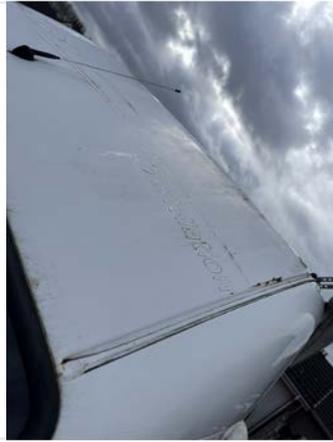
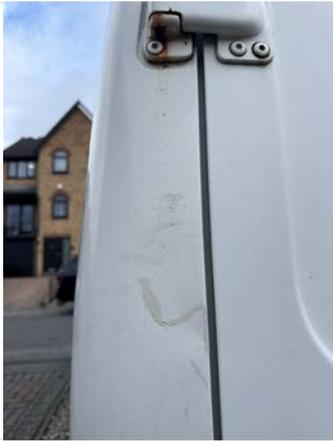
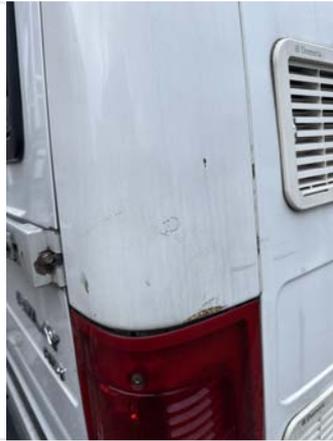
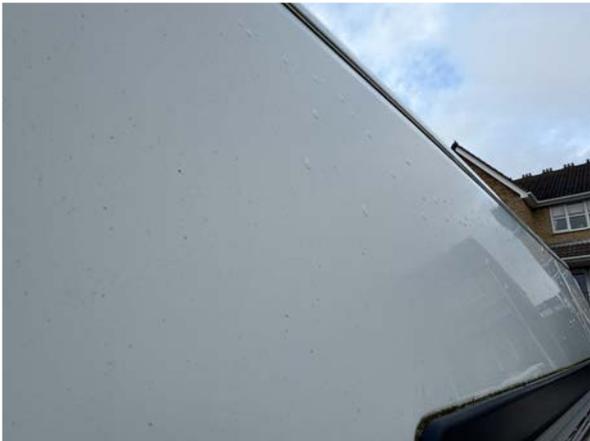
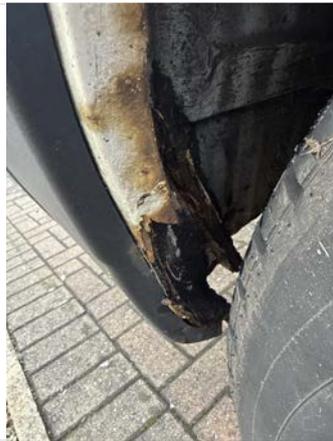
Any Damage Found	Yes
Damage Further Info	Paint flake on rear, o/s front upper corner. Bonnet stone chips, door dented o/s, sill rusty o/s. Paint bubble o/s few touch ups to the rear

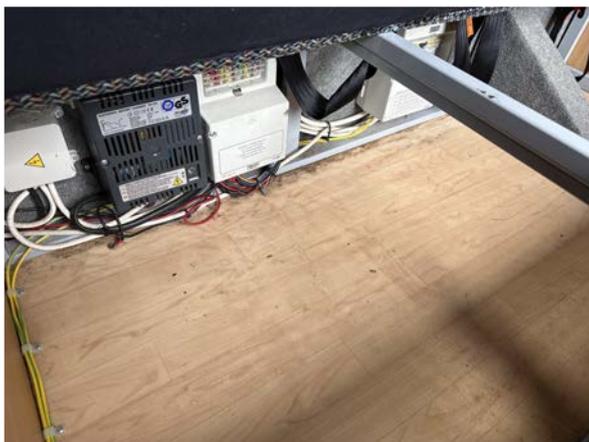
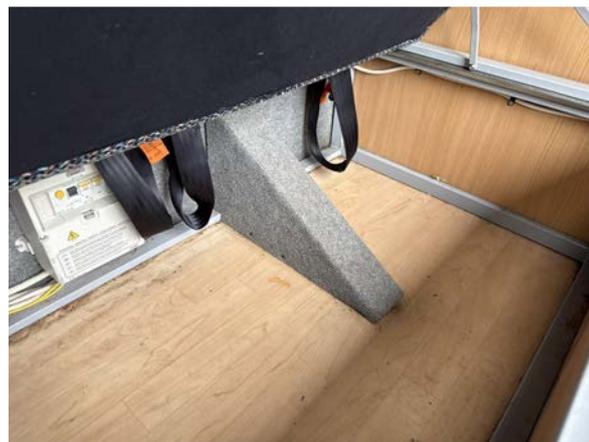
Damp (visible/soft)	Yes
Damp Info	Floor under o/s bench seat reading 40's and soft
Floor damp/spongy/damaged	Yes
Floor Info	See above damp section

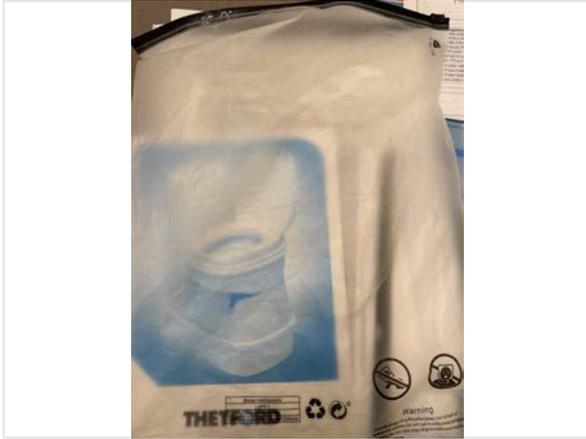
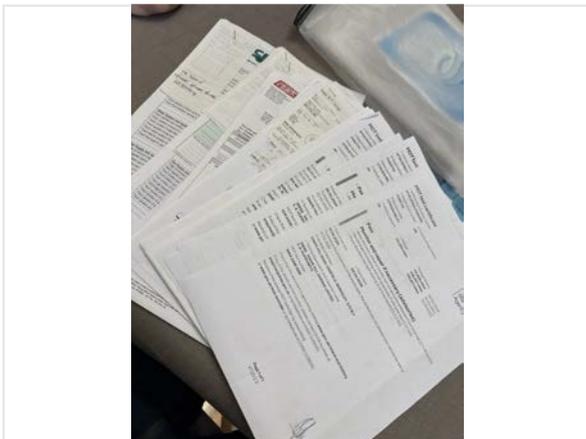
Engine Service History	Partial
Service Info	Paperwork for all previous services
Cam belt changed	No
Habitation service reports	Partial
Habitation Info	N/A
