CMS MOTORHOME INSPECTION FORM

Make & Model	Eura Mobil Terrestra
Reg Number - NO GAP	FJ17DAA
HPI Clear	Yes
VAT	No
Engine Size	2.3
BHP	150
Transmission	Automatic
Vehicle Weight (kg)	3650
Miles or KM	Miles
Mileage	15378
Confirm miles (within 5,000)	Yes
Is Mileage Warranted	Yes
Engine Keys Count	2
V5 present	Yes
V5 VIN Match	Yes

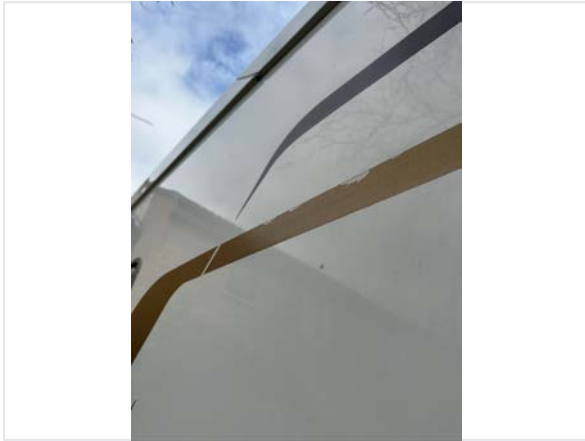
External Extras	Awning, Alloys, LED daytime running lights, Electric step, Reversing camera, Solar panel, Tv Aerial
Other External Extras	N/A
Decals	Need attention
Decals Further Info	Some decals on NS torn

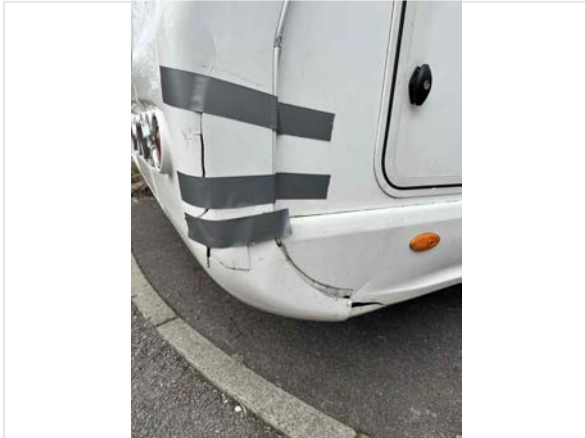
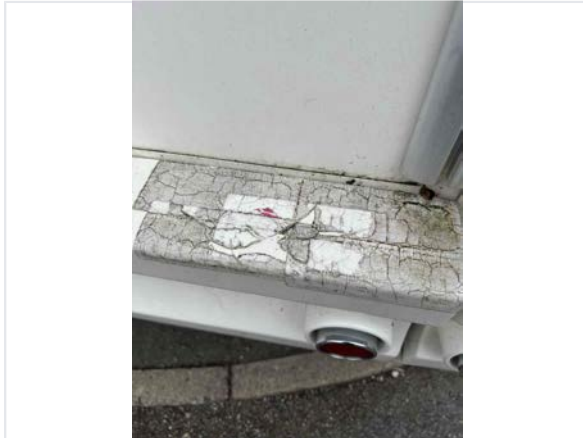
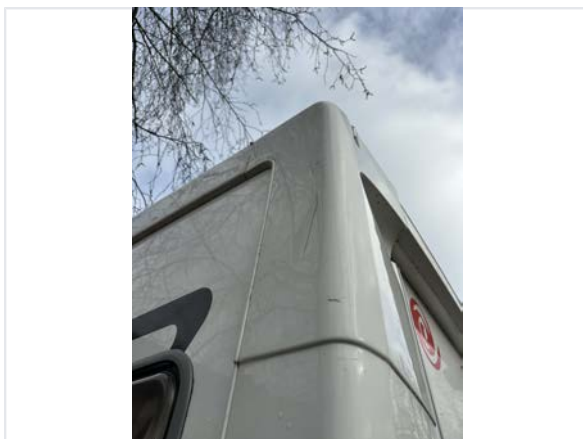
Any Damage Found	Yes
Damage Further Info	N/A

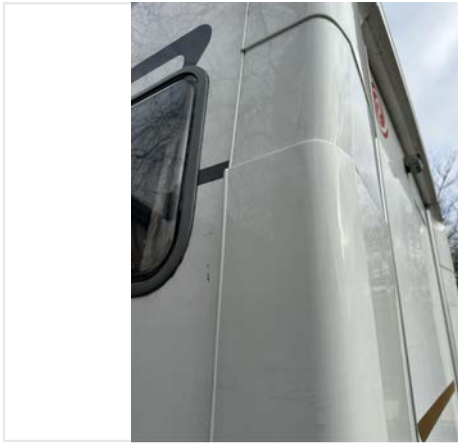
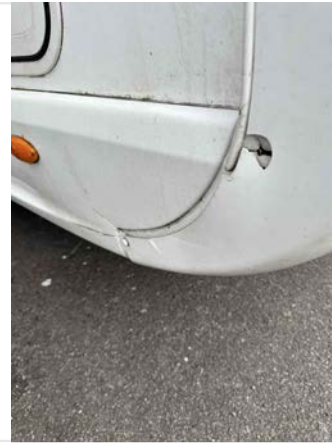
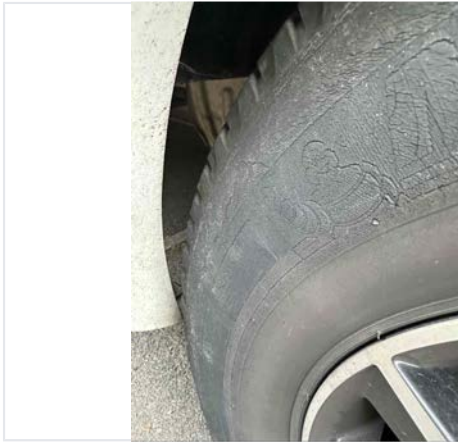
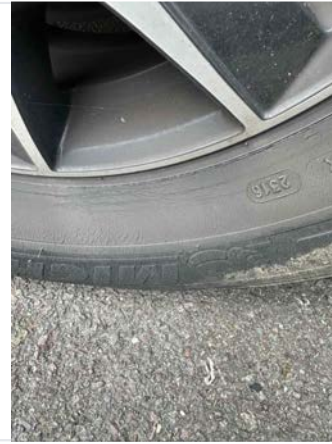
Windscreen	No damage
Alloy Wheels	Good
Tyres illegal/cracking/out of date	Yes
Tyre Further Info	Both rear tyres are perishing and dated 2015

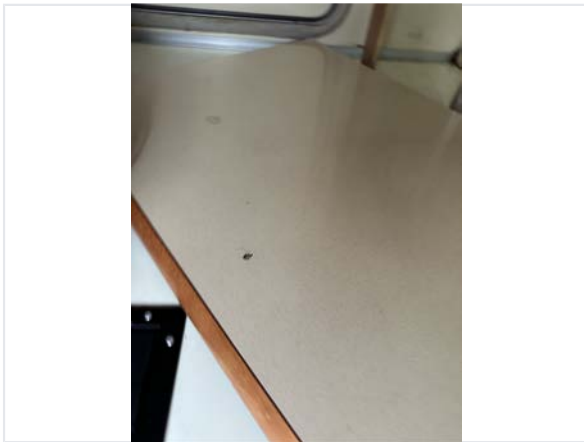
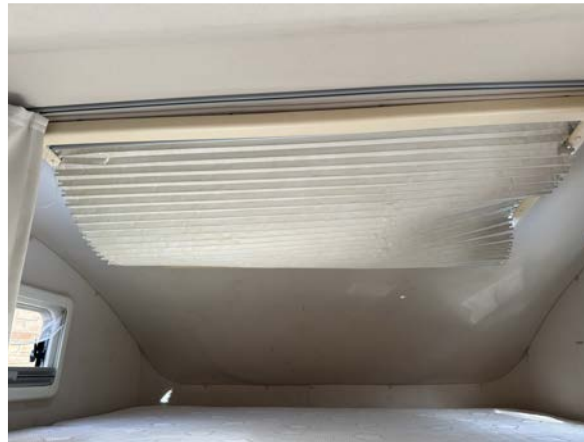
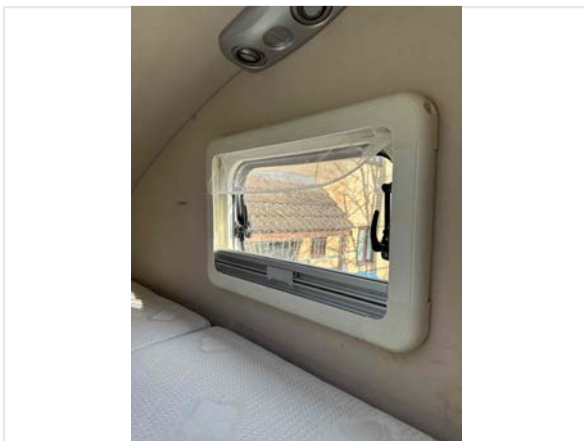
Internal Extras	cab A/C, Climate control, Cab blinds, Cruise control, Sat nav, Multifunction steering wheel, DAB radio, Bluetooth, Oven, Tv(s)
Other Extras	Additional TV next to bed
Electrics turn on	Yes
Control panel damaged	No
Stereo turn on	Yes
Smell or signs of smoking	No
Cushions correct	Yes
Boiler present	Yes
Overhead lockers ready	Yes
Internal Damage	Yes
Damage Info	Damage to table // Damage to floor in entrance // Overcab skylight and both window blinds are damaged // Wear and tear on drawer handles // Bench seat upholstery dirty // Patches on mould on rear wall fabric
