CMS MOTORHOME INSPECTION FORM

Make & Model	Elddis Majestic 155
Reg Number - NO GAP	PO16CYU
HPI Clear	Yes
VAT	No
Engine Size	2.2
BHP	128bhp
Transmission	Manual
Vehicle Weight (kg)	3.5T
Miles or KM	Miles
Mileage	24723
Confirm miles (within 5,000)	Yes
Is Mileage Warranted	Yes
Engine Keys Count	2
V5 present	Yes
V5 VIN Match	Yes

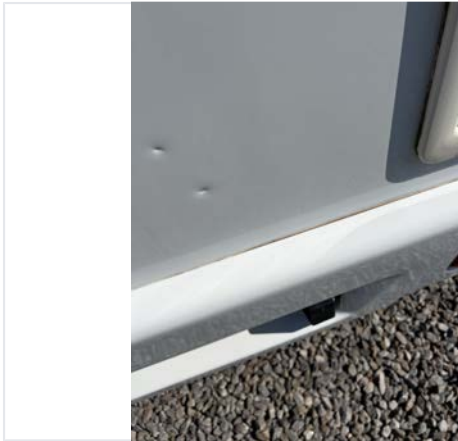
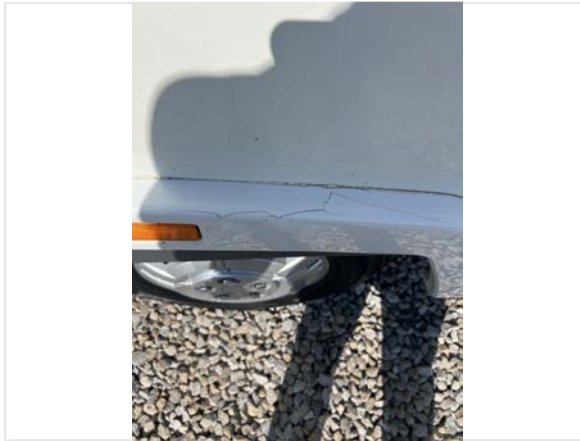
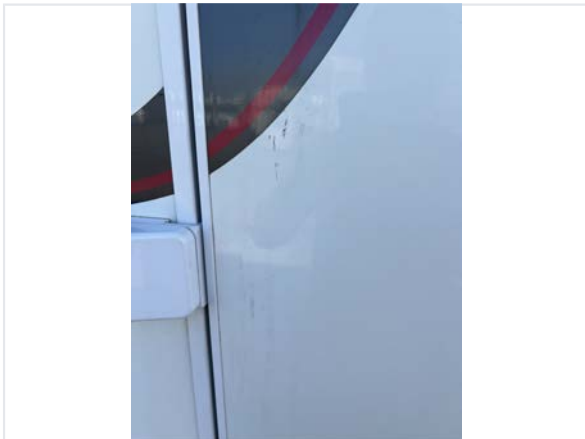
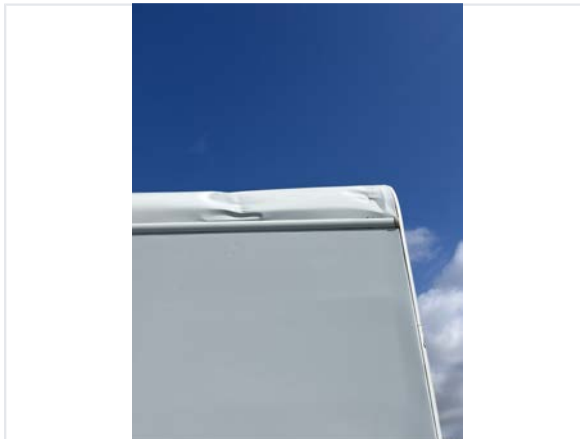
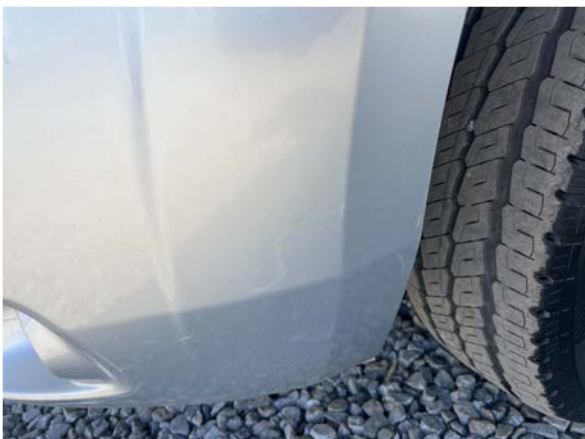
External Extras	Awning, Electric step, Front fog lights, Habitation door lock, Reversing camera, Solar panel, Tv Aerial
Decals	Good
Any Damage Found	Yes
Damage Further Info	Scratches on hab door // Crack on near side rear bumper // Dents on back of van // Damage to rear pillar off side near side marker // Damage to off side wheel arch // Damage to off side corner of roof

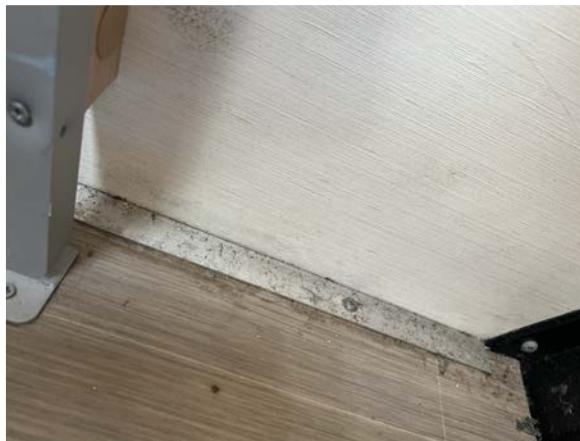
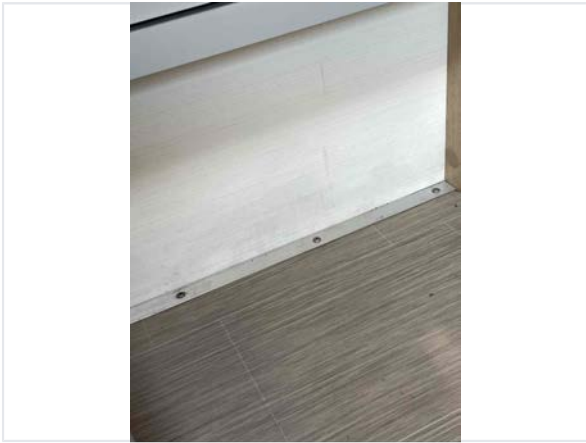
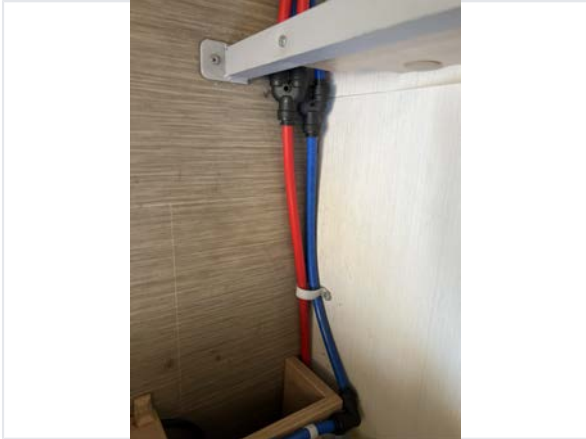
Internal Extras	Bluetooth, cab A/C, Cab blinds, Cab curtains, Cruise control, Multifunction steering wheel, Oven, Tv(s), Sat nav, DAB radio
Other Extras	N/A
Electrics turn on	Yes
Control panel damaged	No
Stereo turn on	Yes
Smell or signs of smoking	No
Cushions correct	Yes
Boiler present	N/A
Overhead lockers ready	Yes
Internal Damage	Yes
Damage Info	Worktop scuffed behind tap

Damp (visible/soft)	Yes
Damp Info	Blue staining under ns and rear panel under french bed // blue staining under ns bench seat //
Floor damp/spongy/damaged	Yes
Floor Info	Floor soft to the point of being close to be able to push your finger through under French bed
