## CMS MOTORHOME INSPECTION FORM

Make & Model	Carado T449
Reg Number - NO GAP	KY16PXP
HPI Clear	Yes
VAT	No
Engine Size	2.3 litre
BHP	130 bhp
Transmission	Manual
Vehicle Weight (kg)	3500 kg
Miles or KM	Miles
Mileage	35987
Confirm miles (within 5,000)	Yes
Is Mileage Warranted	Yes
Engine Keys Count	2
V5 present	Yes
V5 VIN Match	Yes

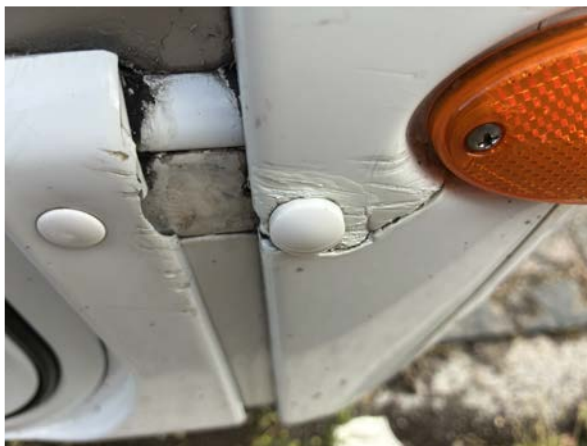
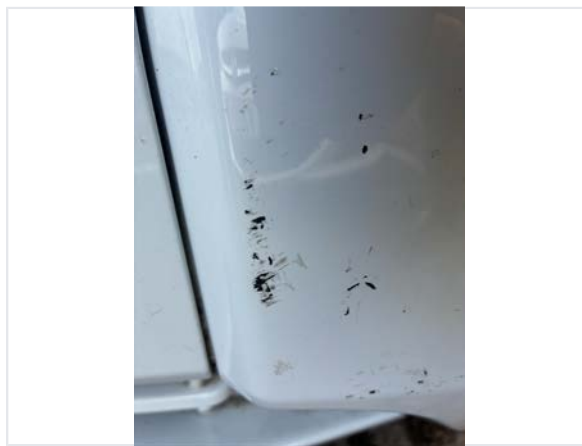
External Extras	Awning, Bike Rack, Electric step, Solar panel, Tv Aerial, Alloys, LED daytime running lights
Other External Extras	N/A
Decals	Good
Any Damage Found	Yes
Damage Further Info	Small area of damage on NSR corner // Scratches on front bumper

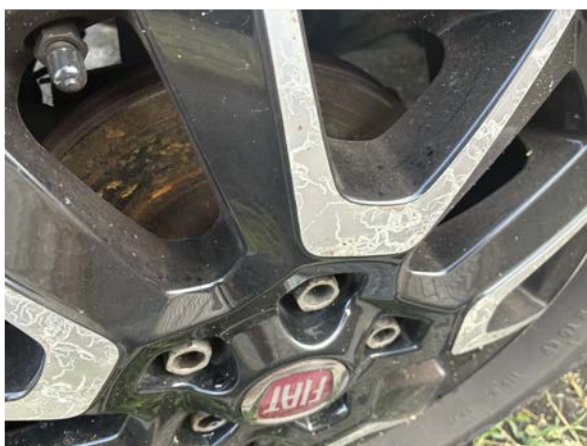
Windscreen	No damage
Alloy Wheels	Need attention
Alloy Further Info	NSF alloy tarnished

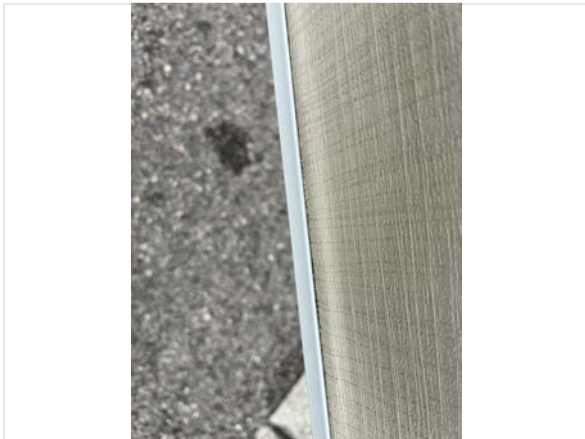
Damp (visible/soft)	Yes
Damp Info	Near side locker door soft and rippled
Floor damp/spongy/damaged	No

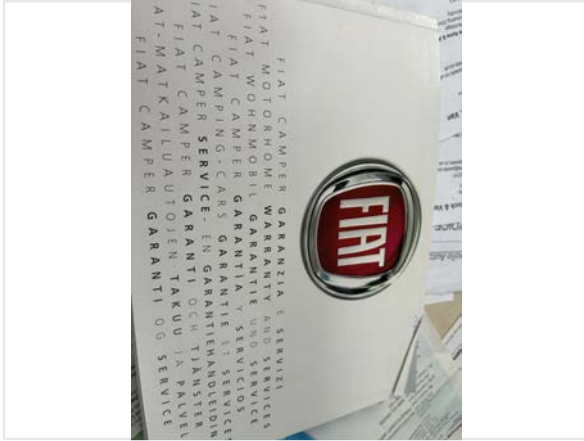
Engine Service History	Full
Service Info	Book pictured
Date of Last Engine Service	09/08/2025
Cam belt changed	No
Habitation service reports	Partial
Habitation Info	Last service pictured
Date of Last Habitation Service	03/10/2025
