CMS MOTORHOME INSPECTION FORM

Make & Model	Swift Select 184
Reg Number - NO GAP	YY66VAA
HPI Clear	Yes
VAT	No
Engine Size	2.3
BHP	130
Transmission	Manual
Vehicle Weight (kg)	3500
Miles or KM	Miles
Mileage	37395
Confirm miles (within 5,000)	Yes
Is Mileage Warranted	Yes
Engine Keys Count	2
V5 present	Yes
V5 VIN Match	Yes

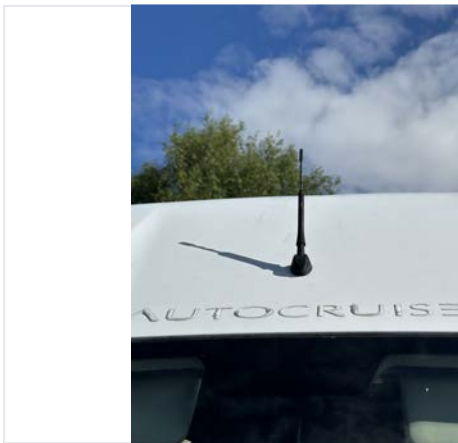
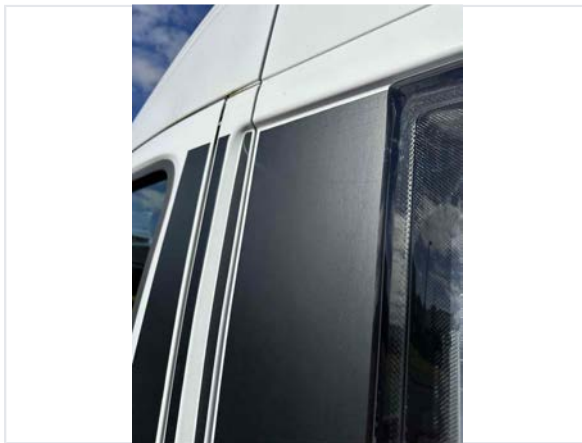
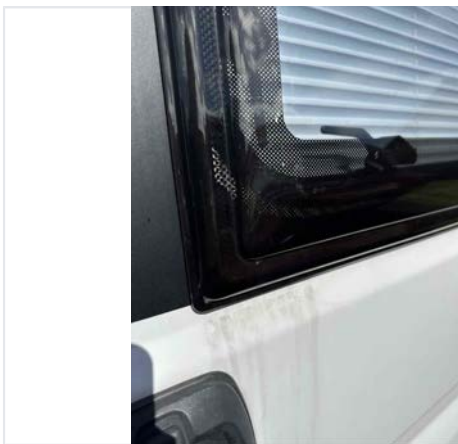
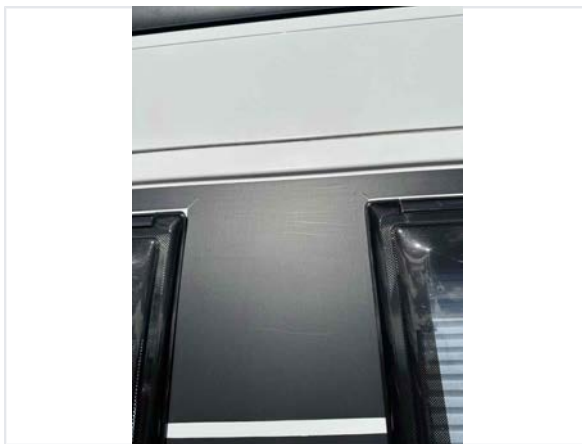
External Extras	Awning, Tow bar, Solar panel, Tv Aerial
Other External Extras	N/A
Decals	Need attention
Decals Further Info	Overcab lettering rusting // N/S decals have bush scratches and ripping in corners

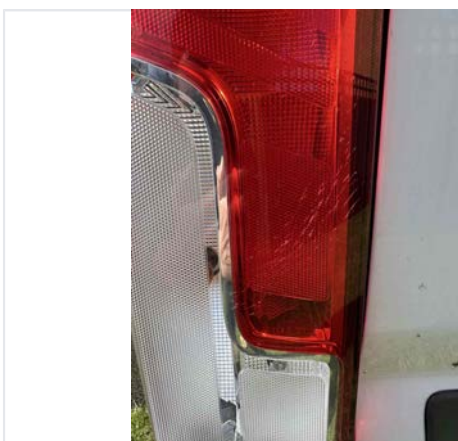
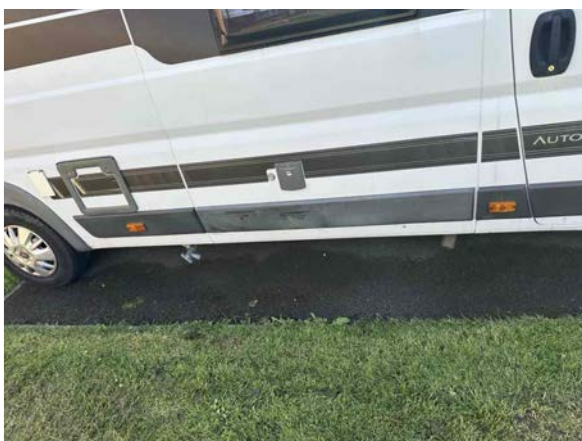
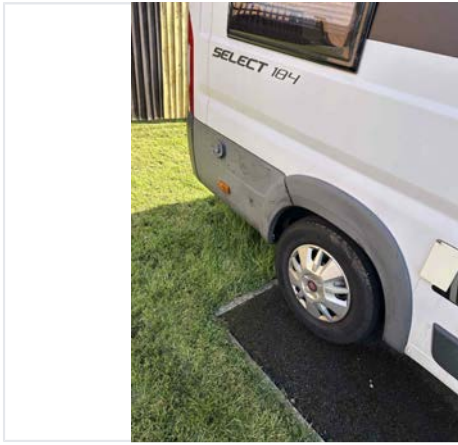
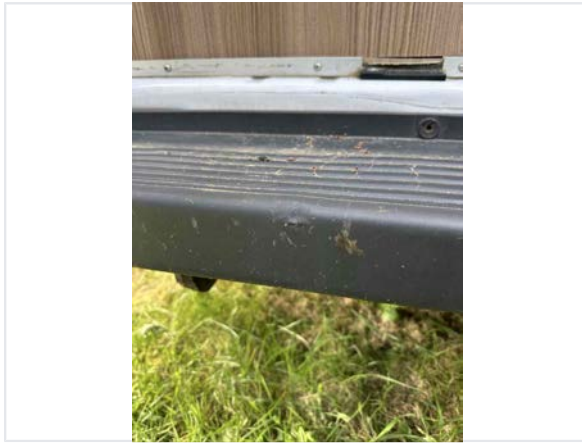
Any Damage Found	Yes
Damage Further Info	Light cracking on NSR light cluster // OS plastic trims are faded // Small area of damage on rear bumper

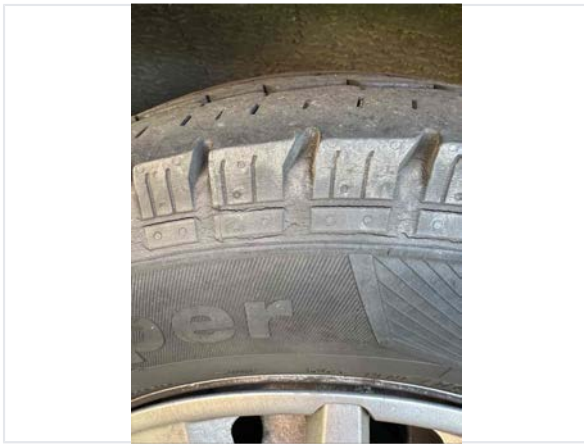
Windscreen	No damage
Alloy Wheels	N/A
Tyres illegal/cracking/out of date	Yes
Tyre Further Info	2x tyres dated 2018 but good condition // OSR tyres dated 2016 starting to crack

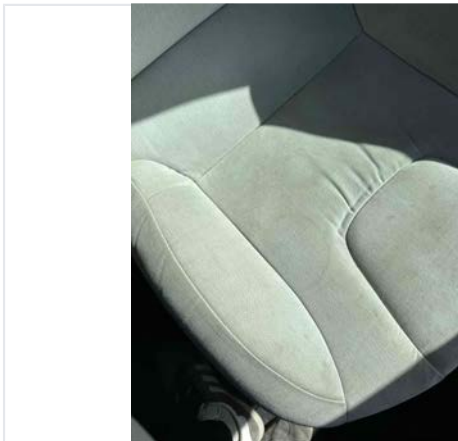
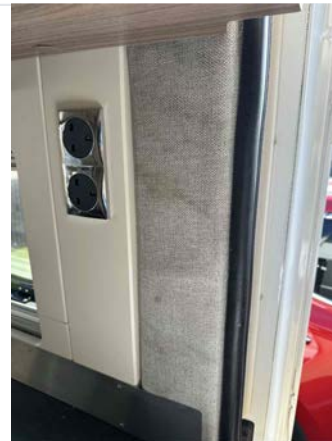
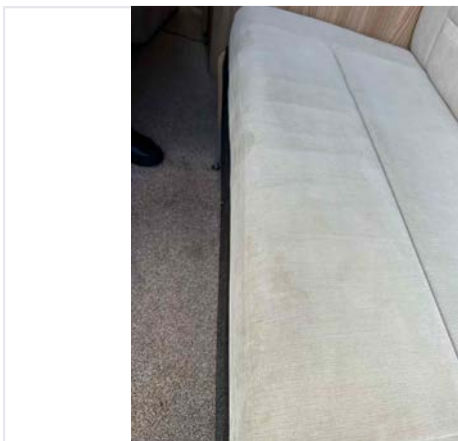
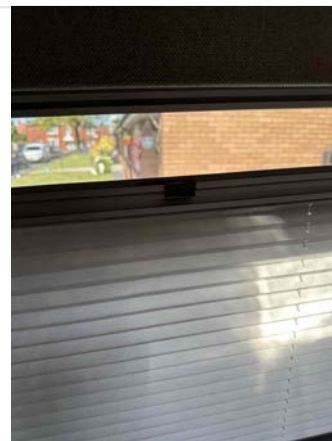
Internal Extras	Bluetooth, cab A/C, Cruise control, Oven, Carpets
Other Extras	N/A
Electrics turn on	Yes
Control panel damaged	No
Stereo turn on	Yes
Smell or signs of smoking	No
Cushions correct	Yes
Boiler present	Yes
Overhead lockers ready	Yes
Internal Damage	Yes
Damage Info	Stains on passenger seat, NS fabric next to sliding door, OS bench seat and fabric on N/S lower wall under bench seat // Clip missing off OSR blind

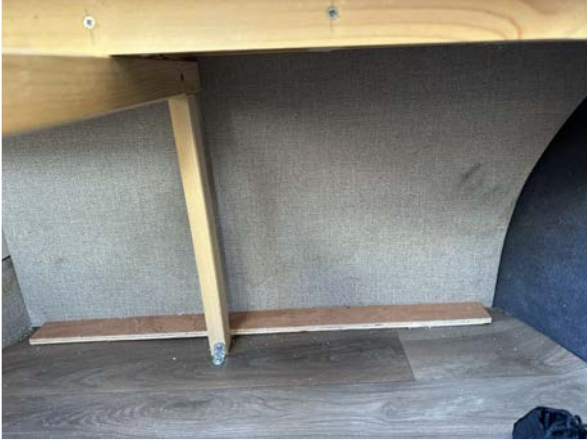
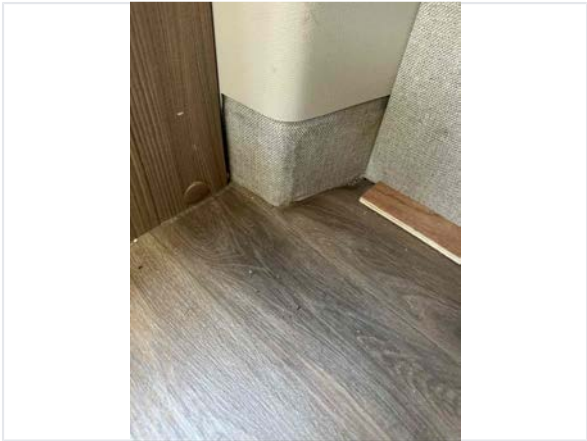
Soft floor NSR corner
