## CMS MOTORHOME INSPECTION FORM

Make & Model	CI Cusona 594
Reg Number - NO GAP	WA56FGK
HPI Clear	Yes
VAT	No
Engine Size	2.0l
BHP	98bhp
Transmission	Manual
Vehicle Weight (kg)	3500kg
Miles or KM	Miles
Mileage	48567
Confirm miles (within 5,000)	Yes
Is Mileage Warranted	Yes
Engine Keys Count	2
V5 present	Yes
V5 VIN Match	Yes

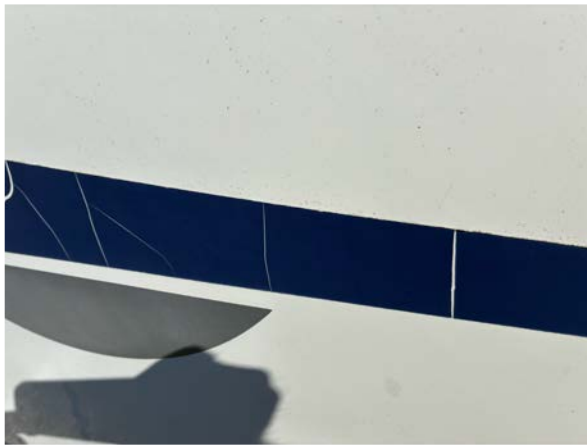
External Extras	Awning, Bike Rack, Manual step, Reversing camera, Solar panel
Other External Extras	N/A
Decals	Need attention
Decals Further Info	Faded but reasonable for age

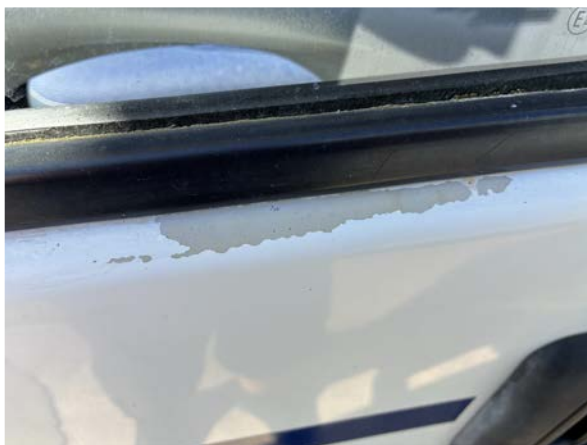
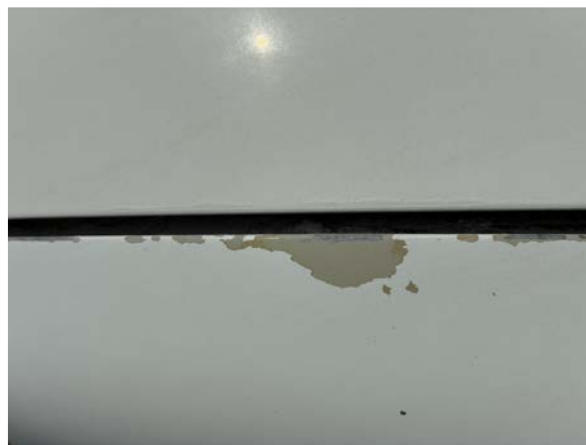
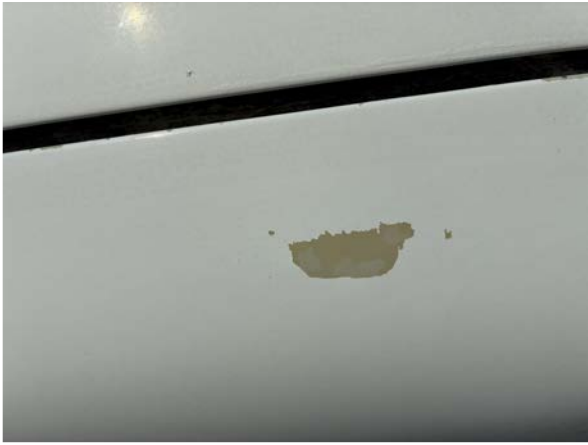
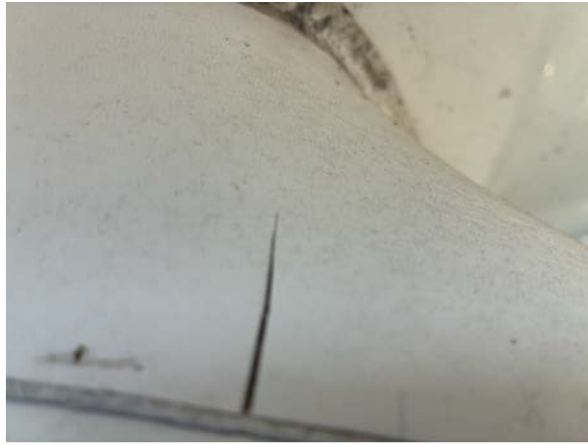
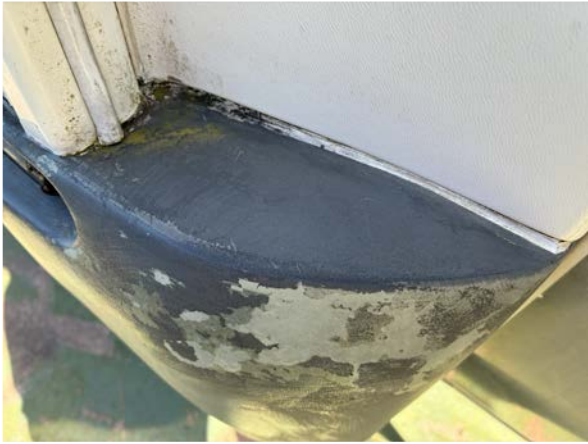
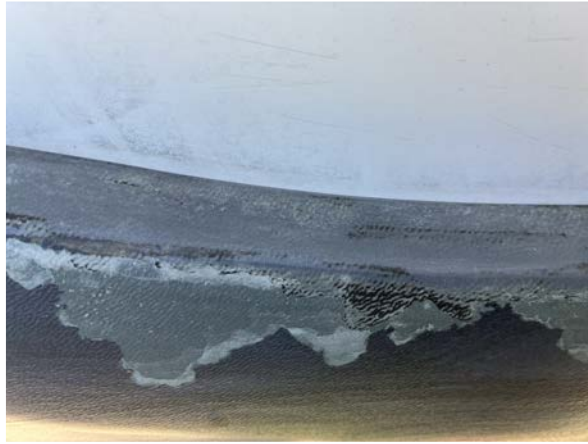
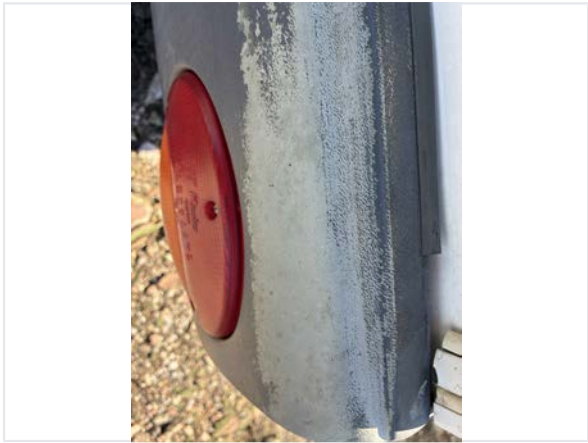
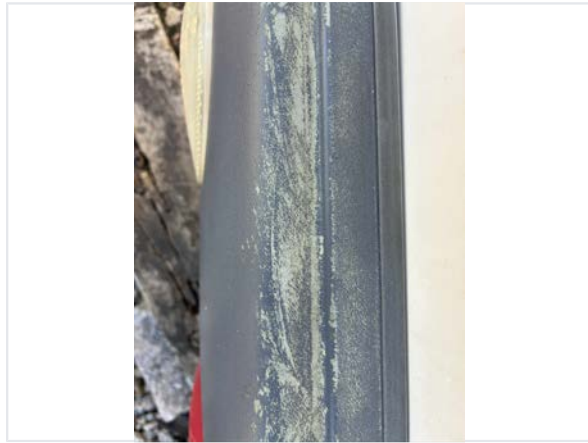
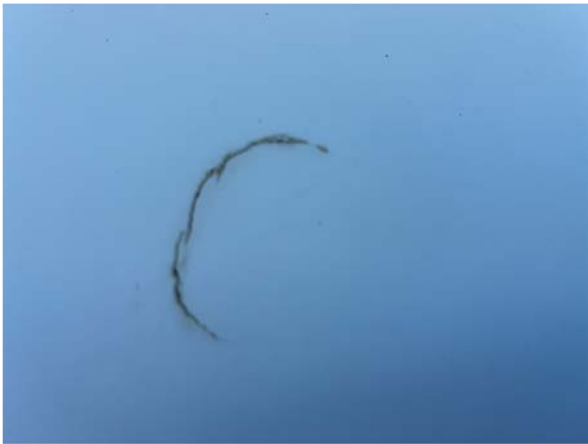
Any Damage Found	Yes
Damage Further Info	Plastic skirt around vehicle in poor repair Paint peeling around vehicle Crack on back of vehicle Crack on vinyl above drivers door

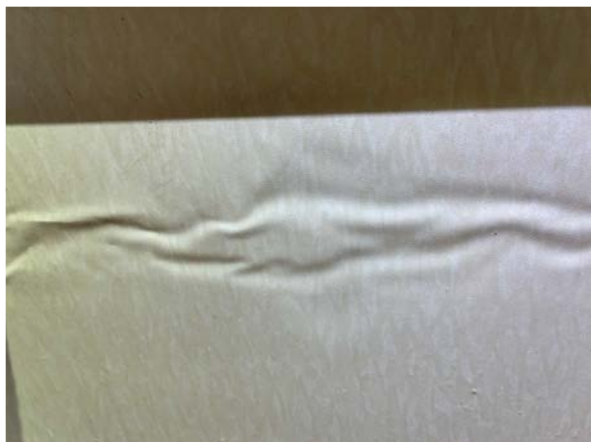
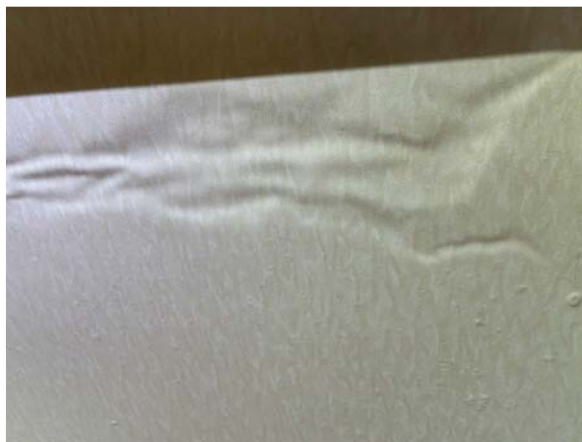
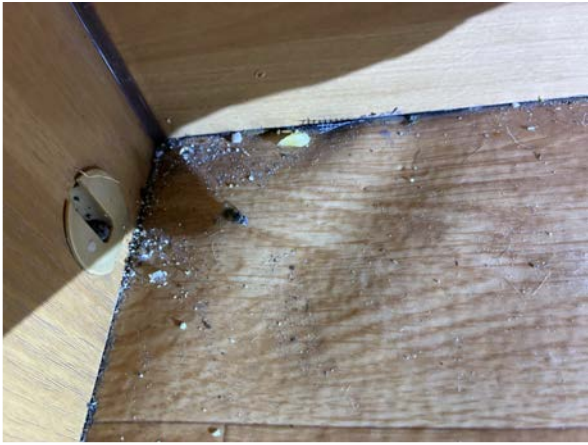
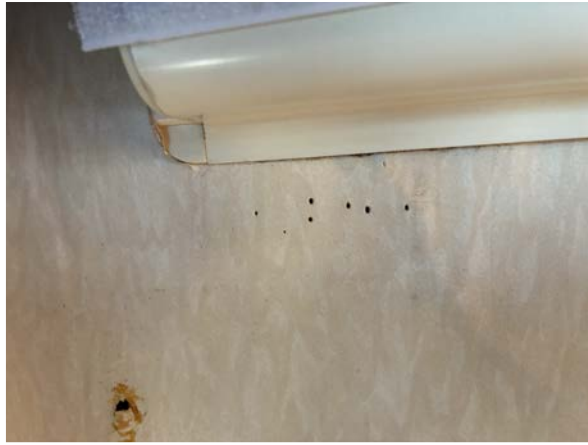
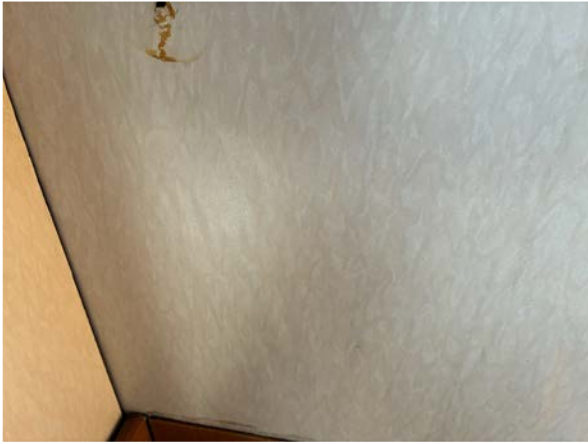
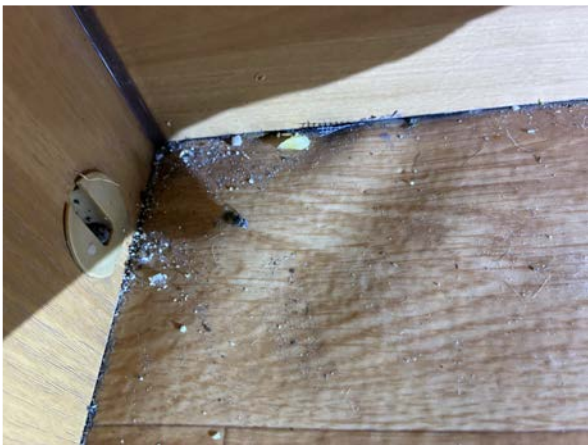
Damp (visible/soft)	Yes
Damp Info	Under off side window wall soft with lifting wallpaper Extensive soft flooring under both bench seats Walls soft under both Bench seats All rear wall soft in places with 99% readings all Over
Floor damp/spongy/damaged	Yes
Floor Info	Discussed as above
